Assessment & Repairs to **Fire** Damaged Concrete Foundations

A Historic & Devastating 2017 Fire in Santa Rosa, CA

Ashok Kakade, P.E., Principal Engineer

Concrete Science, Inc.
Materials & Structural Engineers

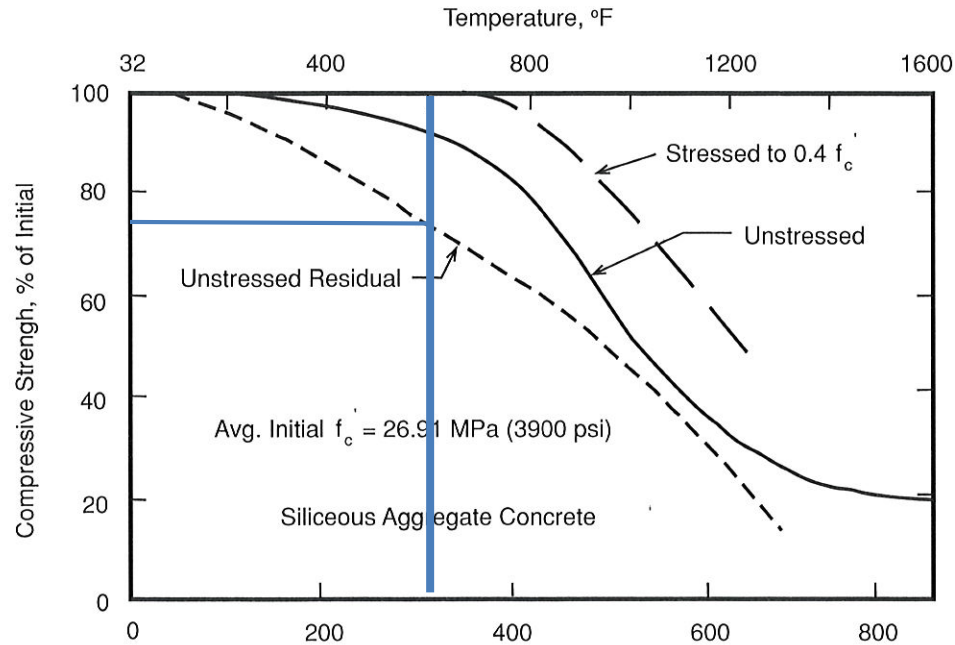
Relative Compressive Strength After Fire

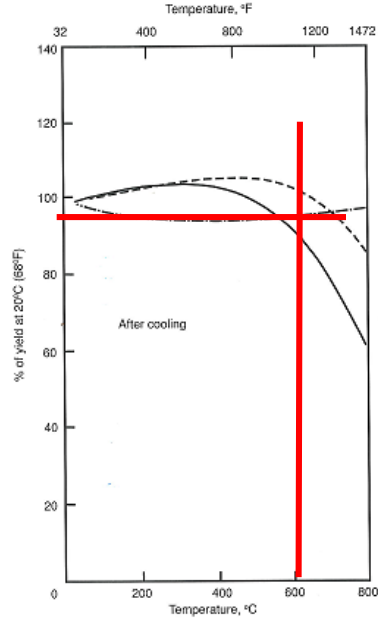
Fig. 4b. Yield strength of steel reinforcement after cooling.

Yield Strength of Steel After Fire
