# The Science of Saving Money

## *A Split Slab Waterproofing Project*

Miracote Division  
Crossfield Products Corp.

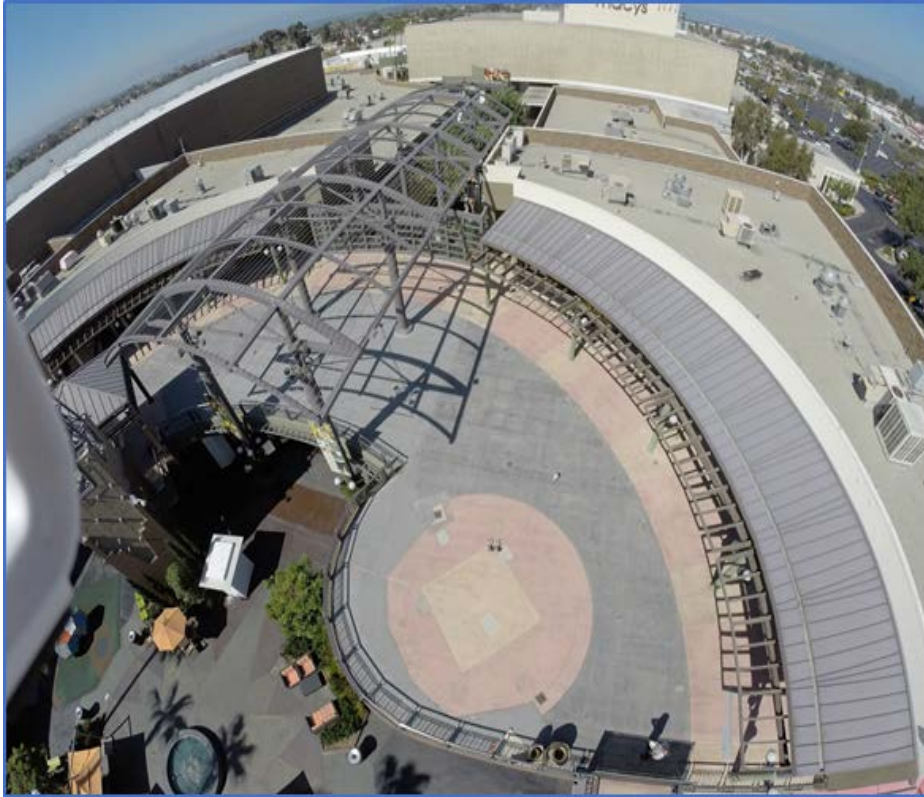
# The Structure

- Construction consisted of a structural concrete slab with an applied sandwich waterproofing membrane.
- Followed by a cast-in-place 3” decorative concrete topping slab.
- Initial design issues and as-built conditions contributed to the leakage problem.

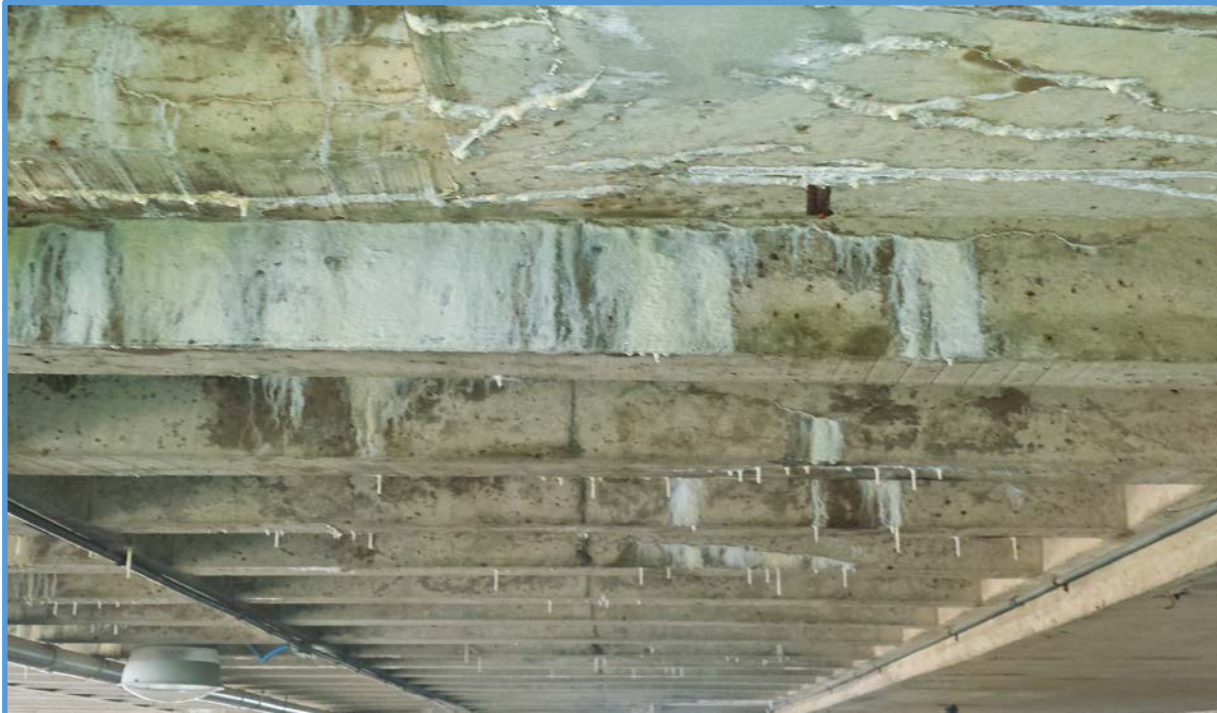
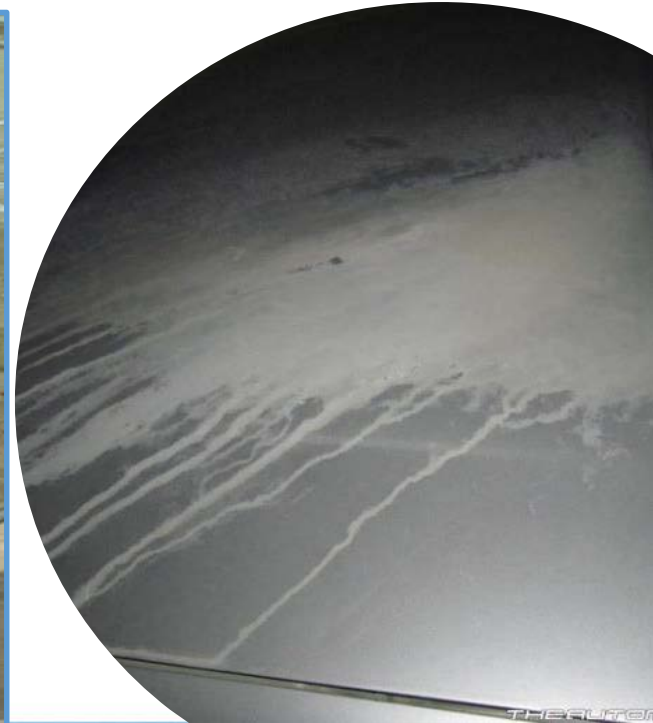
# Split Slab Waterproofing Failure

- 14,000 SF 2<sup>nd</sup> story pedestrian plaza deck was leaking profusely into occupied retail tenant space with every rain event.
- This was causing a negative impact on business making it difficult to retain and attract tenants.
- Previous attempts to mitigate the problem were unsuccessful.

“The Damage – Leakage into Occupied Spaces”

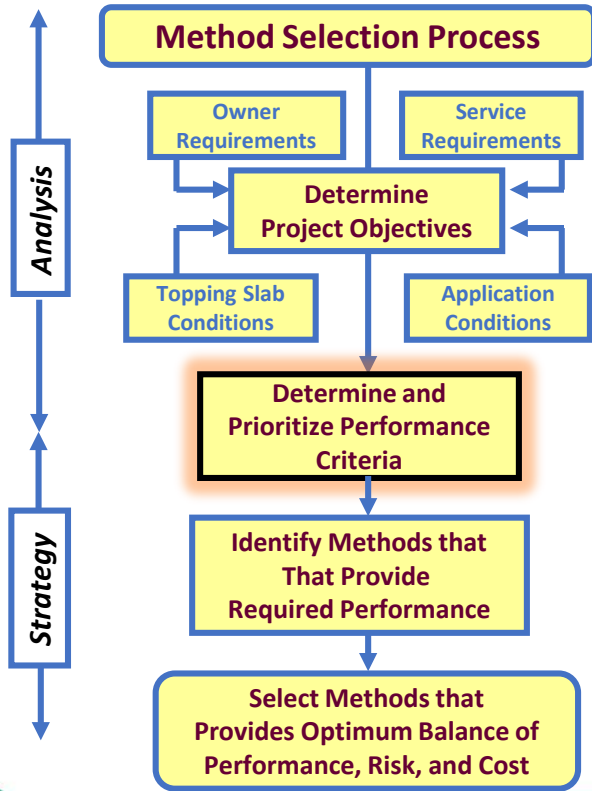
# Waterproofing Method Selection Flow Chart

- Cost for Complete Replacement
- Cost for Topical Waterproofing
- Impact on Operations
- Impact on Occupants
- Project Completion Time
- Waterproofing Material Options
- Longevity
- Exposure Conditions
- Durability
- Wear resistance
- Environmental – VOC's – Odor

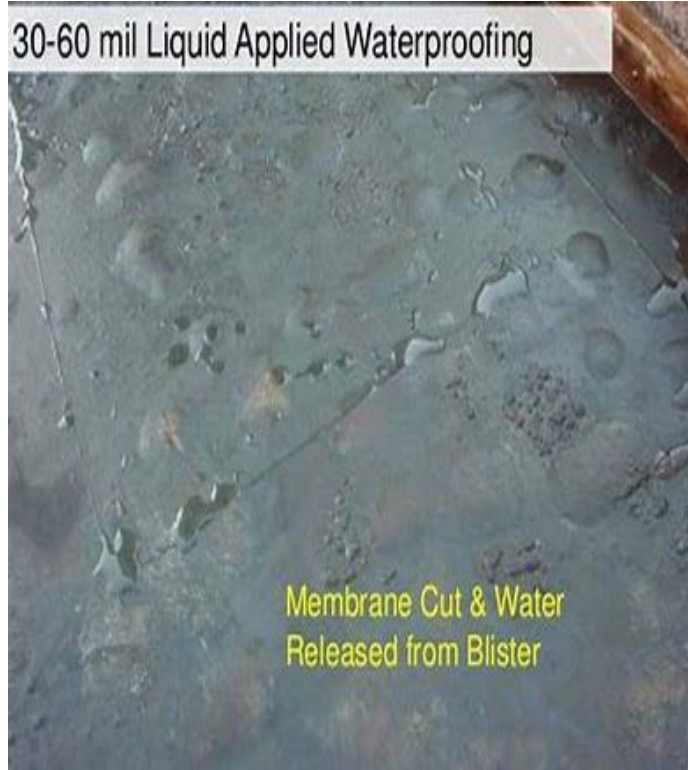
# Trapped Moisture Issues

- Moisture trapped in between split slab membranes and impermeable topical waterproofing membranes can cause bond issues!

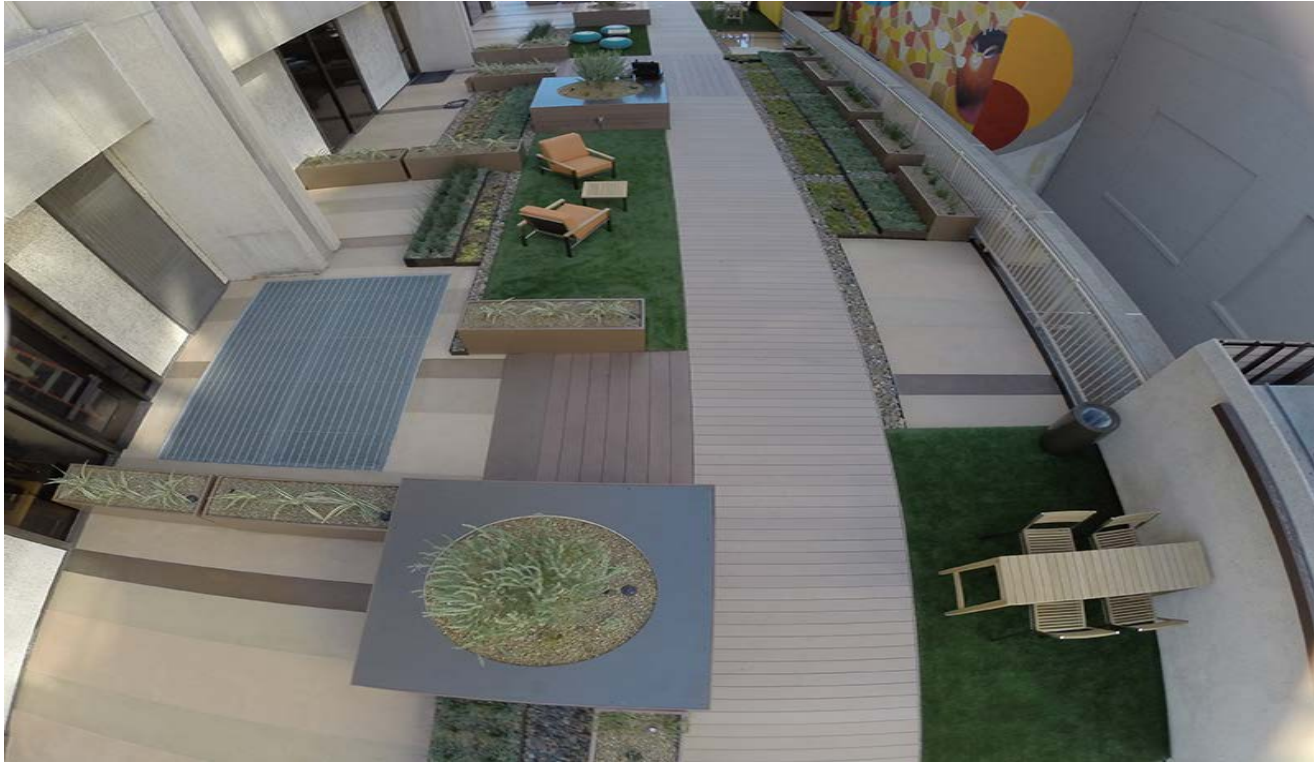
# The Selected System

*Cementitious, Decorative, Moisture Vapor Permeable!*

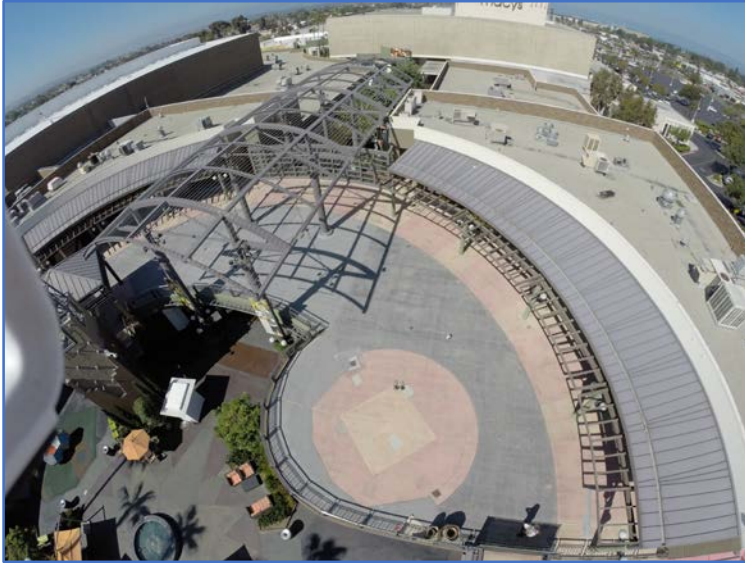
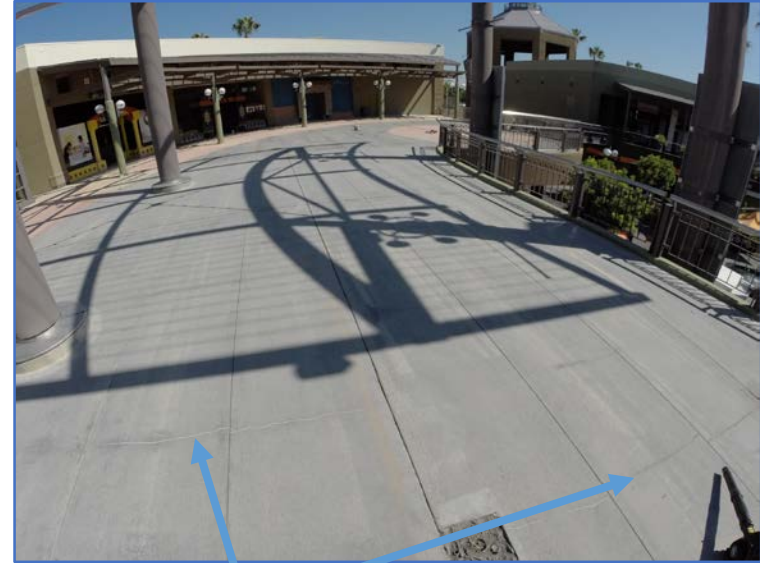
Inadequate Joint Design – Leads to Moving Cracks

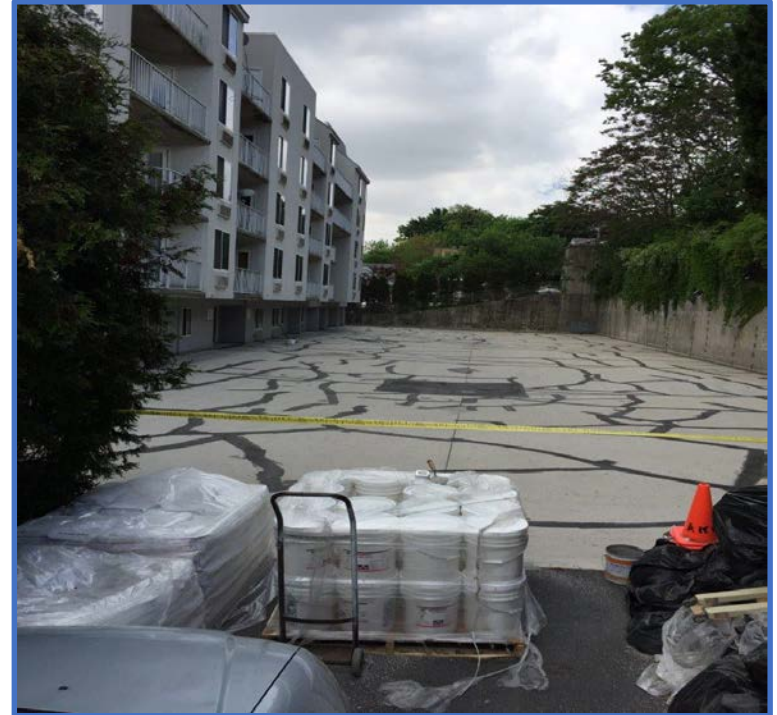
### Insufficient Joint Details

- Deck dimensions: (L)188' X (W) 61'
- Joint spacing: 1 (Longitudinal) - 30' o/c  
4 (Transverse) – 46' o/c
- Coefficient of Expansion (5.5 millionths/° F)
- Assuming a 100° F annual temperature swing
- $LF \times 12'' \times 100^\circ F \times .0000055$
- Unrestrained contraction 1.24'' (L) and .41'' (W)
- Timing and Proper Saw-cut Depth are Crucial
- Install Additional Relief Joints, as required.

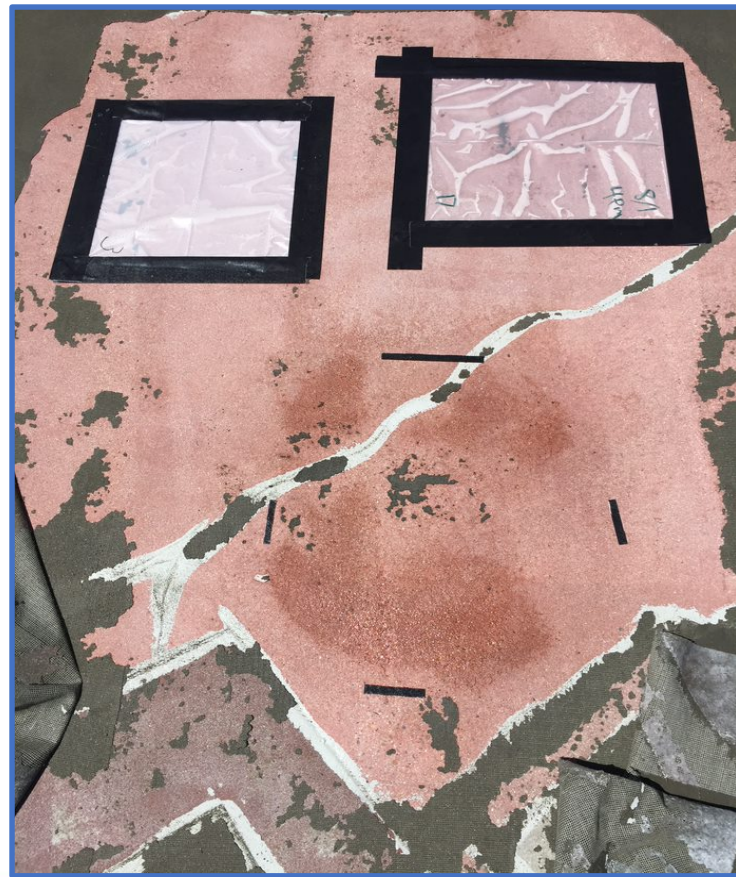
# On Site Moisture Testing

**#3 Plastic Sheet Test**

**#4 Plastic Sheet Test**

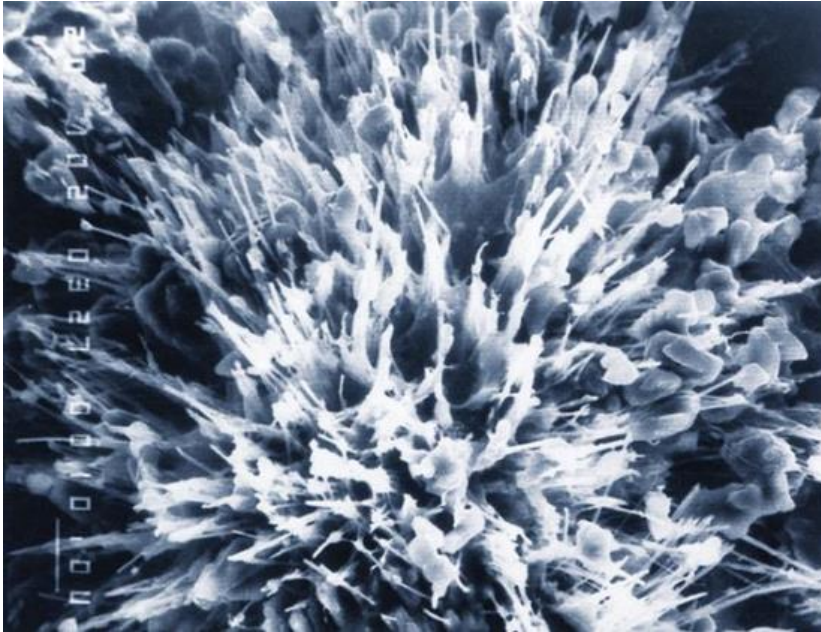
# What is a Colloidal Silicate

- **Colloidal** always refers to a liquid material.
- Contains suspended particles of **solid silica**. Will not settle.
- **Nano-size** (5 nm) solids in permanent liquid suspension.
- Colloidal Silicates – **Not to be Confused** with Crystalline Powder Formulations.
- **Powder** Formulations – **Hydrophobic** and exhibit **Shallow Penetration**.
- **Colloidal Silicates** – **Hydrophilic and Migrate Deep** into the Concrete.

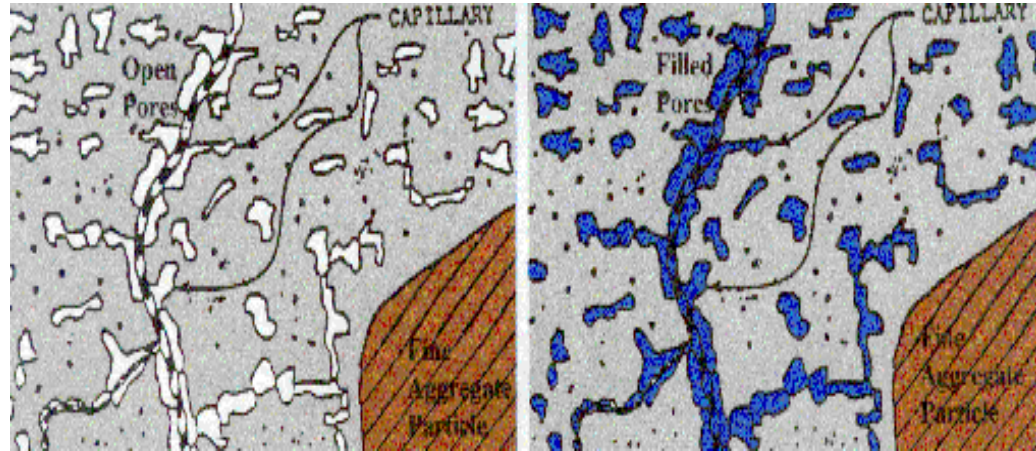
## PROCESS OF MIGRATION & CHEMICAL REACTION

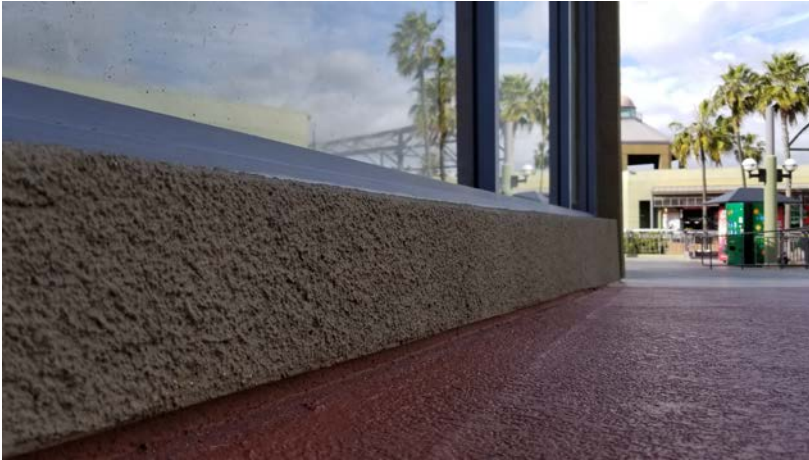
- 'L' Metal flashing installed behind weep screed

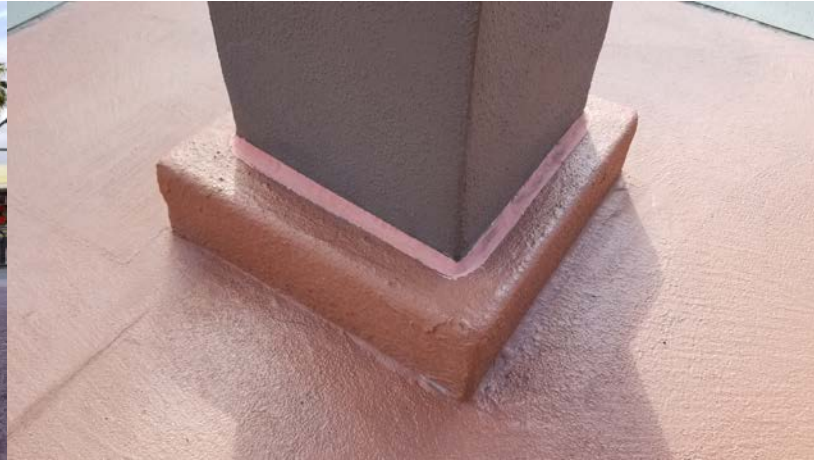
- Sealant termination at square columns

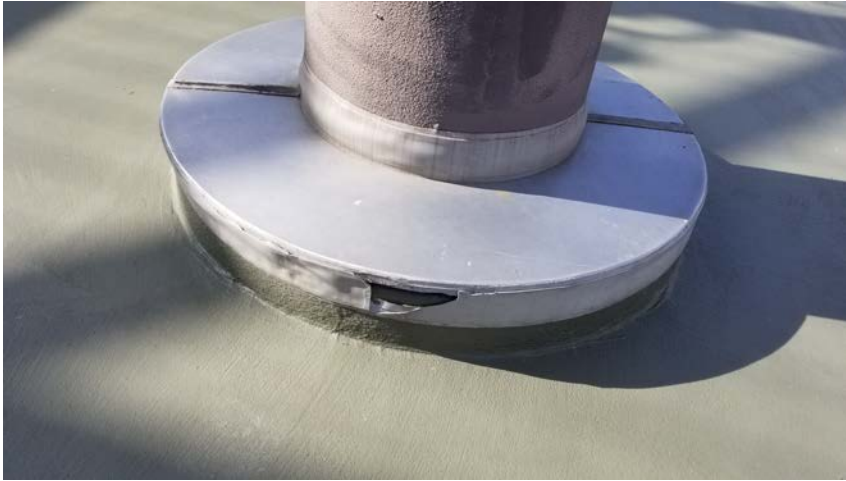
- Extruded silicone was used
- Works but subject to vandalism

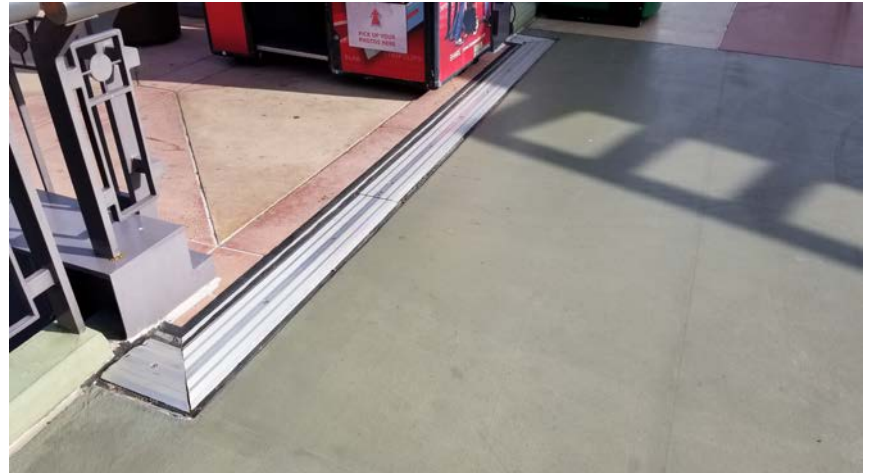
- Proper termination to earthquake joint body

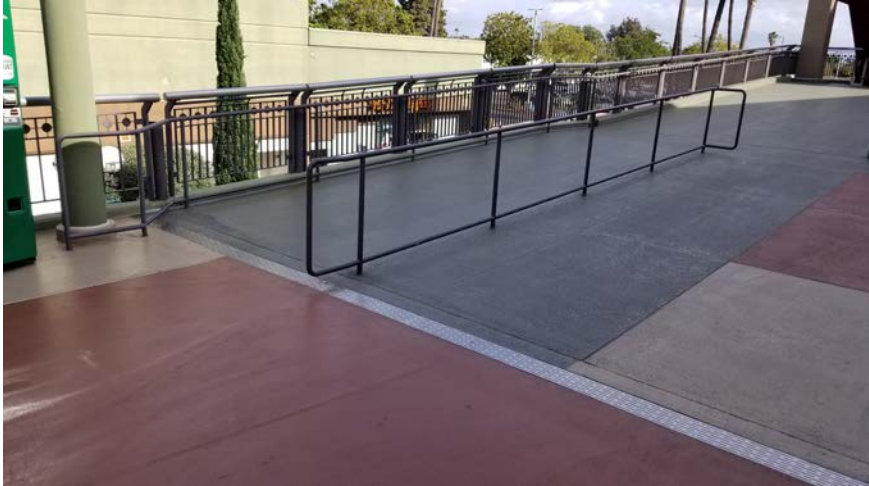
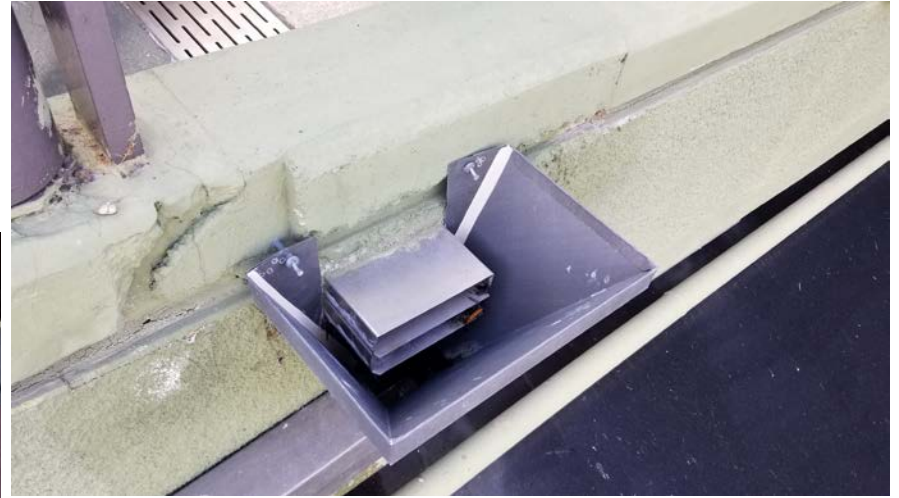
- Dual level drainage installed
