Experimental Response and FRC Strengthening of Existing RC Members

2018 Spring Convention | April 11-13 | San Francisco, CA

Case Study 5 storey RC building built in 1963
severely damaged by the L'Aquila earthquake (2009)

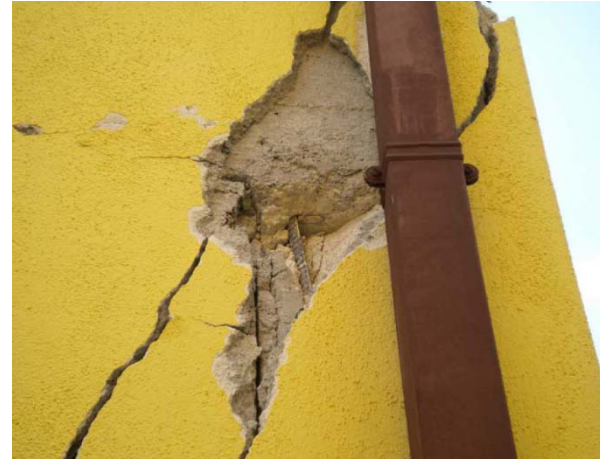
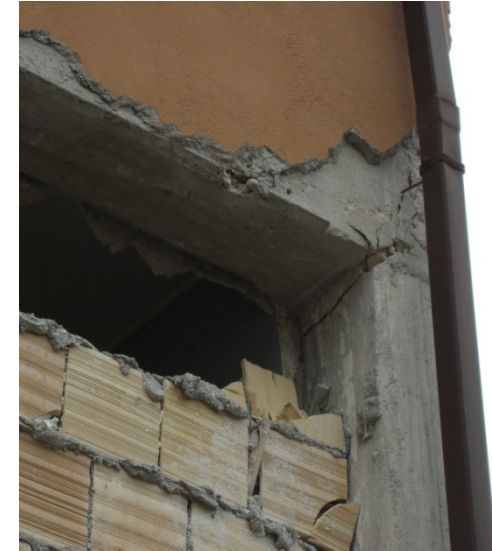
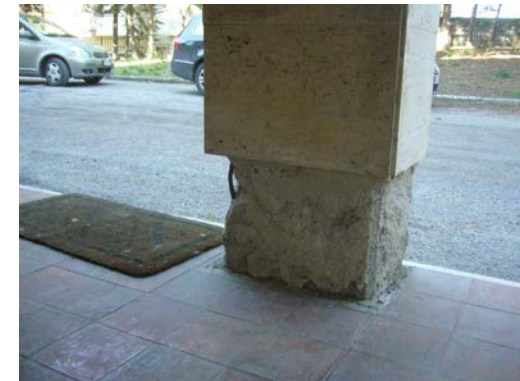
Recent seismic events outlined the main structural weaknesses of existing RC buildings:

- **Brittle failure** of structural members due to lack of proper seismic details
- **Joint panel shear failure** due to the lack of stirrups in the joint panel
- **Buckling of longitudinal reinforcement** due to the high spacing of stirrups (200-300 mm)

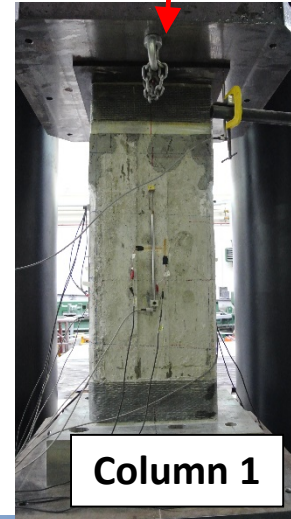
Two Columns were extracted at the second floor of the same frame

Column 1

Column 2

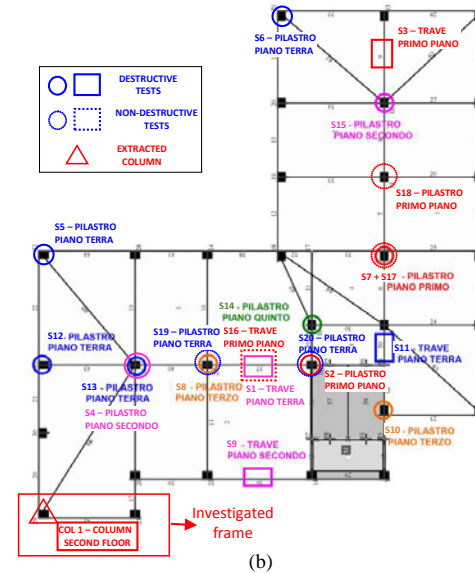
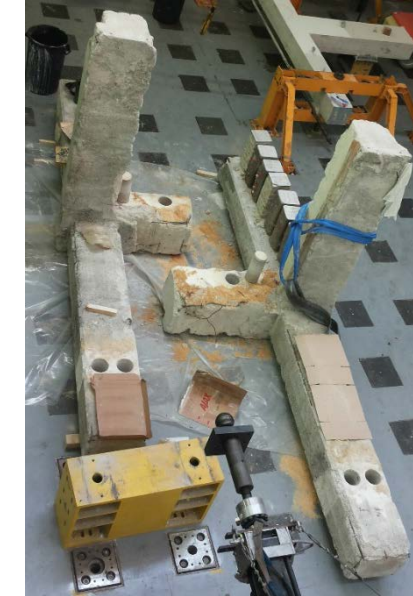
smooth internal reinforcements

Concrete
 $f_c = 12 \text{ MPa}$

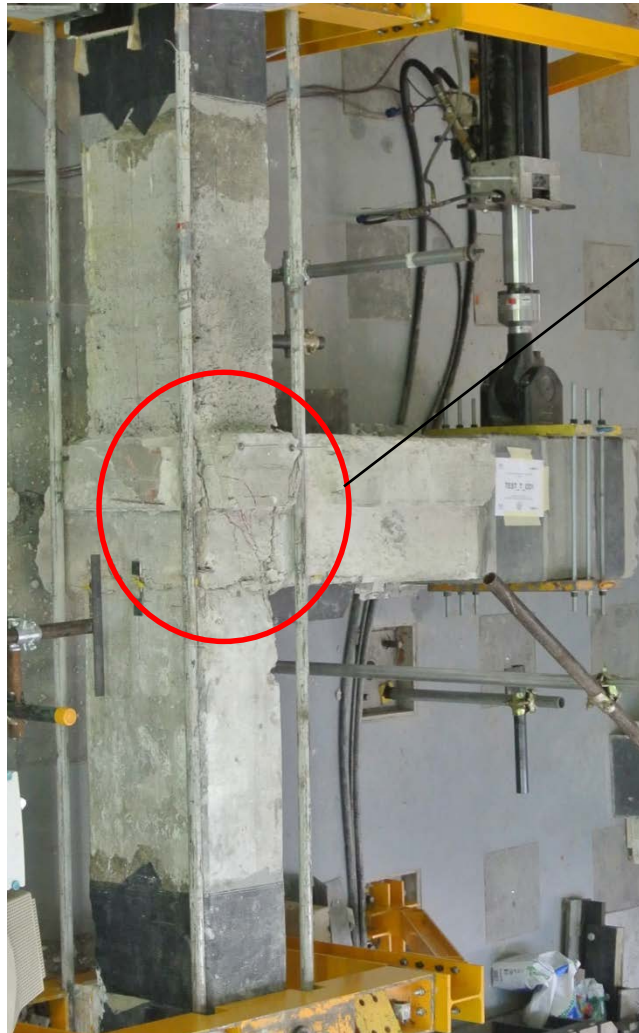
TEST RESULTS – AS-BUILT JOINT

Poor seismic performance due to the **joint panel shear failure** (in the positive load direction)

Beam yielding (in the negative load direction)

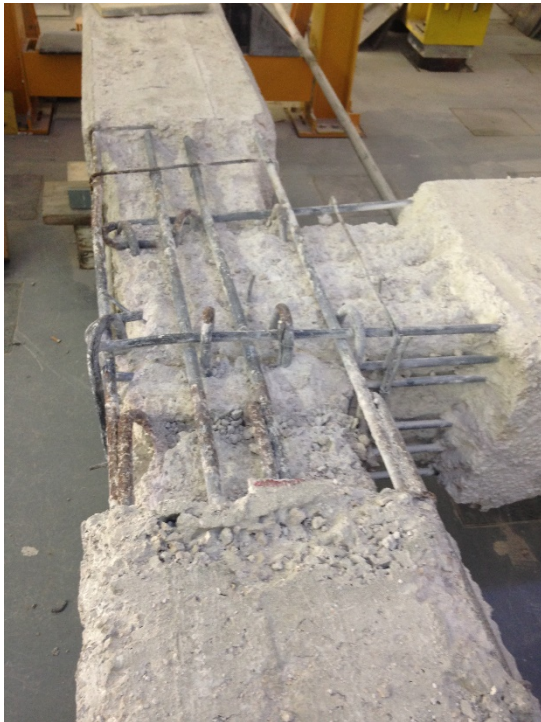
Concrete cover removal
(40 mm by using a
jackhammer to have a
rough surface)

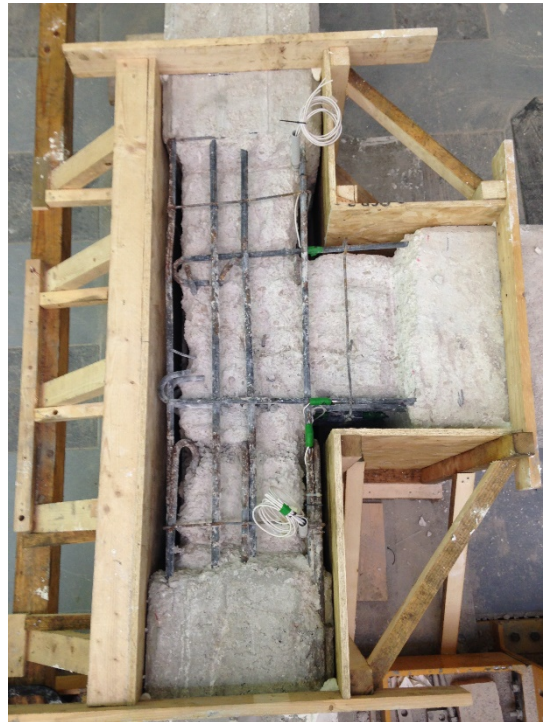
Stiff and hydraulic
sealed formwork

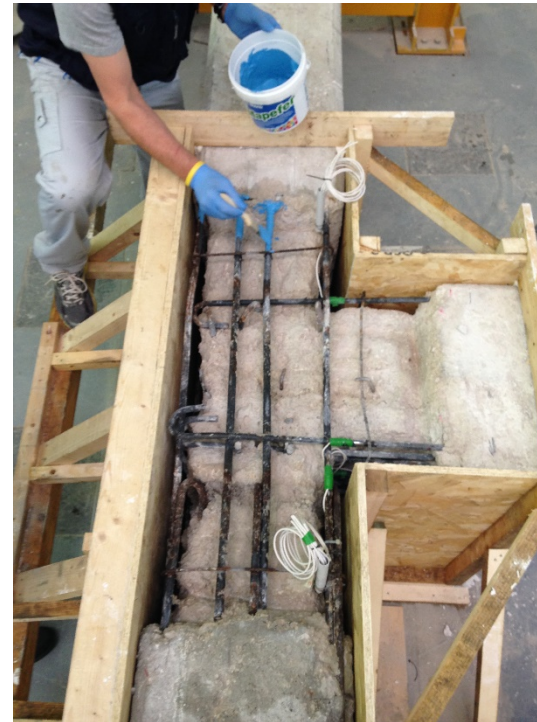
Anti-corrosion
cementitious mortar

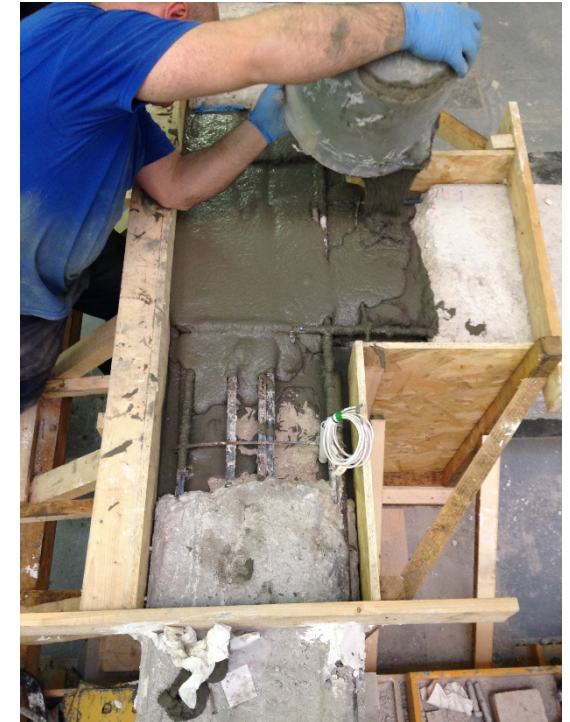
Cast of the HPC
strengthening

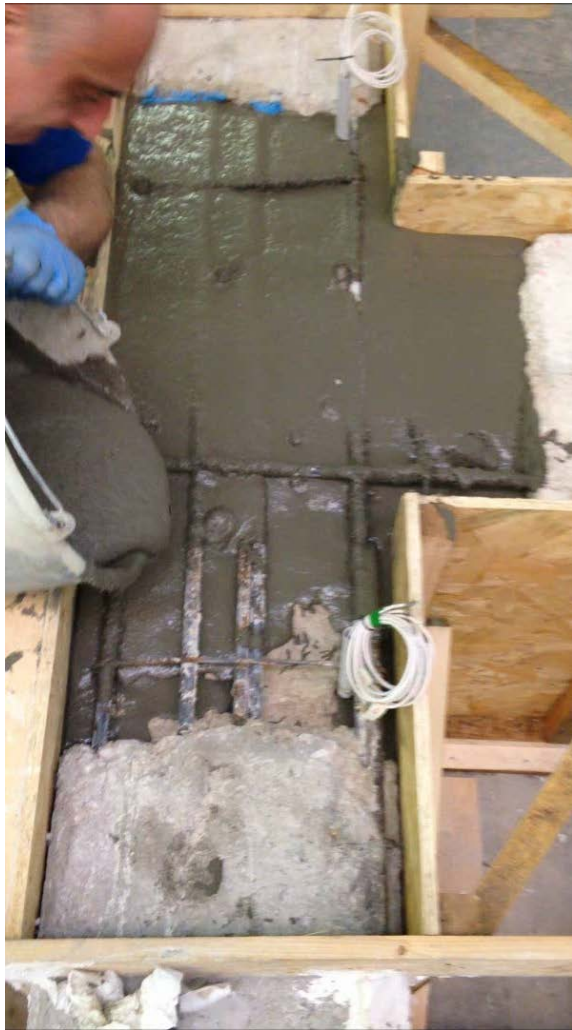
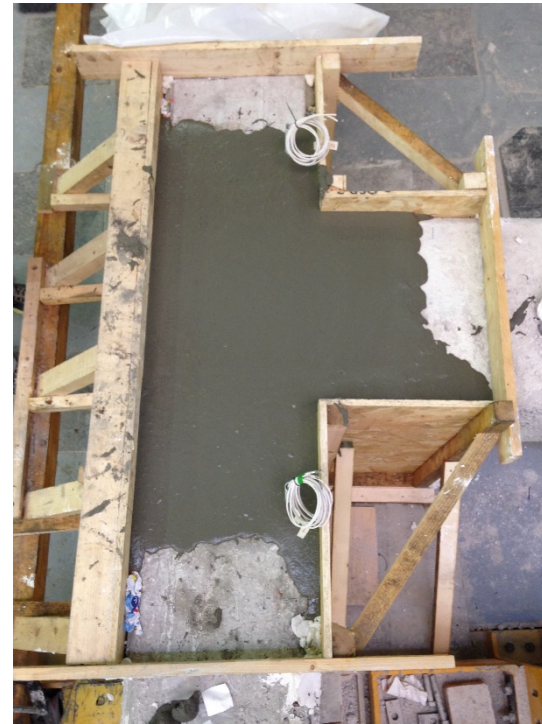
View of the strengthened specimen

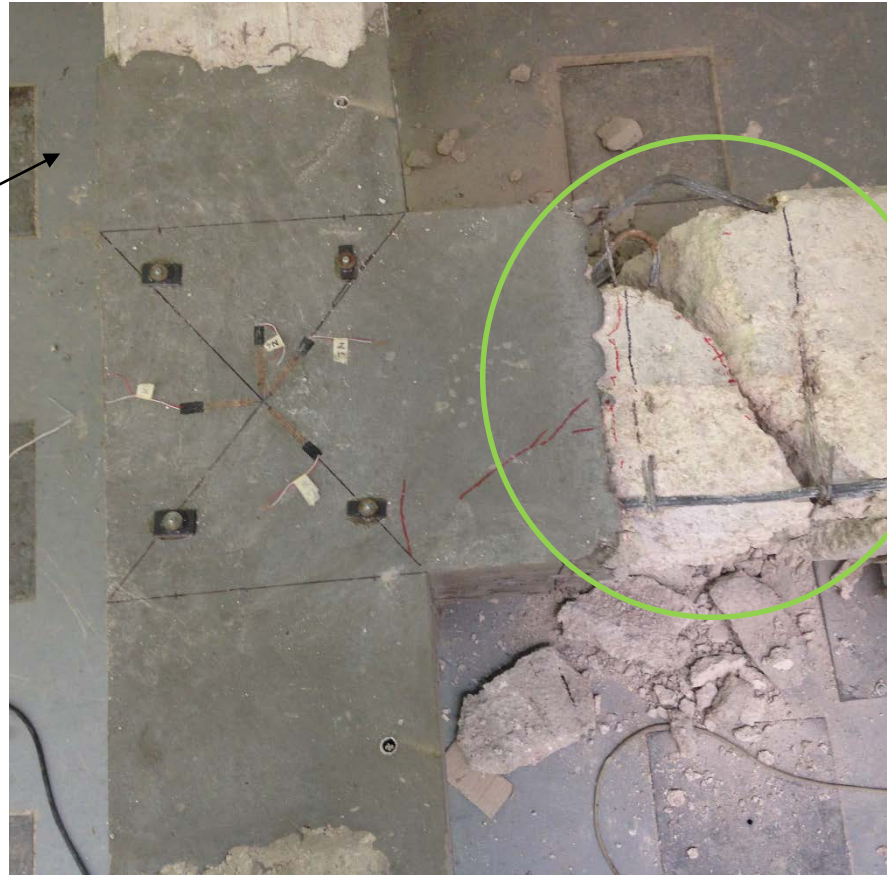
TEST RESULTS- HPC JOINT

High effectiveness of the HPC strengthening which avoided the joint panel shear failure promoting a more ductile failure mode

Beam hinge in both the directions

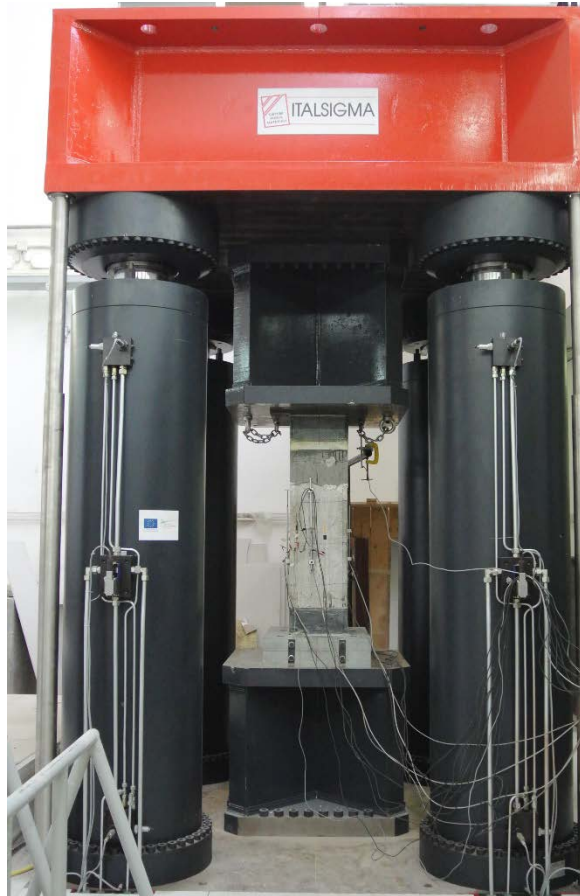
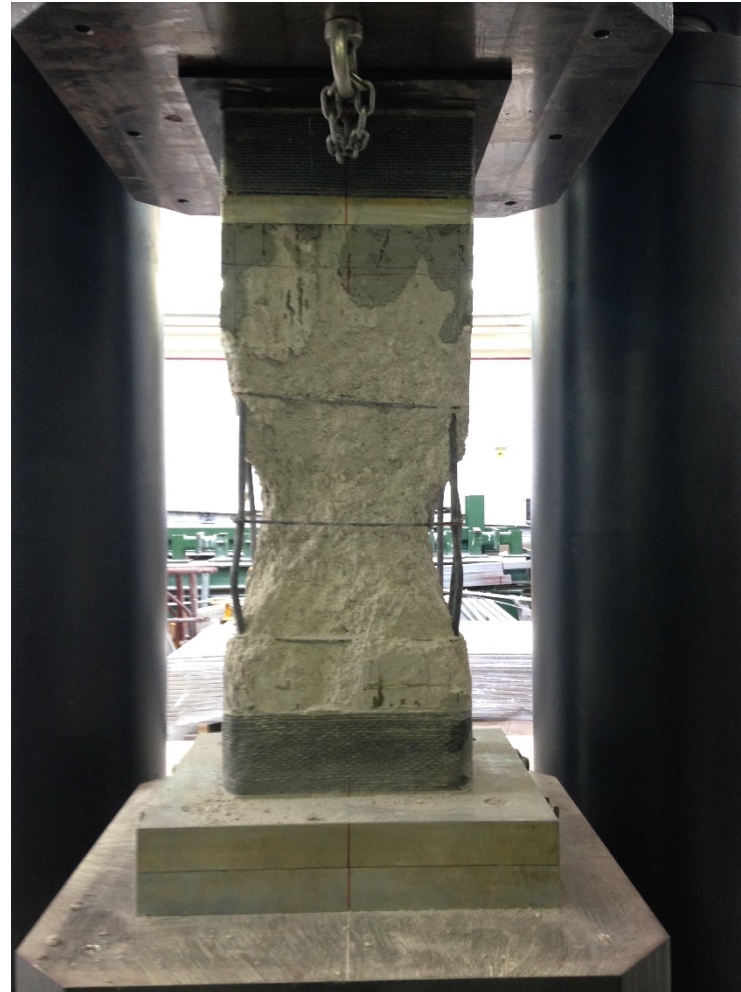
TEST RESULTS-AS-BUILT COLUMN

Mega testing machine (30.000 kN,
3000 tons axial capacity)

Concrete crushing and bar buckling limited the axial load capacity

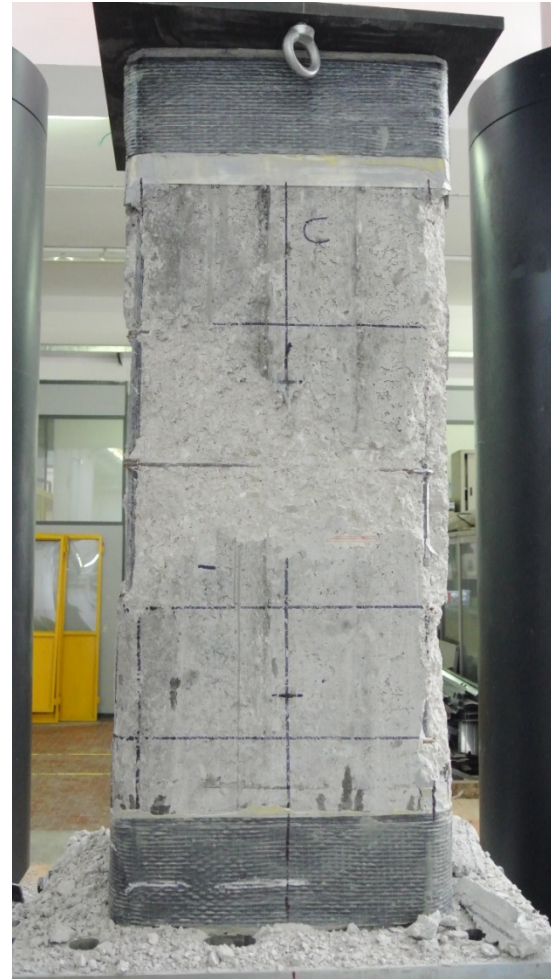
PRE-DAMAGE ON COLUMN 2

Column 2 was pre-damaged until the spalling of concrete cover and then repaired and strengthened

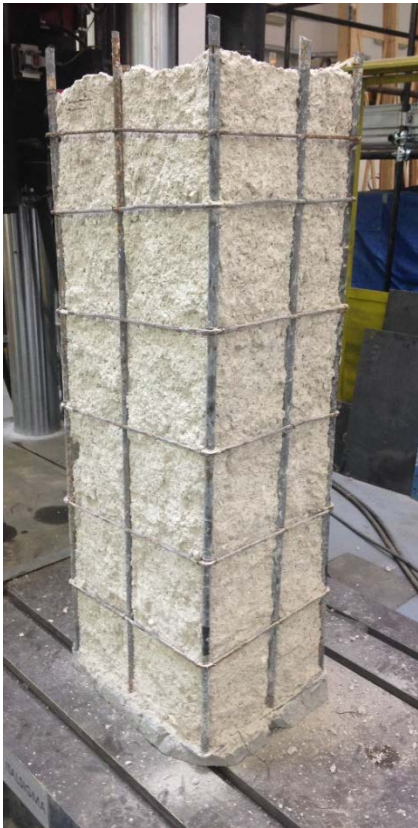
Concrete cover removal
(by using a jackhammer
to have a rough surface)

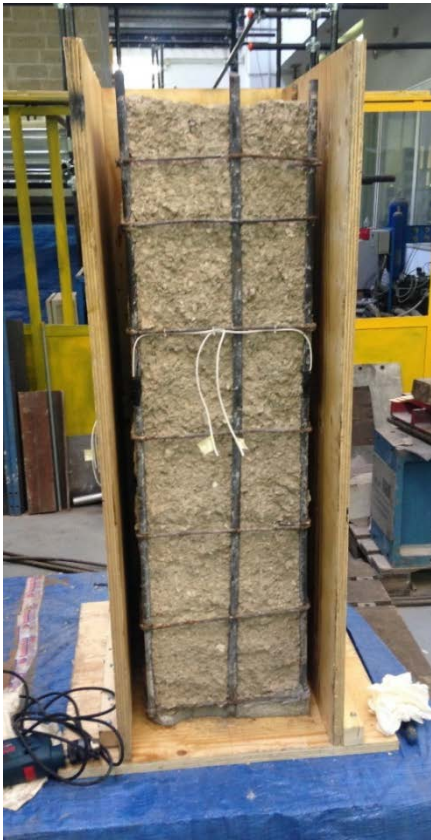
Stiff and hydraulic
sealed formwork

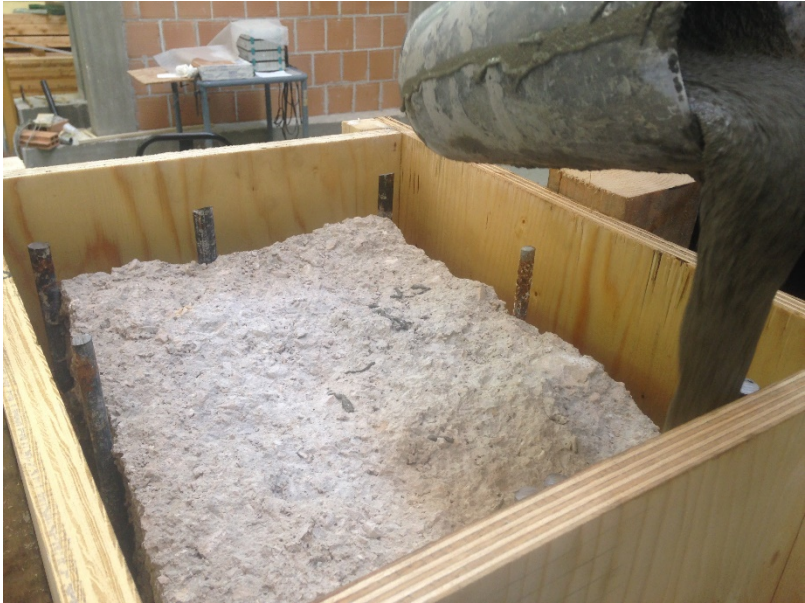
Cast of the HPC
strengthening

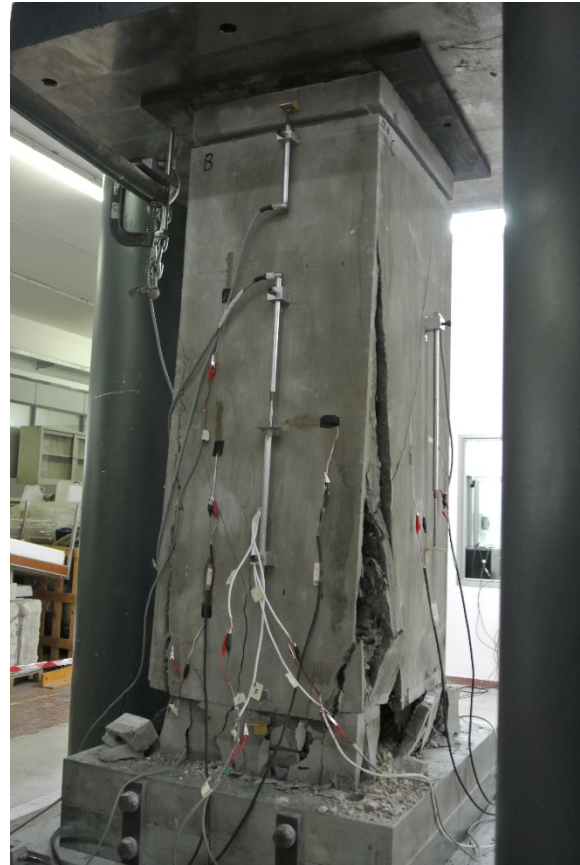
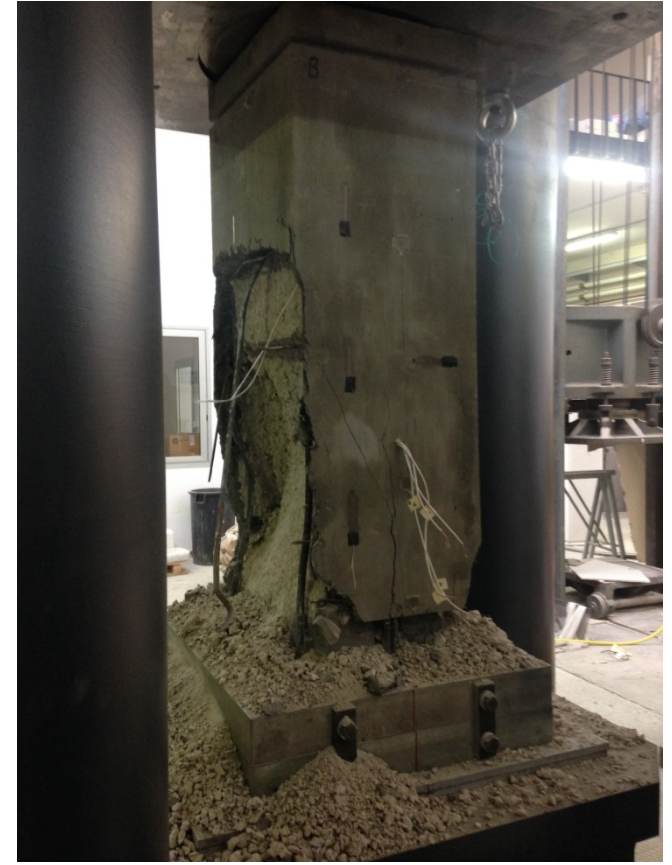
TEST RESULTS - HPC COLUMN

Cut of the HPC jacket
before the test
(it is working only in
confinement)

Experimental test demonstrated the high effectiveness of the HPC strengthening increasing the axial load capacity and delaying bar buckling

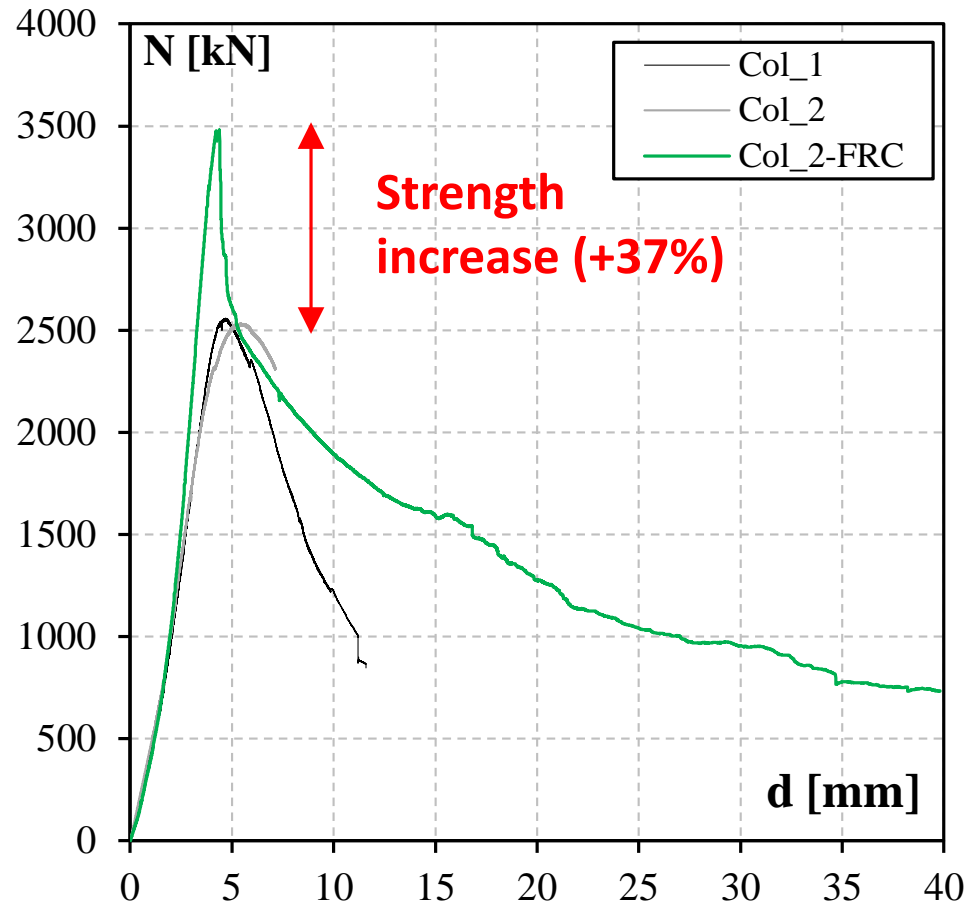
COMPARISON

The confinement by using the HPC strengthening increased the axial load capacity about the 37%

- The **premature shear failure of poorly detailed beam-column joints** may significantly limit the seismic performance of existing buildings
- An **innovative strengthening solution consisting of a thin FRC jacketing** has been proposed and tested
- The experimental test outlined the **high effectiveness of the proposed strengthening solution** which changed the brittle failure mode in a ductile one (+38 to 54% strength increase, +85% energy dissipation)
- The same strengthening technique has been used also for **column confinement** with satisfactory results (+37% strength increase)
