BARE IS BEAUTIFUL

How to waterproof and protect
concrete structures when you cannot
change their appearance

Presenters: Mario Baggio & Peter Kesser - *Alchemco*

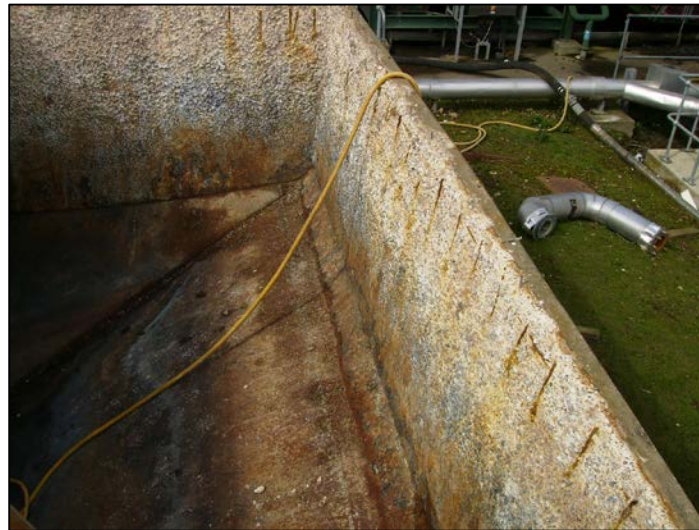
Chemical Deterioration

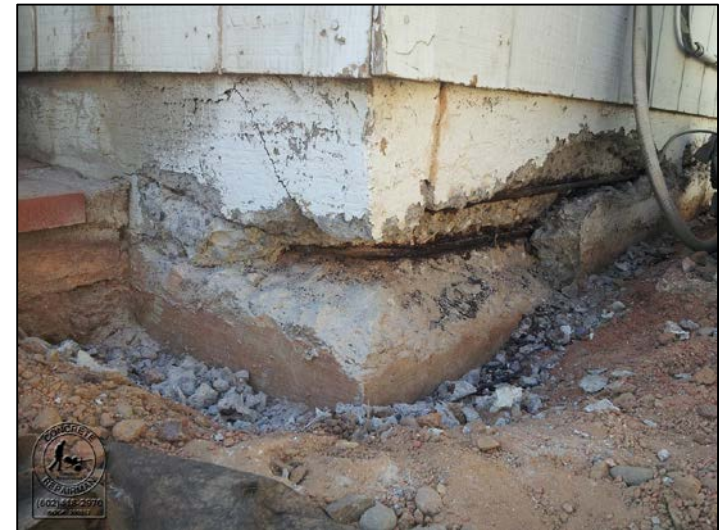
Temperature & Moisture Deterioration

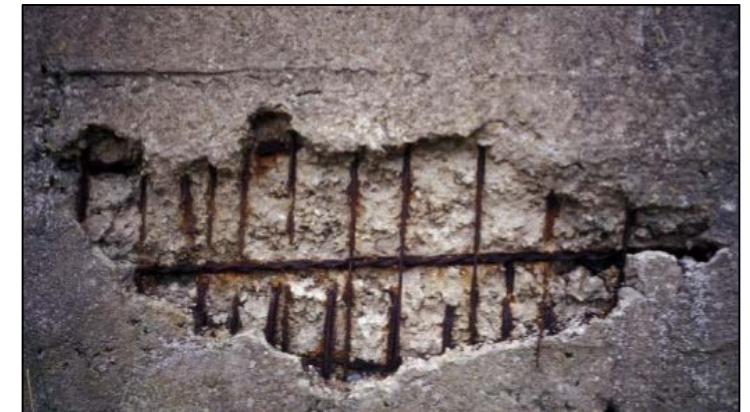
Here is an example of corrosion of the steel reinforcement causing the concrete to 'spall'.

Spalling caused by Corrosion of the Steel Reinforcement

- **'CORROSION'** of the steel reinforcing rods is another potential factor in the deterioration of concrete. This is caused when the 'passive layer' of concrete surrounding the steel reinforcement breaks down ... exposing the steel. When the steel reinforcement corrodes, it expands in size ... exerting a force on the surrounding concrete, which ultimately leads to cracking, spalling, etc. The process accelerates in the presence of chlorides that are dissolved in water from sea water or salts used for de-icing.

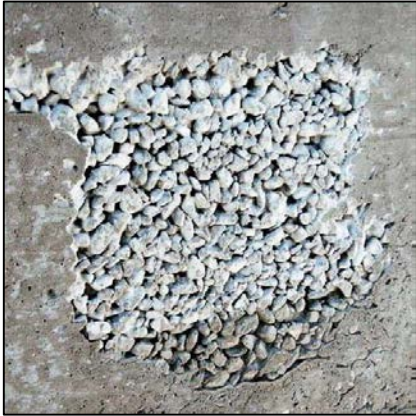
Pitting/Honeycombing

- Pitting or Honeycombing
- Stress Cracks
- Shrinkage Cracks

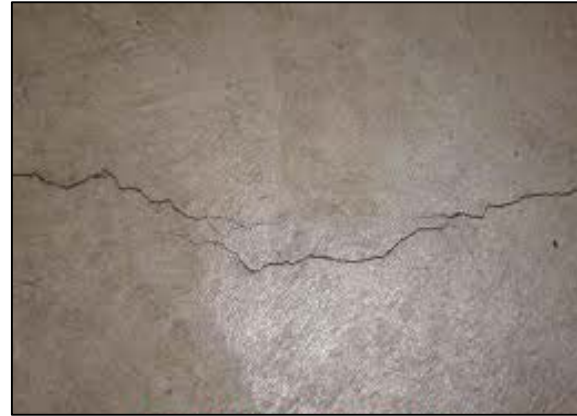
Stress Cracking

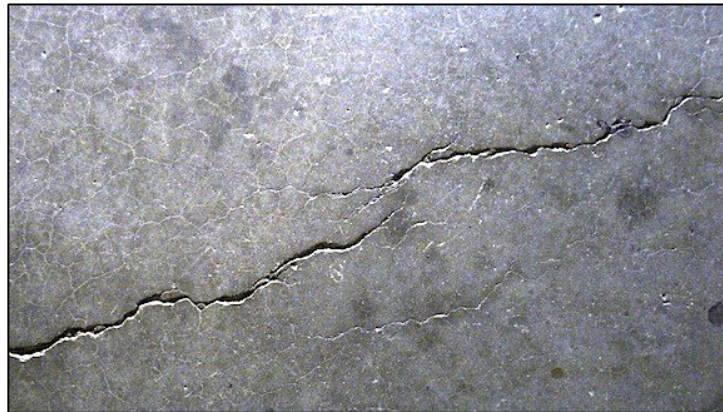
Shrinkage Cracking

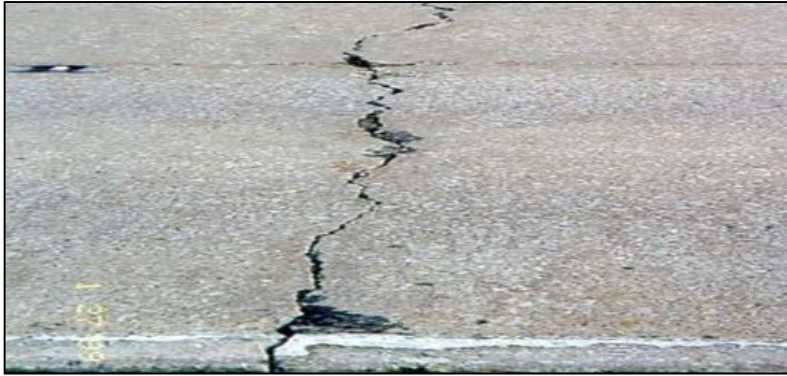
Thermal Stress Cracking

- Thermal Stress Cracks
- Tension Cracks

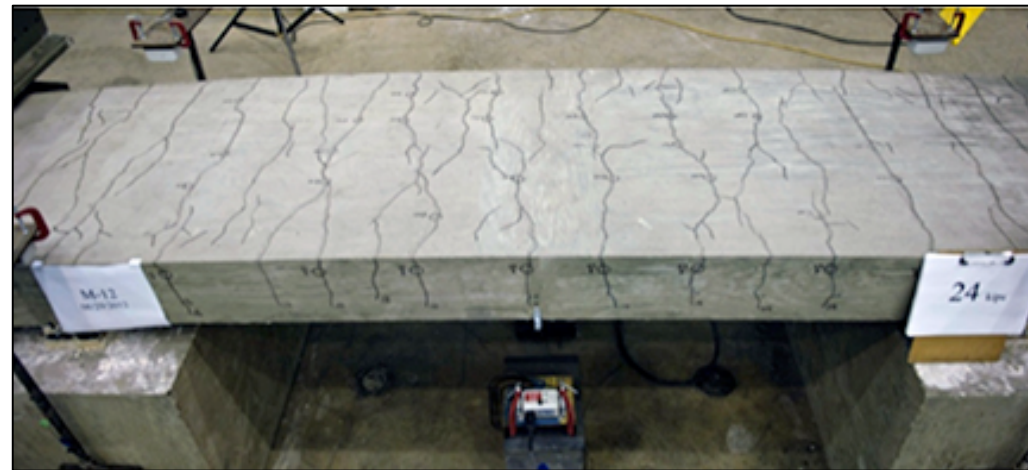
Tension Cracking

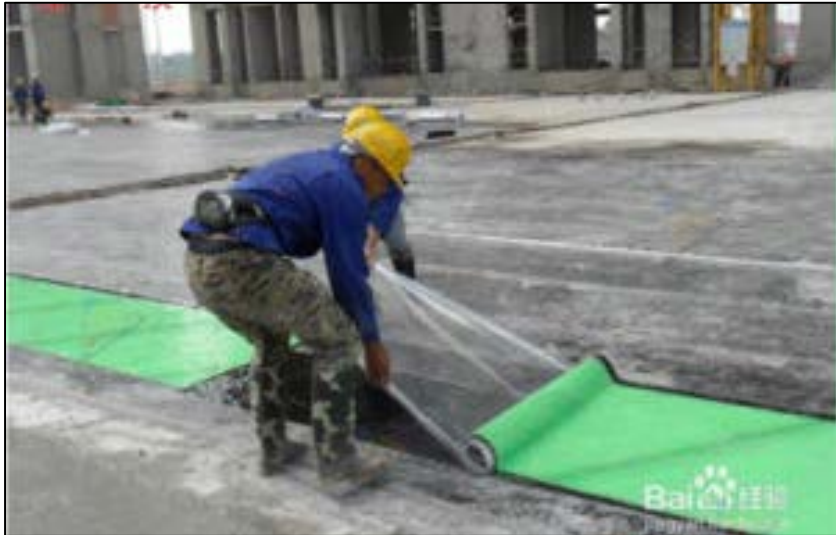
Self-Adhesive (*peel & stick*)

- Modified Bitumen waterproofing sheets are asphalt-based products that have adhesive 'factory applied' to the backside of the sheet ... with a release sheet covering it. The waterproofing sheet is rolled out onto the structure, as the release sheet is removed (*see photo*) ... and adhered to the concrete surface.
- Proper surface preparation and conditions are necessary to insure the system is installed properly.

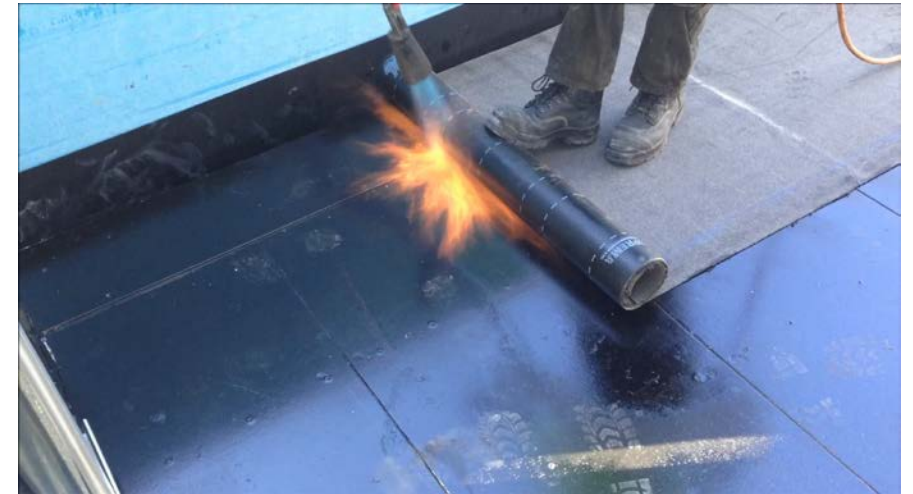
Thermo-fusible *(torch on)*

- Asphalt adhesive on the backside of the modified bitumen waterproofing sheet is melted/liquified with a propane torch. As it cools, it fully adheres the waterproofing material to the concrete.
- The use of open flame can be a problem with this system ... with some insurance companies refusing to insure the contractors that use these systems.
- Proper surface preparation is necessary to insure the system is installed properly.

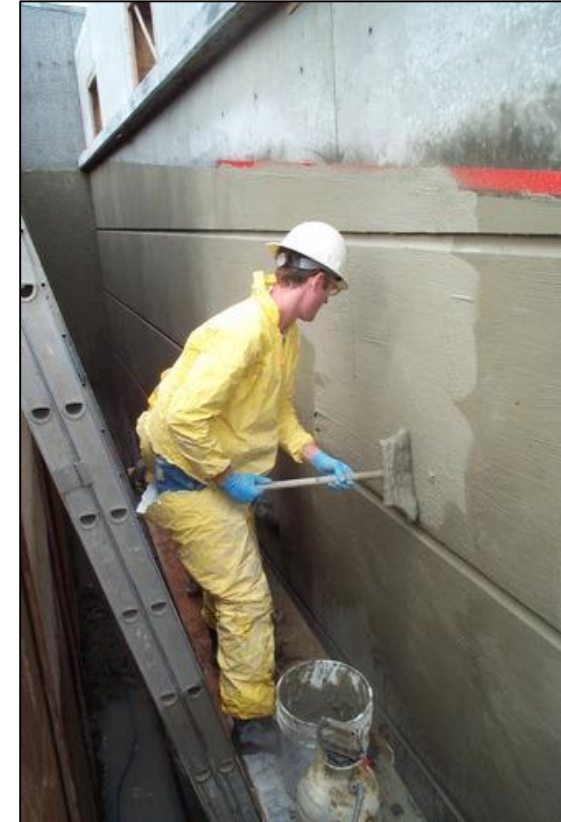
Crystalline Technology 'Slurry'

- Used exclusively on existing concrete structures
- Heavy liquid slurry, that is applied to the surface of the concrete structure by brush, broom or sprayed with the proper spray rig. Proper surface preparation is necessary to insure the system is installed properly
- Active ingredients in these products use the process of diffusion to absorb into the concrete, reacting with the calcium hydroxide and other by-products that were formed during the concrete hydration process that occurred when the concrete was first formed.

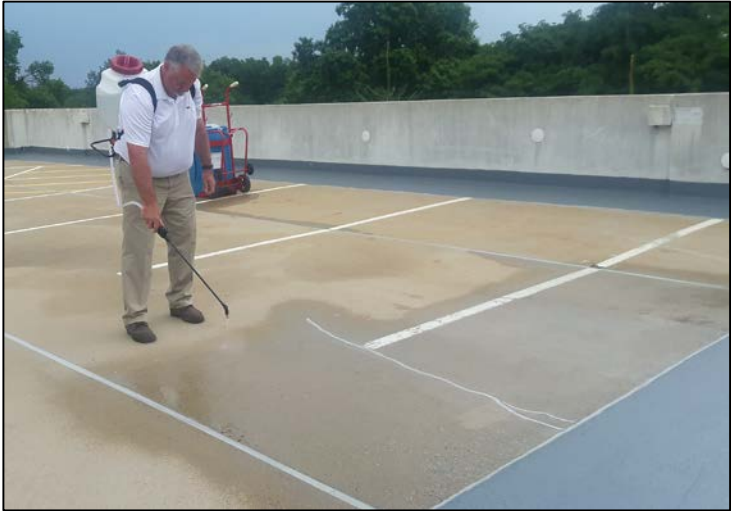
Modified Silica Gel – Spray Applications

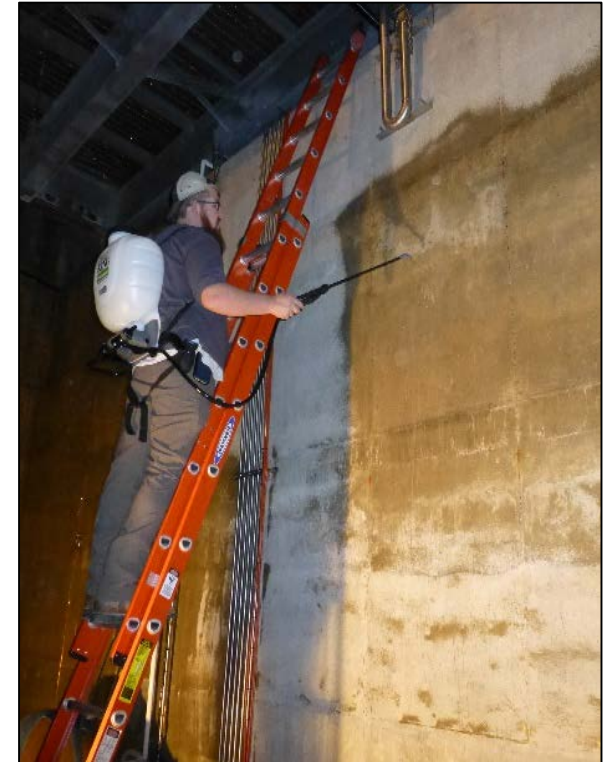
Modified Silica Gel – Spray Application

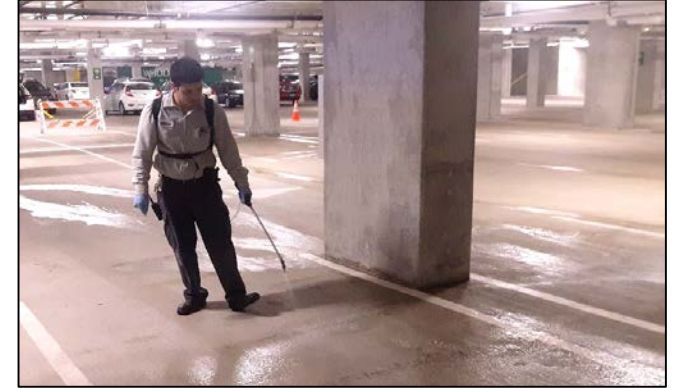
Modified Silica Gel – Spray Applications

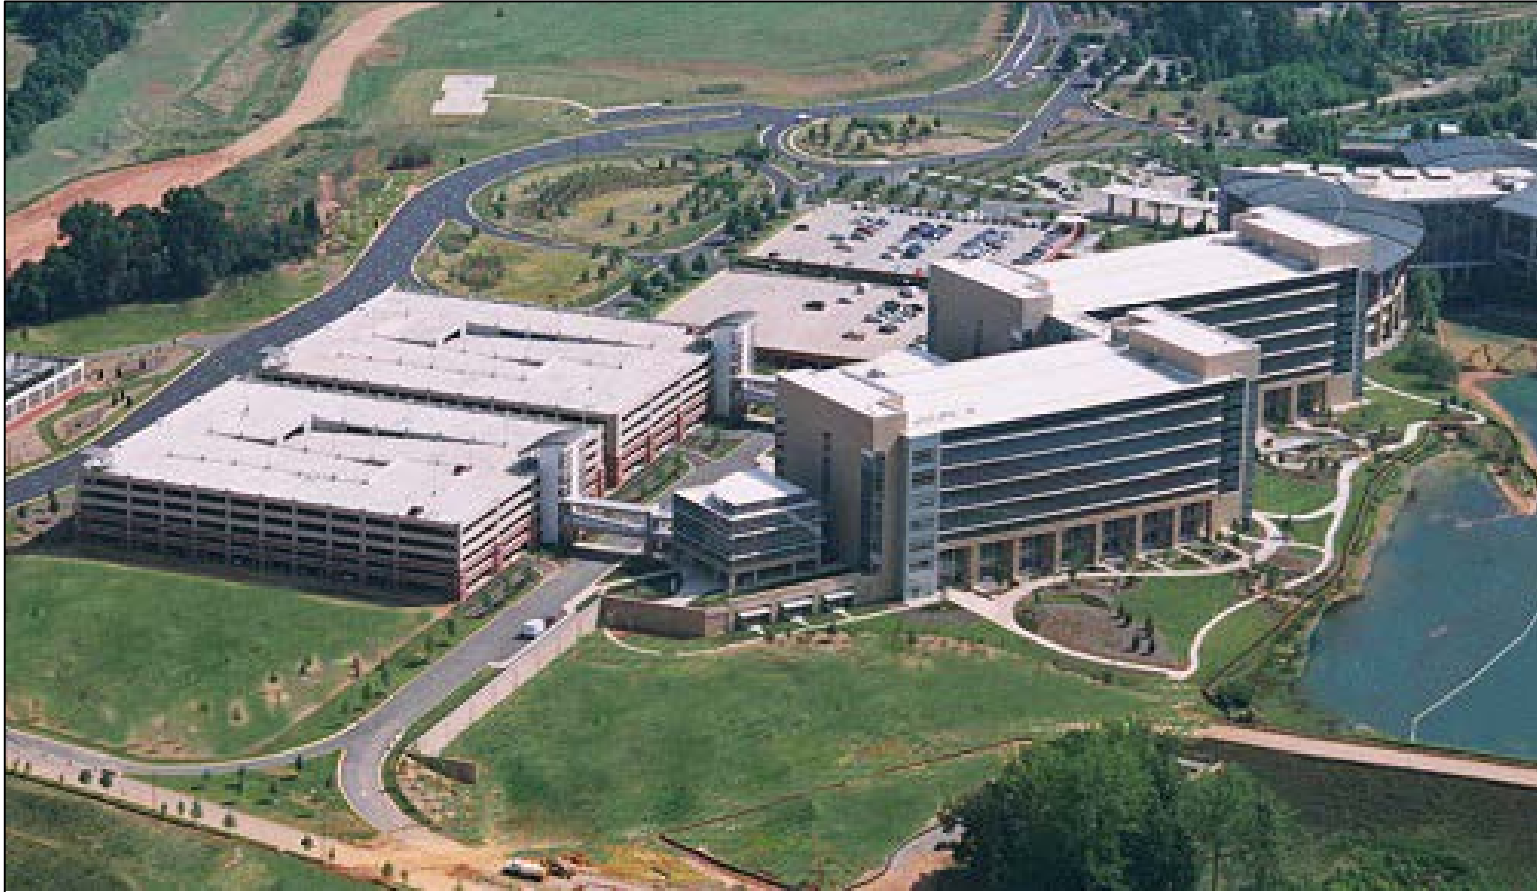
Lowes Corporate Headquarters - Mooresville, NC

Approximately **95,000 square feet** of parking deck was waterproofed in **2006** using a spray applied Modified Silicate Gel.

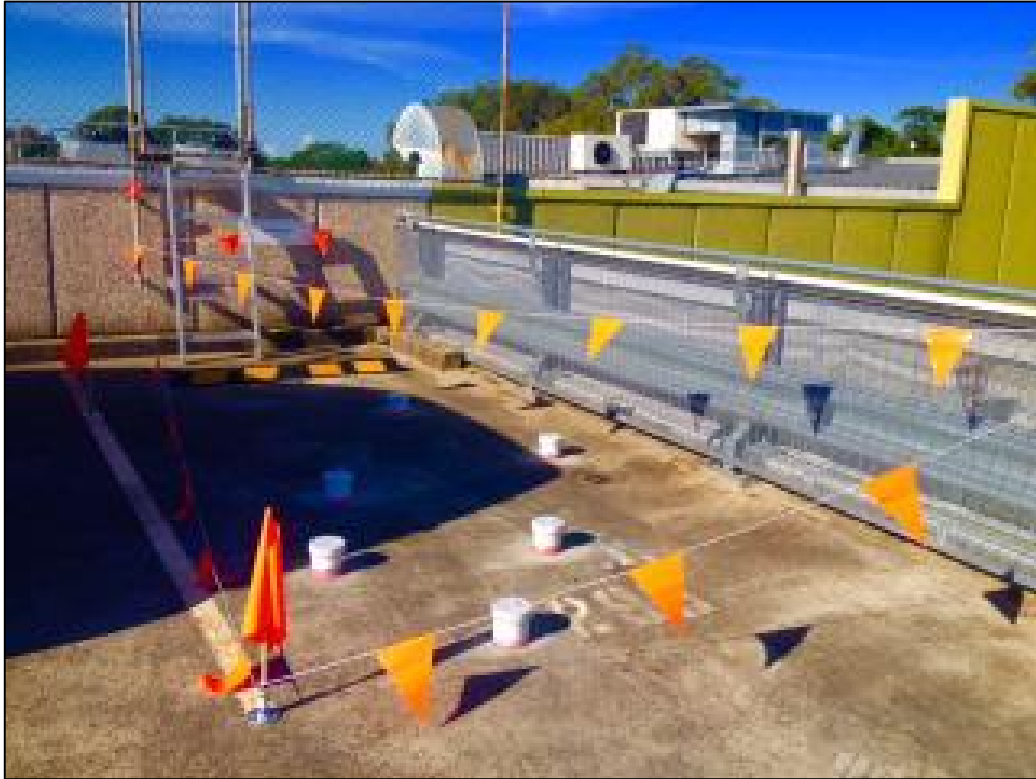
Top Level of Parking Ramp - Australia

In **1988**, a Modified Silicate Gel product was spray applied to the **21,500+ square foot** top level of this parking ramp in Australia.

The watertight status of the parking deck was confirmed by Roger Scerri from the Building Research Centre, University of New South Wales in August **1993** ... and a 100% watertight seal was once again confirmed by Mahaffey Associates in April **2017**.

There has now been over **30 years of watertight performance** **without any interim maintenance** being performed on this project.
