2024 FALL CONVENTION

Repairs During Construction

Lessons Learned the Hard Way

Jose Pacheco, PhD, PE, PEng

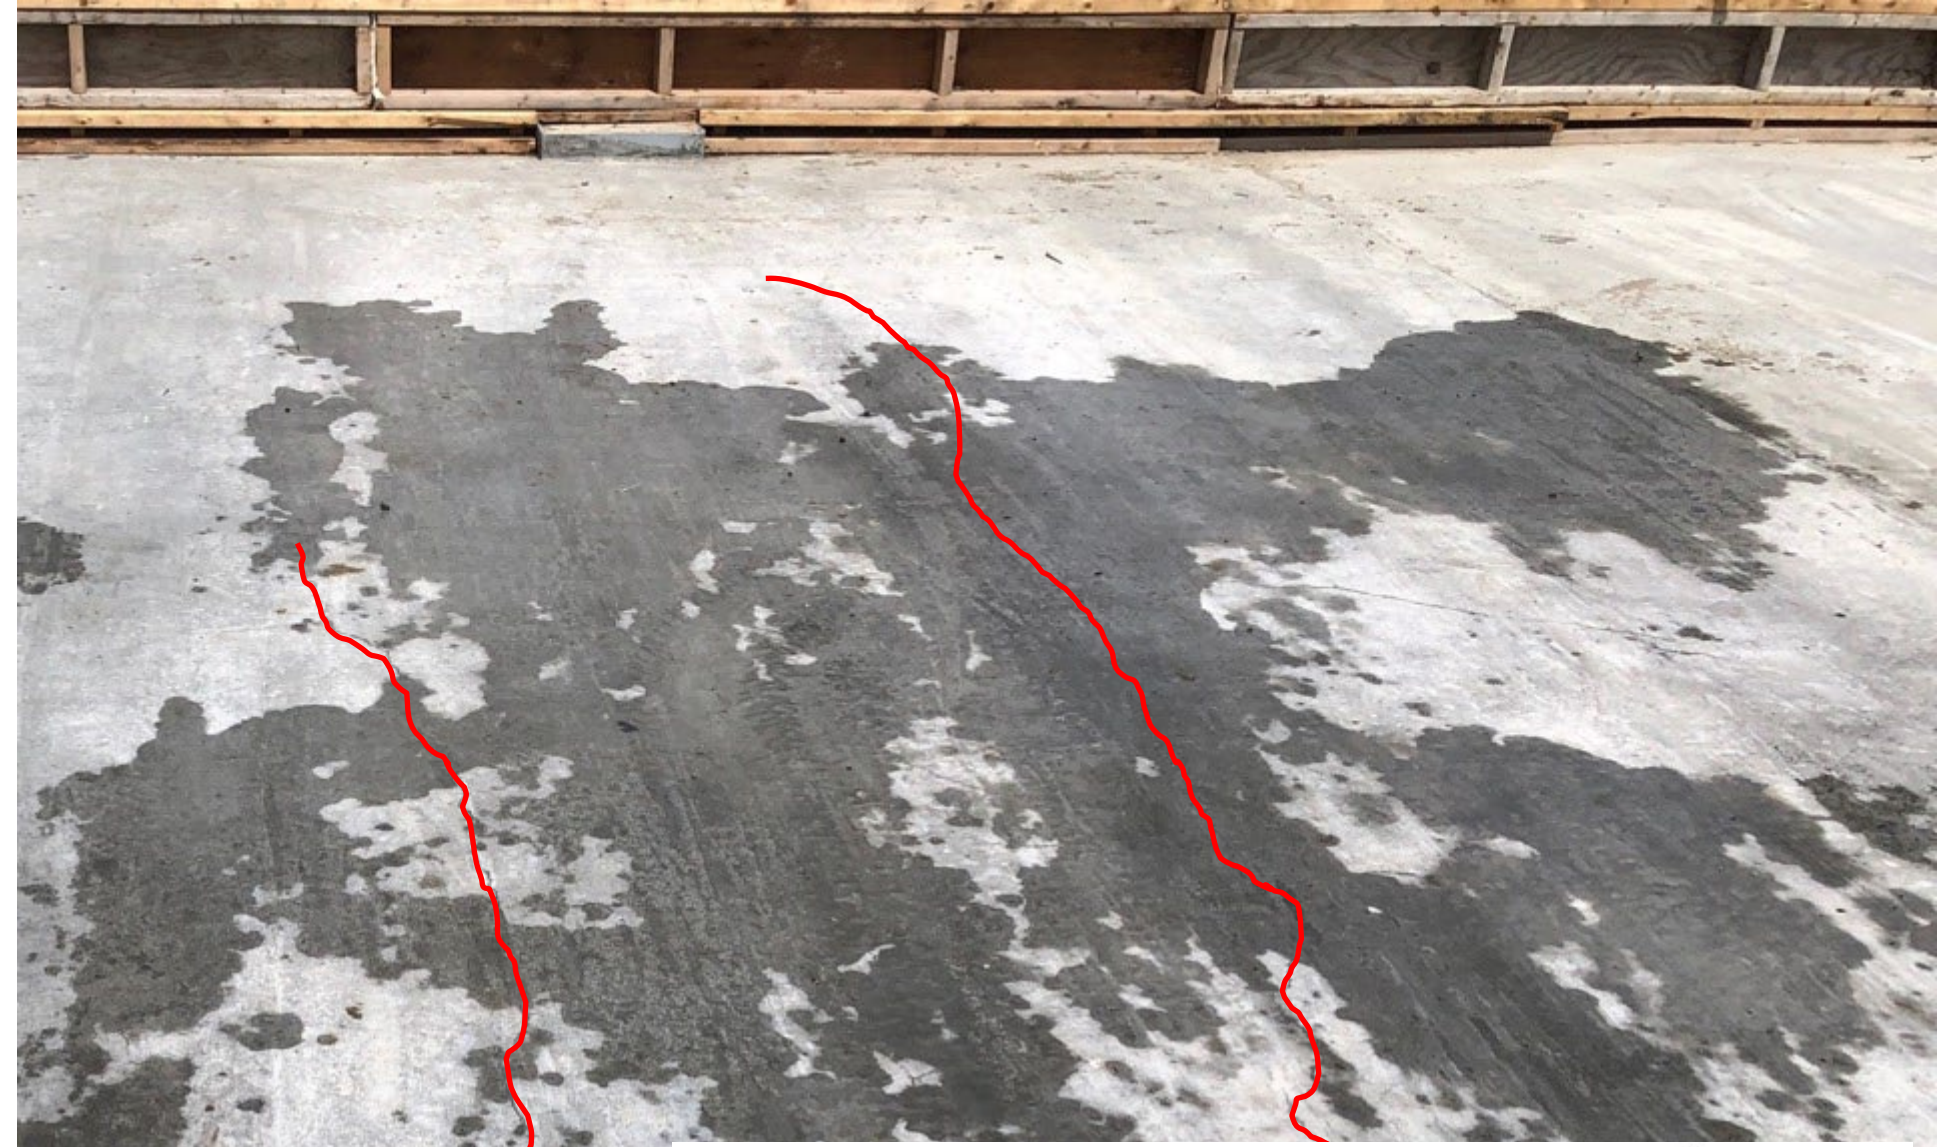
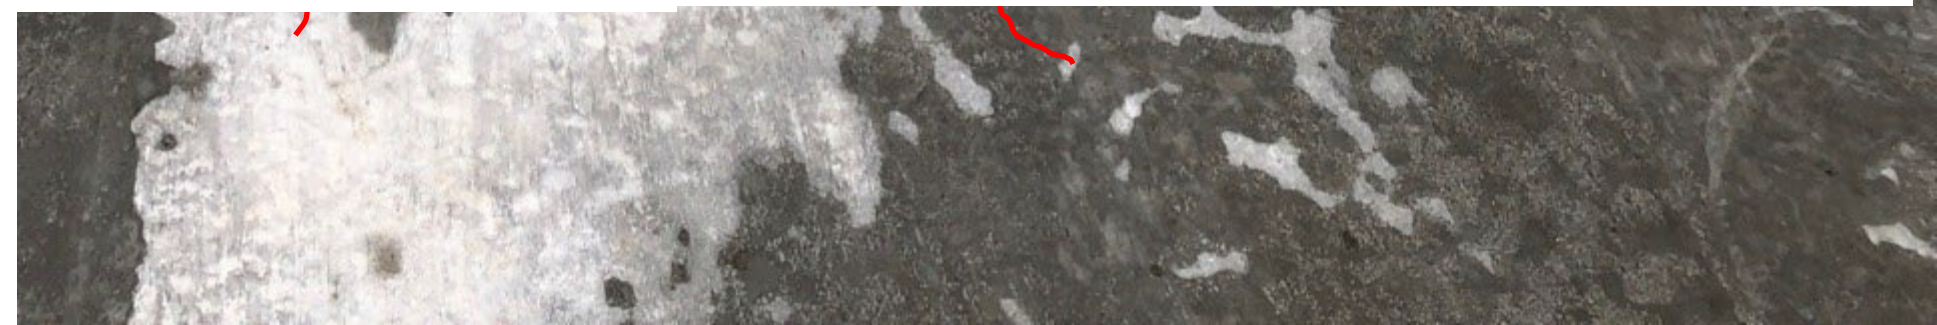
Case Study: 1

- Constructed in 2020
 - *Noticeable deck cracking before the commission*
- Concrete met specification requirements
 - *Compressive strength, chloride penetration*
- Exposure to severe deicing salts
 - *Cracking is a concern for durability*
- Investigation of the potential cause(s)
 - *Document review, coring, petrography, etc.*
- Responsibility
 - *MT, EOR, contractor, material supplier, etc.*
- Repair recommendations
 - *Crack repair vs. crack repair plus overlay*

Core ID	D1	D2	D3	D4	D5	D6	D7	D8
Core Length	7.2 to 7.5 in. Partial depth	9.3 to 9.4 in. Full depth	2.1 to 2.4 in. Partial depth	8.8 to 8.9 in. Full depth	8.9 to 9.0 in. Full depth	9.0 in. Full depth	10.1 to 10.2 in. Full depth	10.2 in. Full depth
Cracking	None	A few hairline cracks at top surface, extending downward to 0.7 in., locally passing through aggregates	A full-depth vertical crack, passing through and around aggregates.	A full-depth vertical crack, passing through and around aggregates, and narrowing toward bottom. Crack is aligned with rebars.	A vertical crack extending from formed bottom surface upward to 5.5 in., passing through and around aggregates	None	None	A full-depth vertical crack, passing through and around aggregates, and narrowing toward bottom. Crack is aligned with rebar.
Microcracking	<ul style="list-style-type: none"> • Shallow vertical microcracks in top and bottom surface regions to depth of 0.3 to 0.7 in. • Core D5 exhibits a few vertical microcracks extending to depths of 1.5 to 4.0 in. from top surface, passing through and around aggregates. Two of these vertical microcracks are aligned with major crack. • Short (discontinuous), randomly-oriented microcracks are commonly observed in paste between aggregate particles throughout body of cores; these microcracks are not related to any deleterious reactions within concrete (like shrinkage-related).

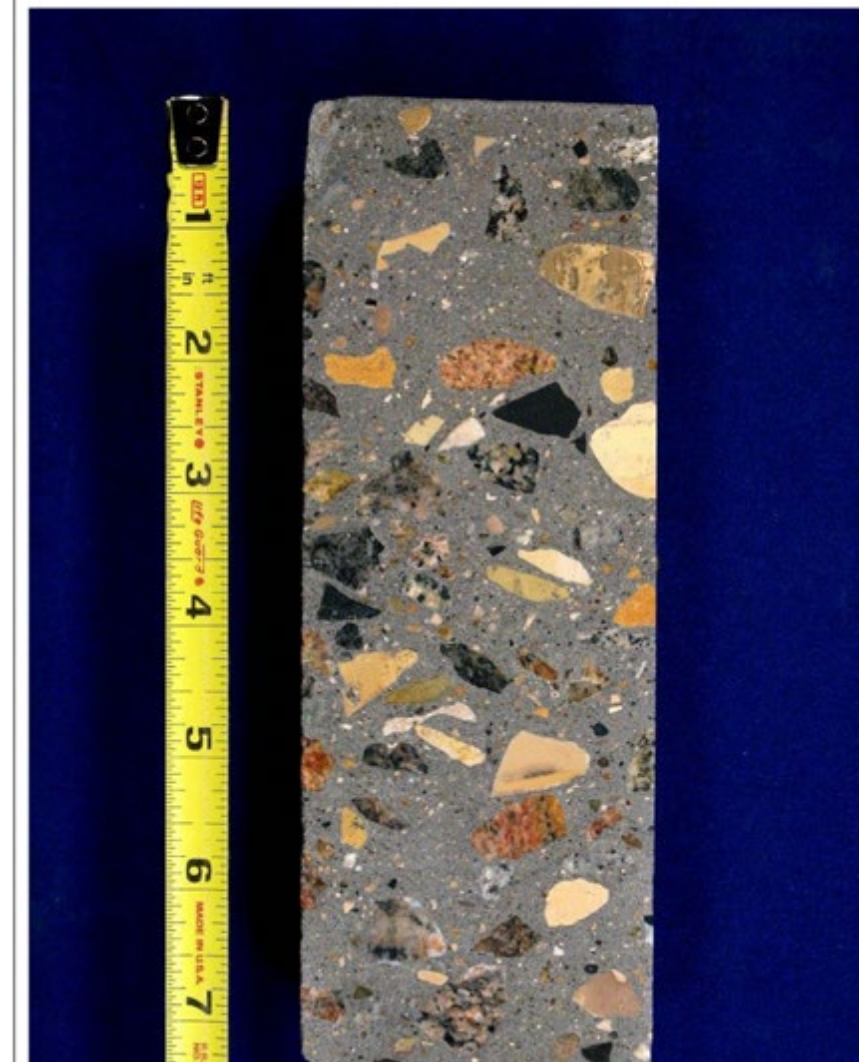
CORE ID: D1

*The paste in the finished top approximately 0.1 to 0.15 in. region of Cores D1, D2, D3, D4, D5, D6, and D8 locally appears somewhat lighter. The paste in this lighter immediate surface region is slightly more absorptive compared to the body, but is still judged to be fairly hard and dense.

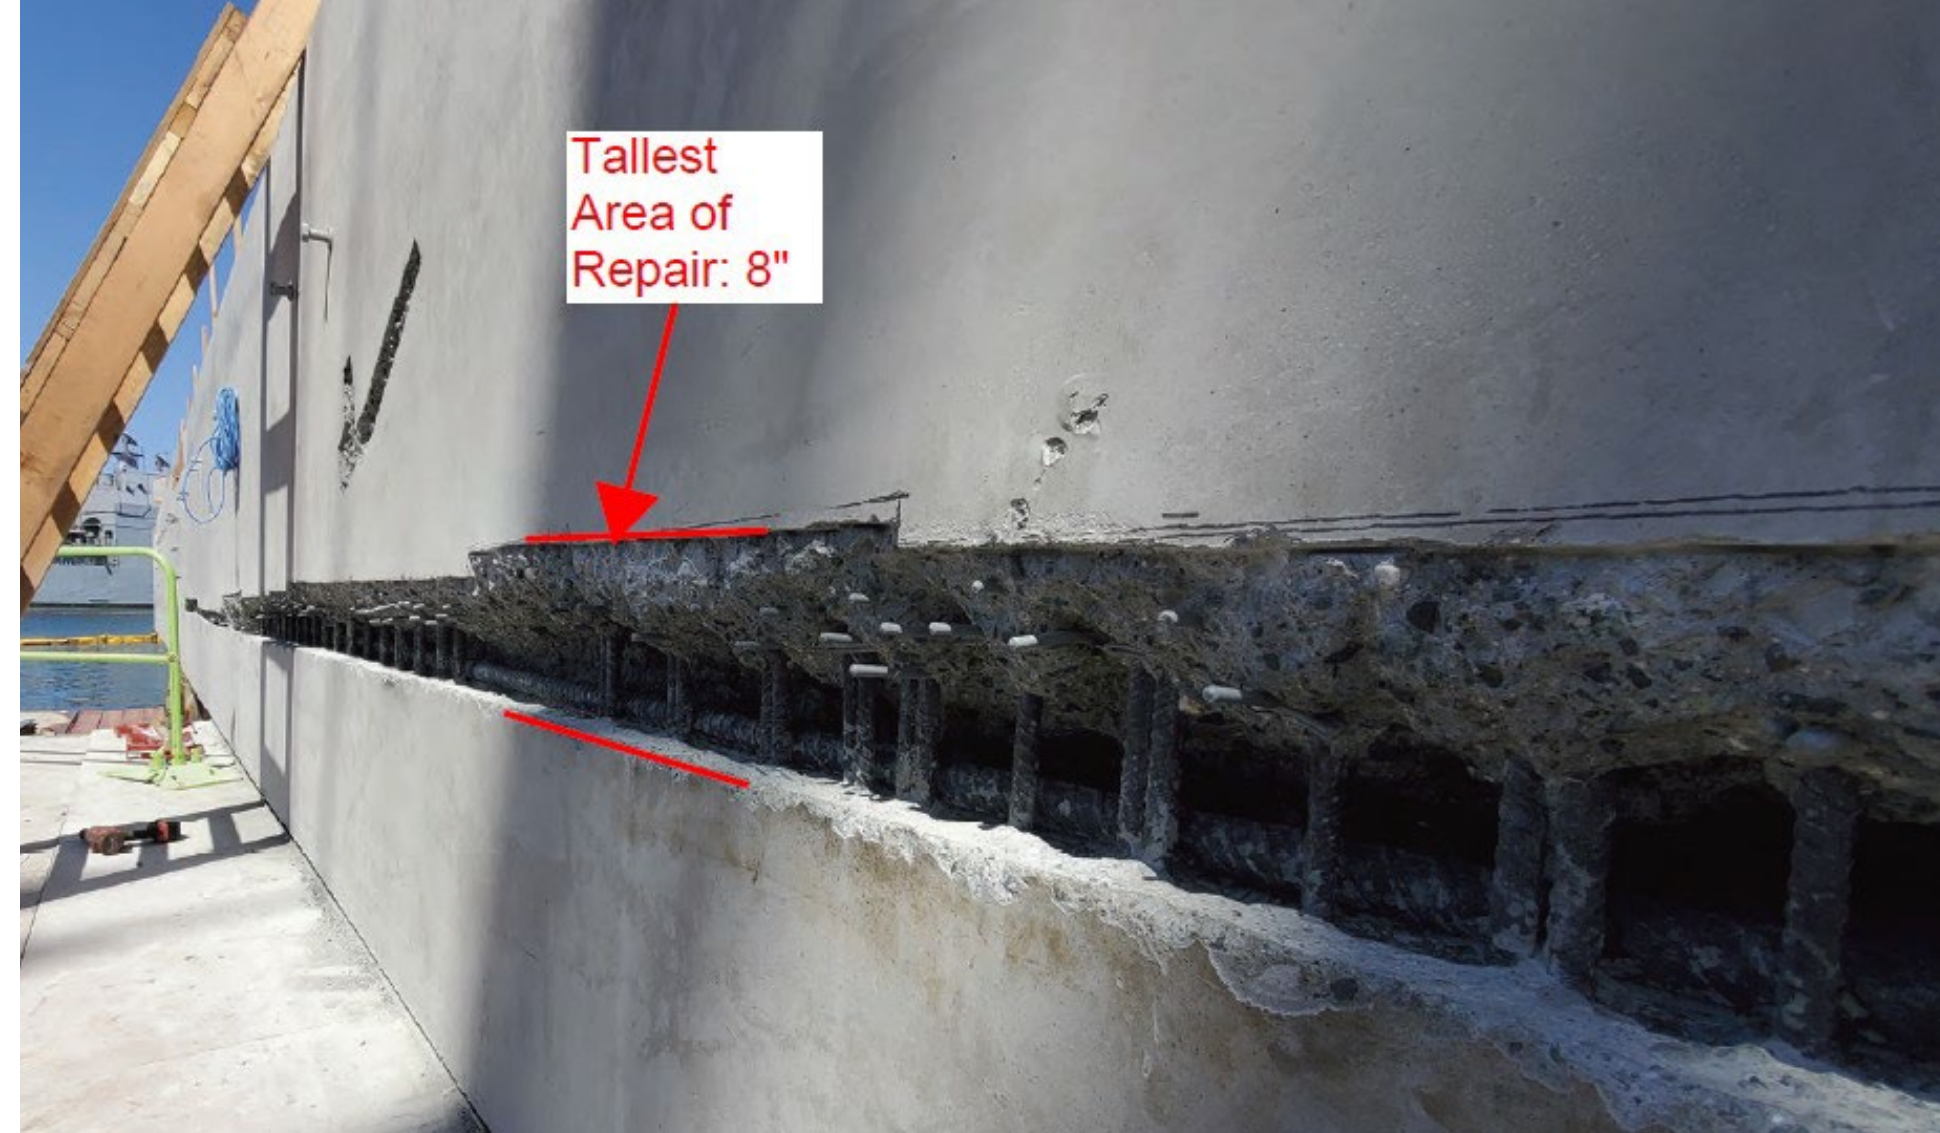
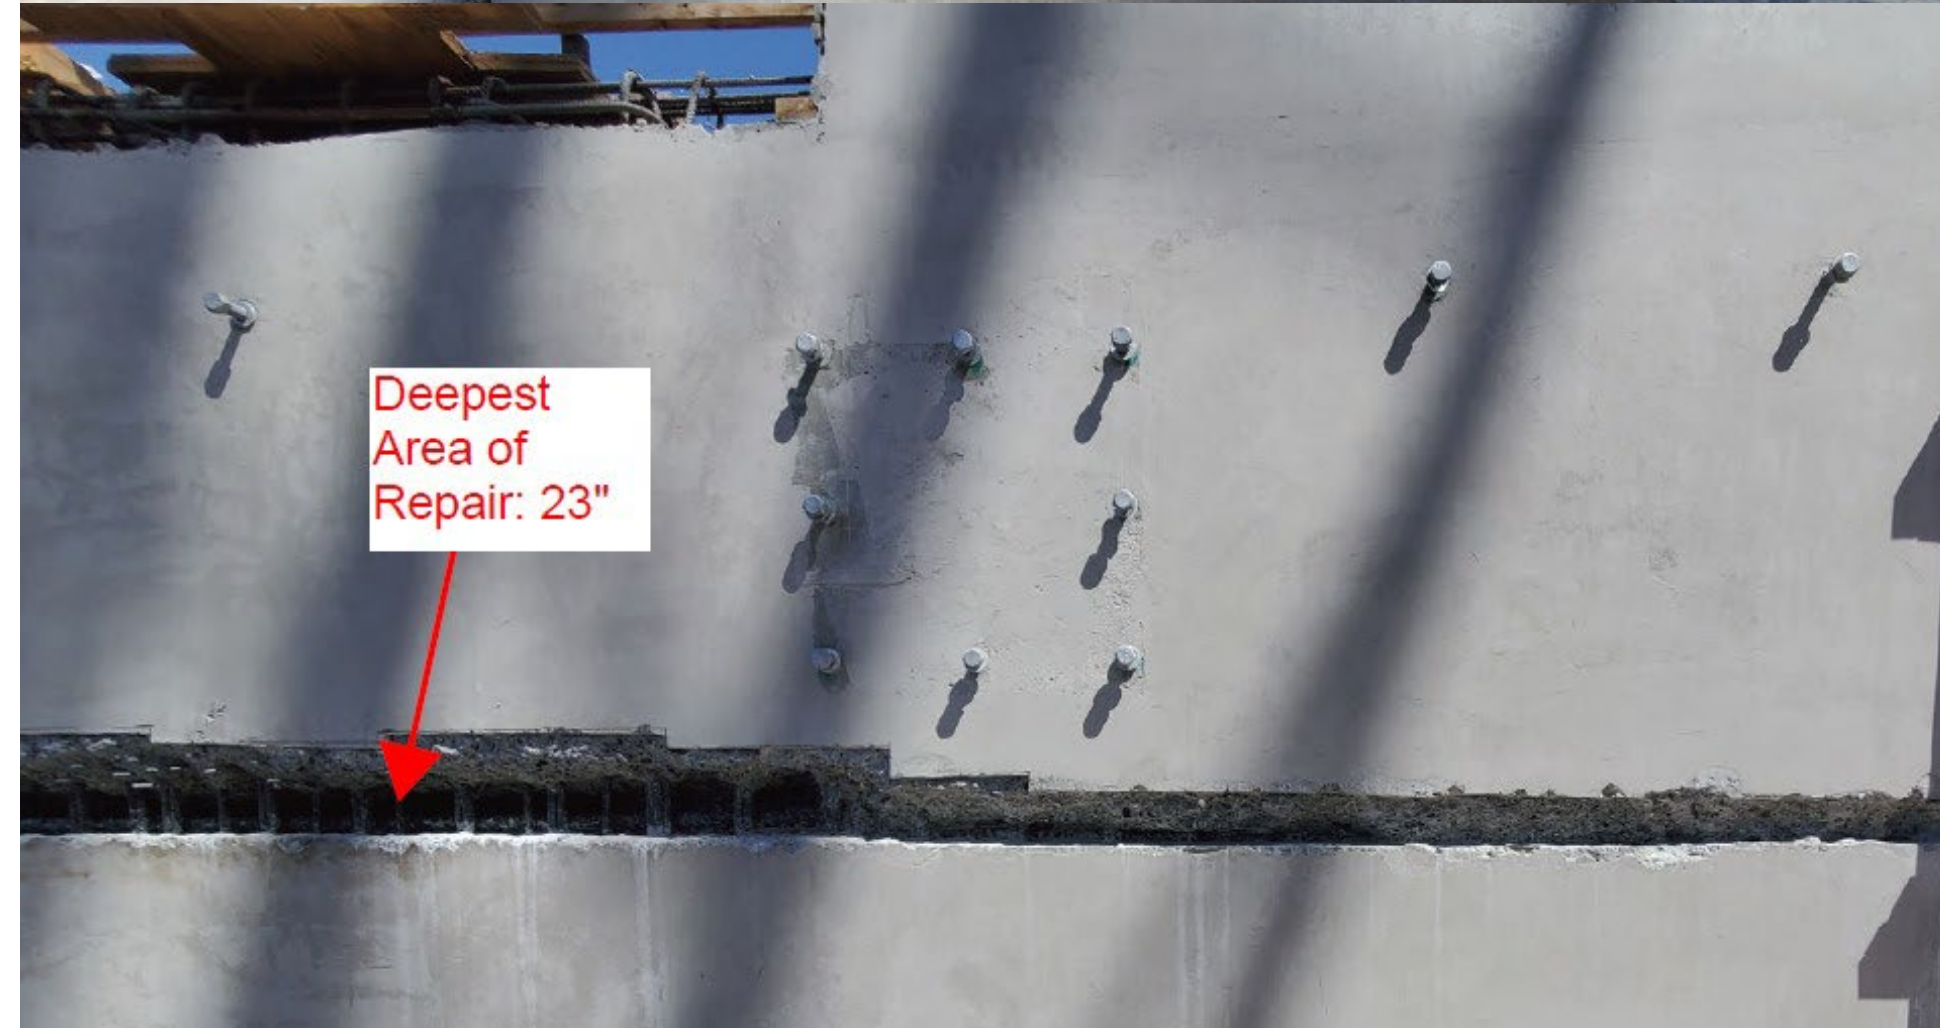
- Constructed in 2023-2024
 - *Consolidation issues in cast-in-place concrete*
- Specified Service Life 75 years
 - *Compressive strength, chloride penetration, etc.*
- Exposure to the marine environment
 - *Reinforcing steel concrete cover protection*
- Investigation of the potential cause(s)
 - *Concrete workability, etc.*
- Responsibility
 - *Contractor*
- Repair recommendations
 - *Substrate preparations*
 - *SCC mixture optimization & placement*

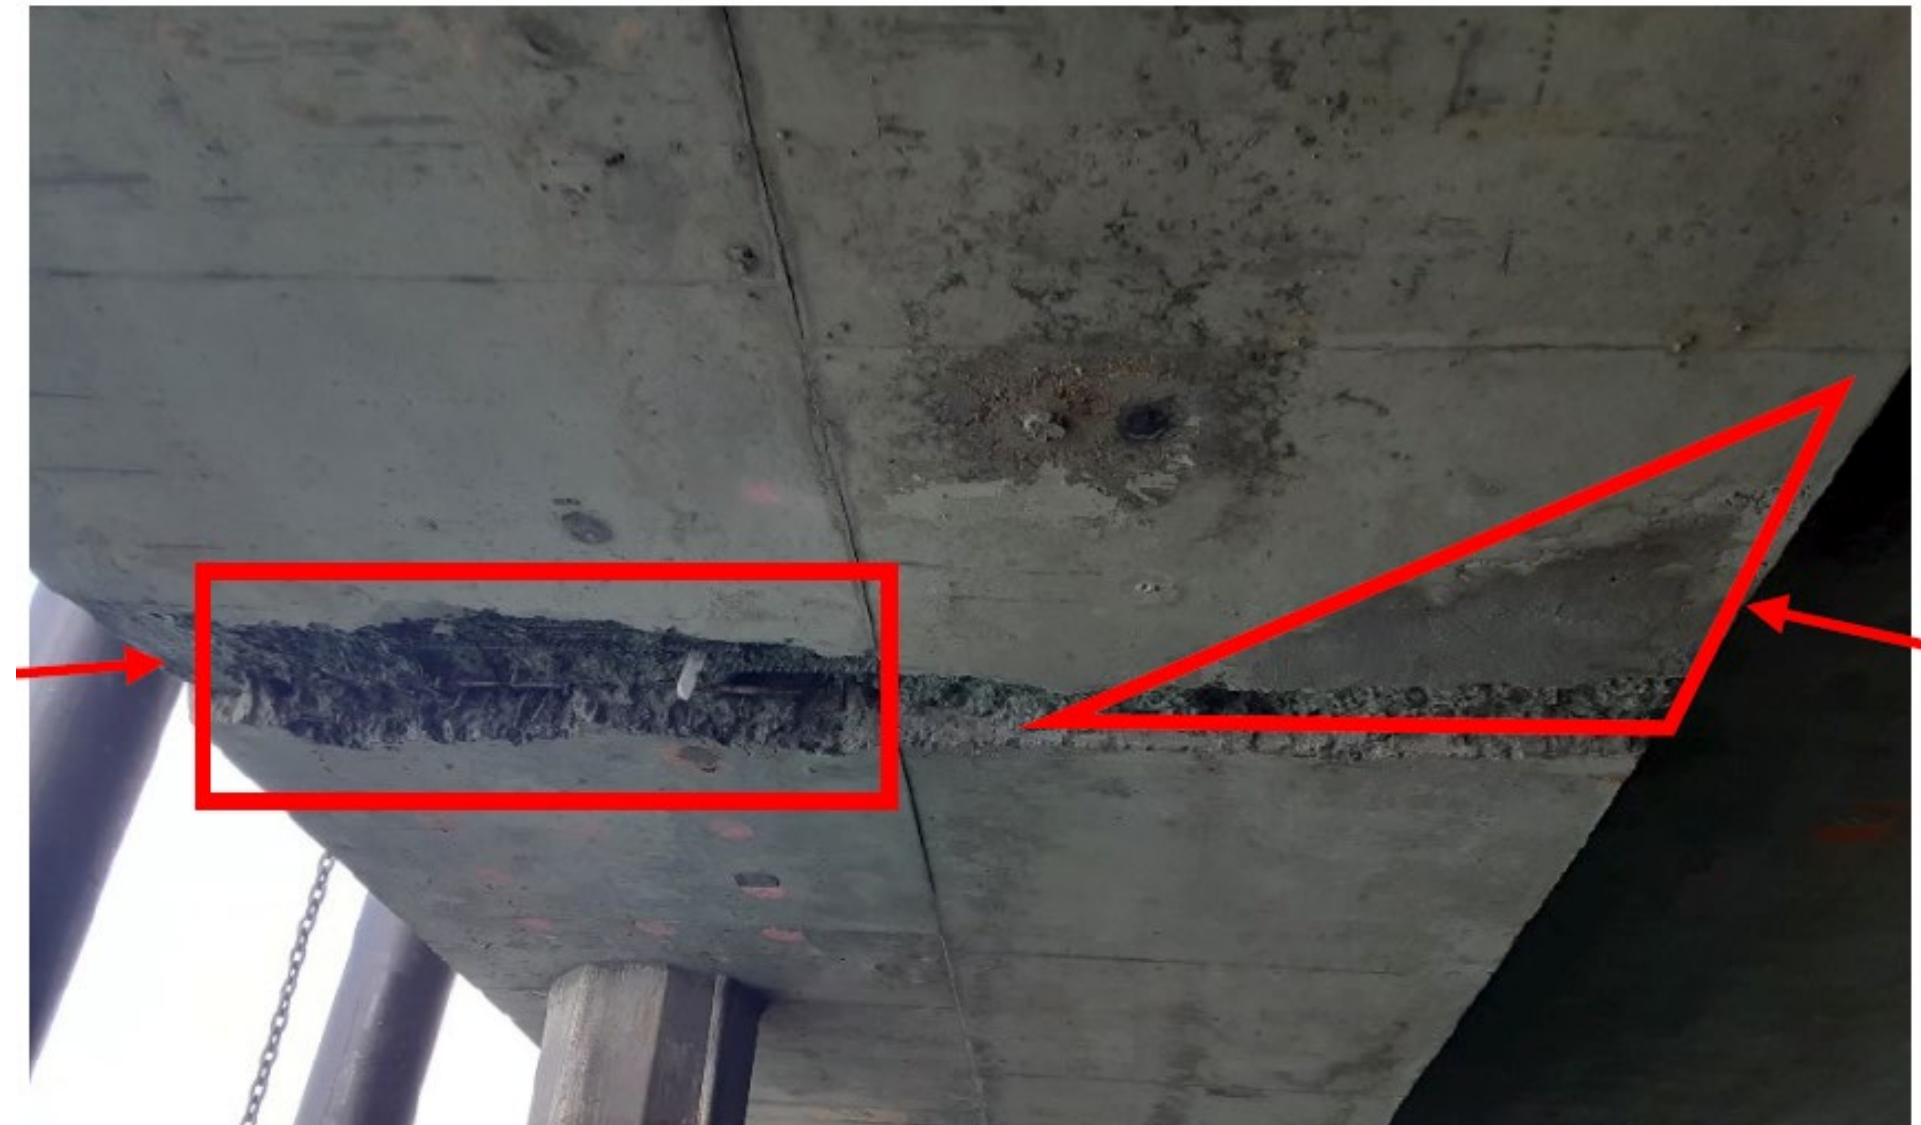
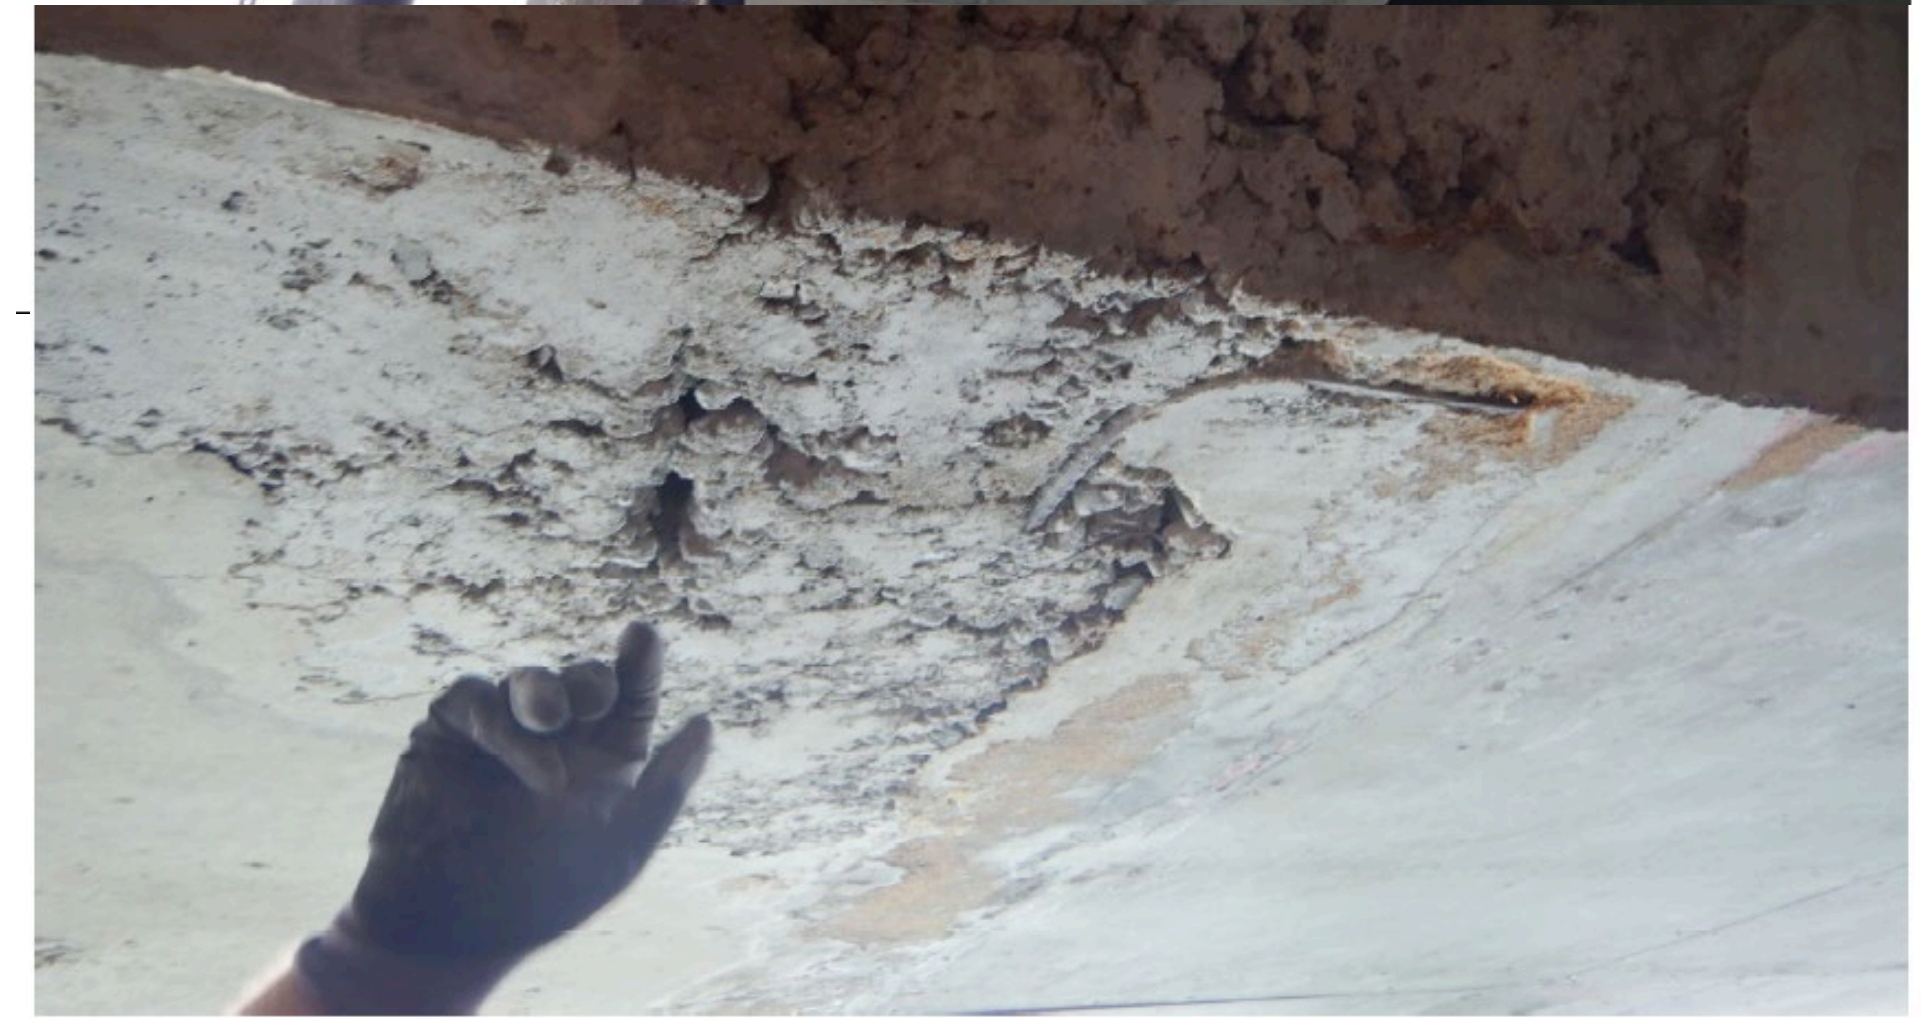
Case Study: 2

- Constructed in 2023-2024
 - *Consolidation issues in cast-in-place concrete*
- Specified Service Life 75 years
 - *Compressive strength, chloride penetration, etc.*
- Exposure to the marine environment
 - *Reinforcing steel concrete cover protection*
- Investigation of the potential cause(s)
 - *Concrete workability, etc.*
- Responsibility
 - *Contractor*
- Repair recommendations
 - *Substrate preparations*
 - *SCC mixture optimization & placement*

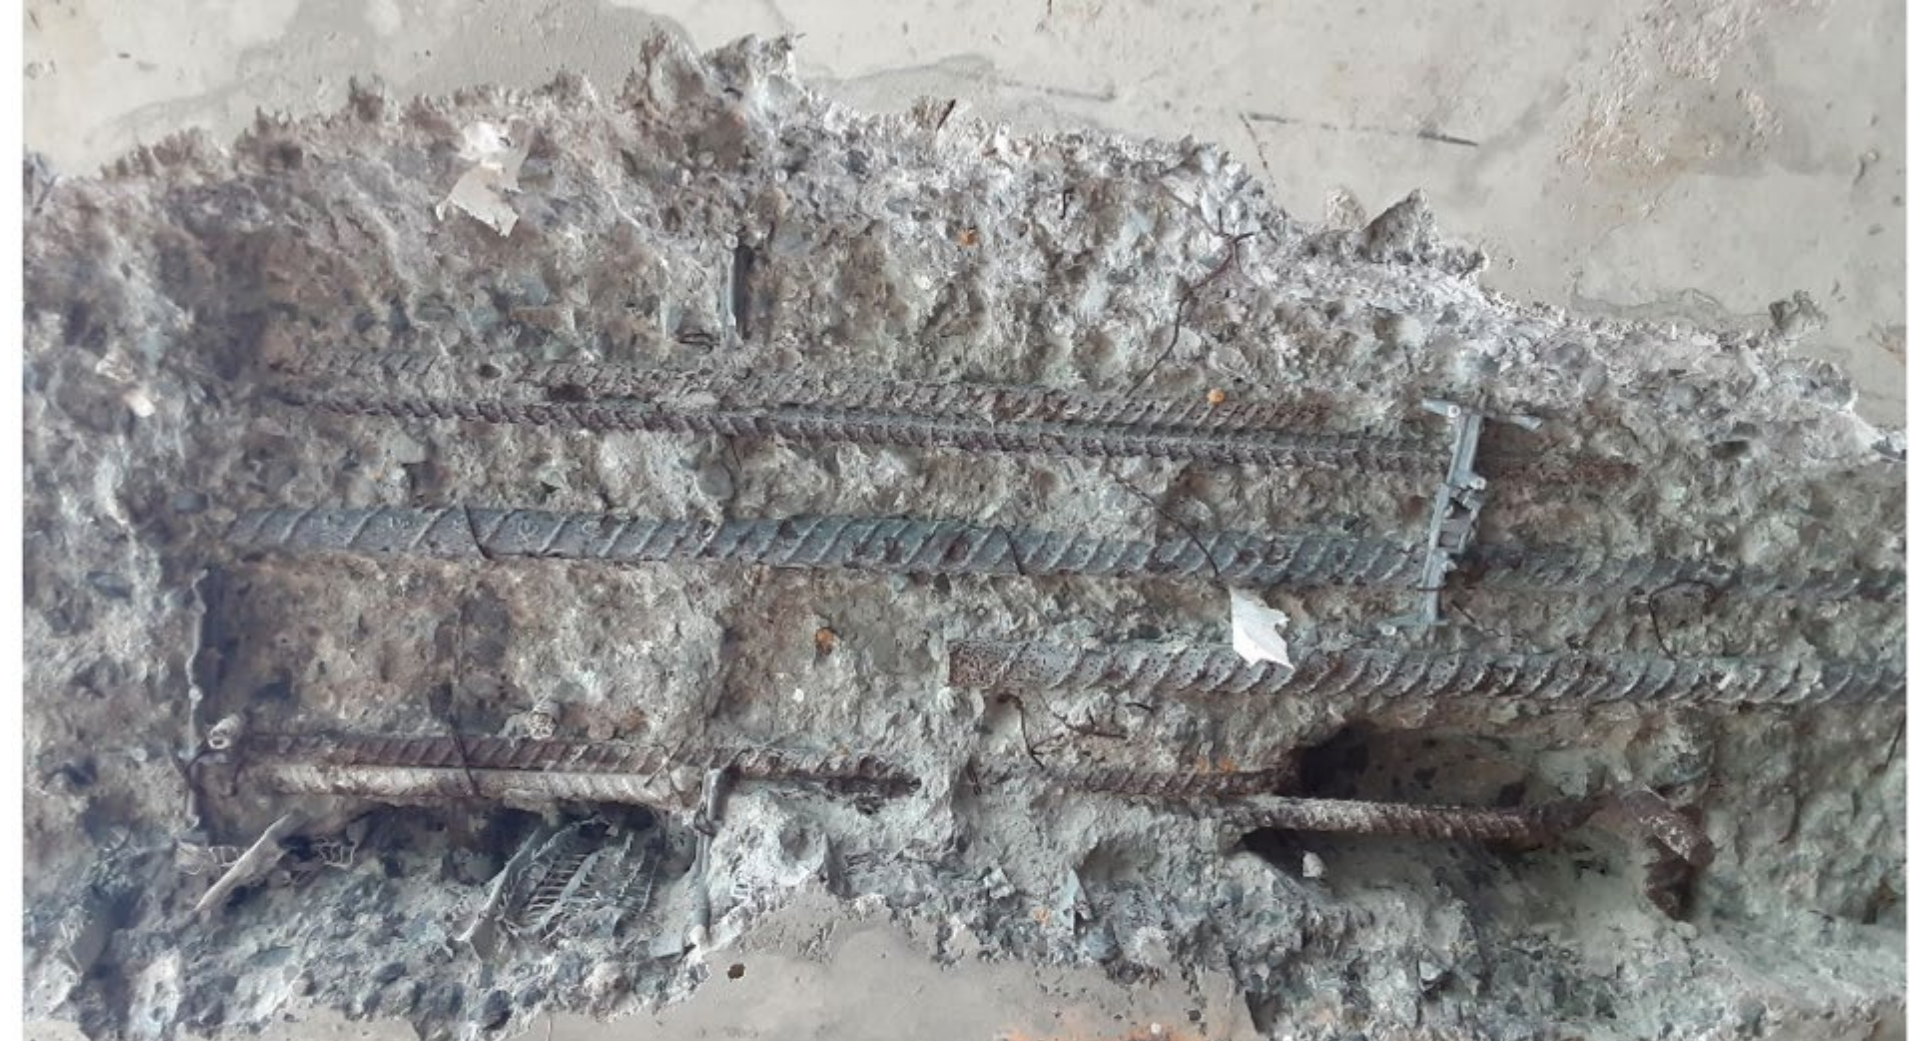
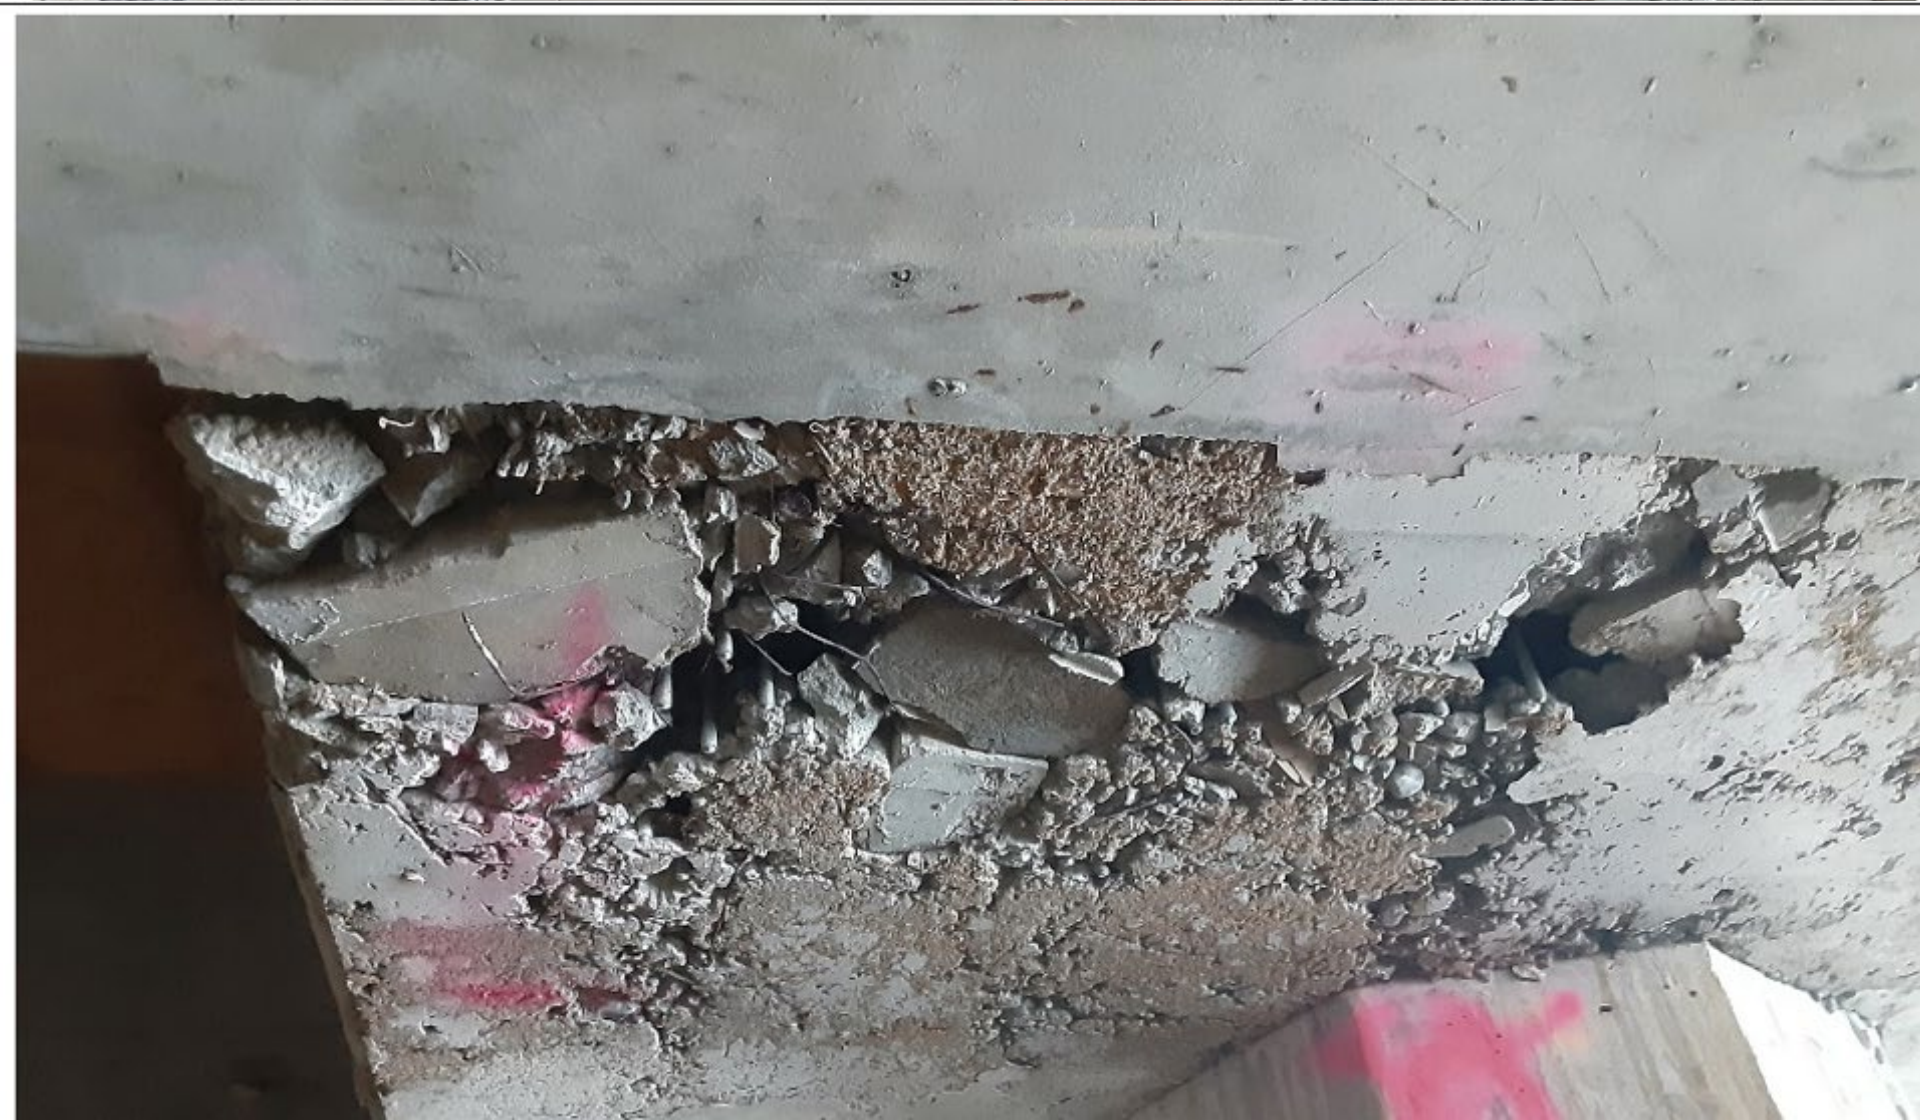
Case Study: 2

- Constructed in 2023-2024
 - *Consolidation issues in cast-in-place concrete*
- Specified Service Life 75 years
 - *Compressive strength, chloride penetration, etc.*
- Exposure to the marine environment
 - *Reinforcing steel concrete cover protection*
- Investigation of the potential cause(s)
 - *Concrete workability, etc.*
- Responsibility
 - *Contractor*
- Repair recommendations
 - *Substrate preparations*
 - *SCC mixture optimization & placement*

Total cementitious content	752 lbs/yd³
SCM replacement level	30.1%
Info by Volume	
Paste concent, including air	38.9 %
Paste concent, not including air	32.9 %
Mortar content, including air	65.6 %
Coarse-to-fine aggregate ratio	57.0 : 43.0
Total Coarse Aggregate	35.4 %
Total Fine Aggregate	31.3 %
Info by Mass	
Paste concent,	25.9 %
Mortar content, including air	57.2 %
Coarse-to-fine aggregate ratio	57.8 : 42.2
Total Coarse Aggregate	42.8 %
Total Fine Aggregate	31.3 %
Theoretical Density (including air)	147.6 lbs/ft³

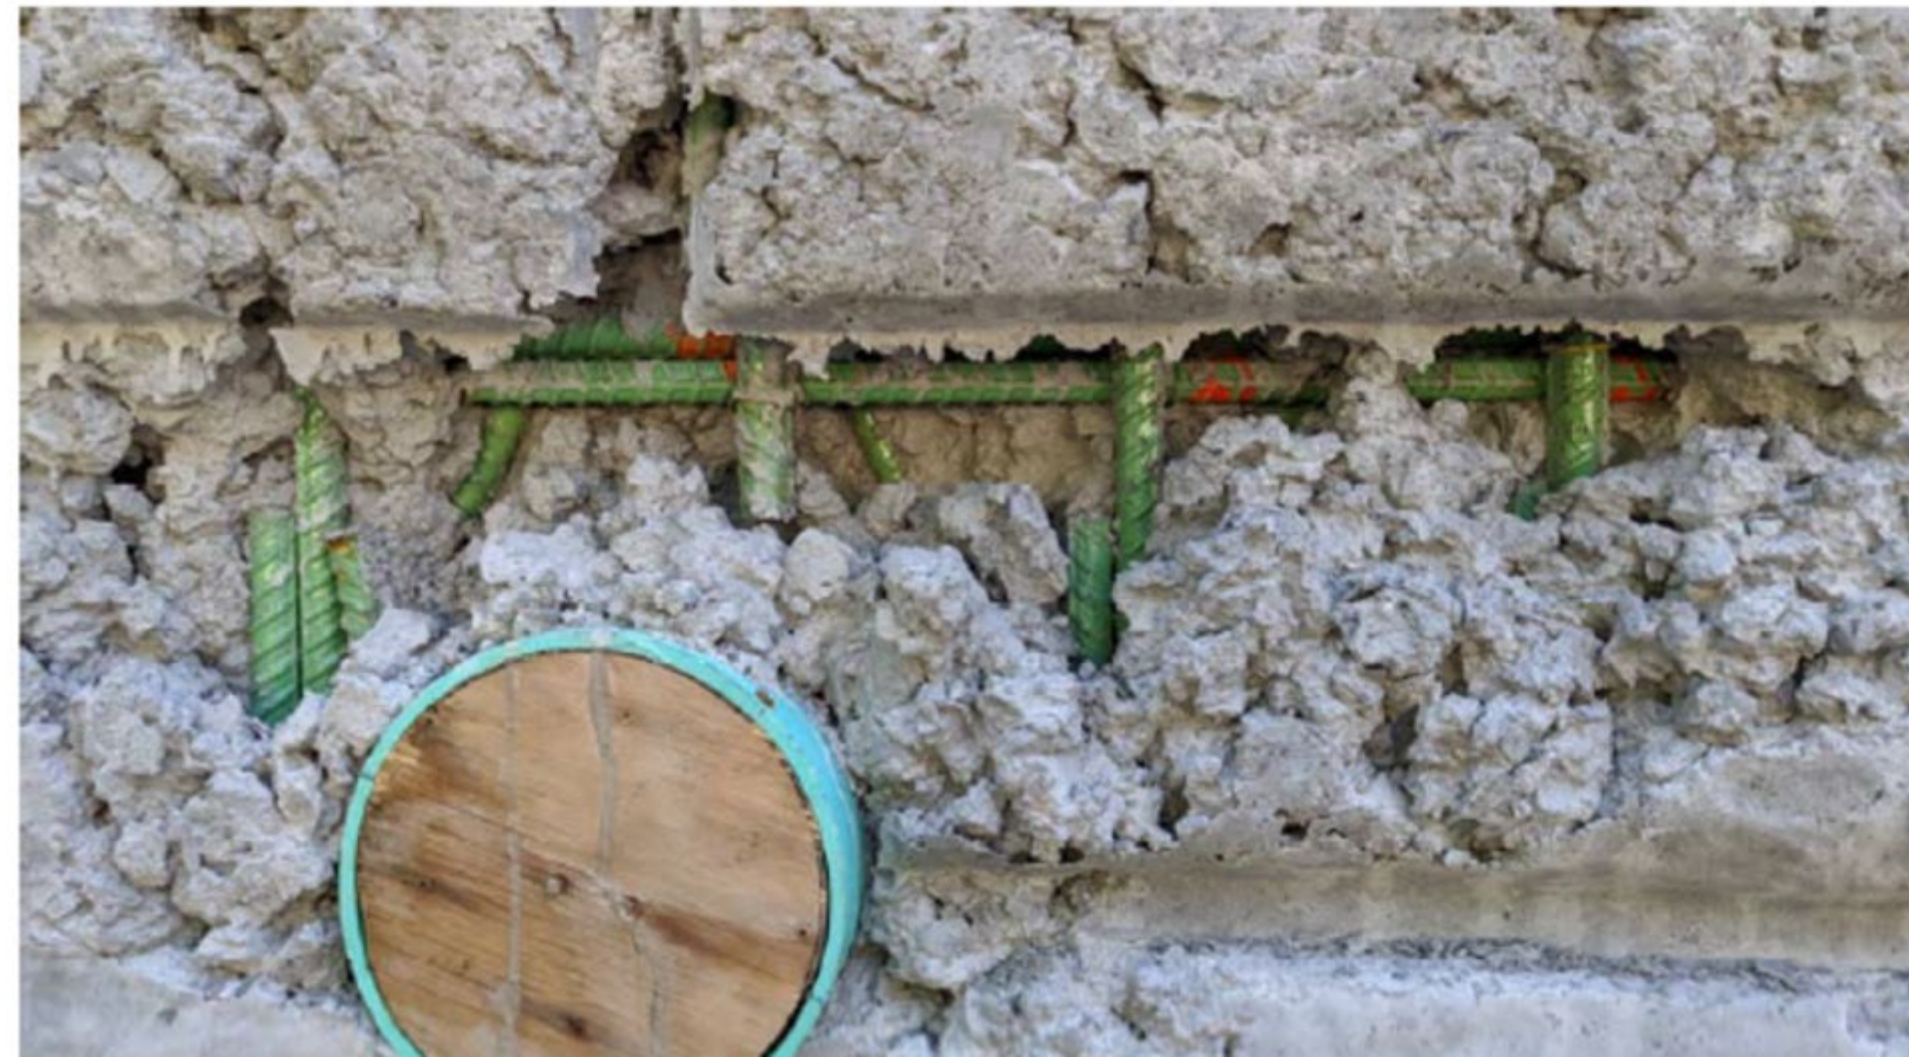
- Constructed in 2020
 - Consolidation issues in cast-in-place concrete
- Specified Service Life 75 years
 - Compressive strength, chloride penetration, etc.
- Exposure to deicing salts
 - Reinforcing steel concrete cover protection
- Investigation of the impact
 - NDT by others, coring, depth of consolidation
- Responsibility
 - Contractor
- Repair recommendations
 - Remove Remove 1" beyond rebar on both faces
 - Shotcrete repair
- Removed due to schedule impact
