2024 FALL CONVENTION

Repairs During Construction

Lessons Learned the Hard Way

Jose Pacheco, PhD, PE, PEng

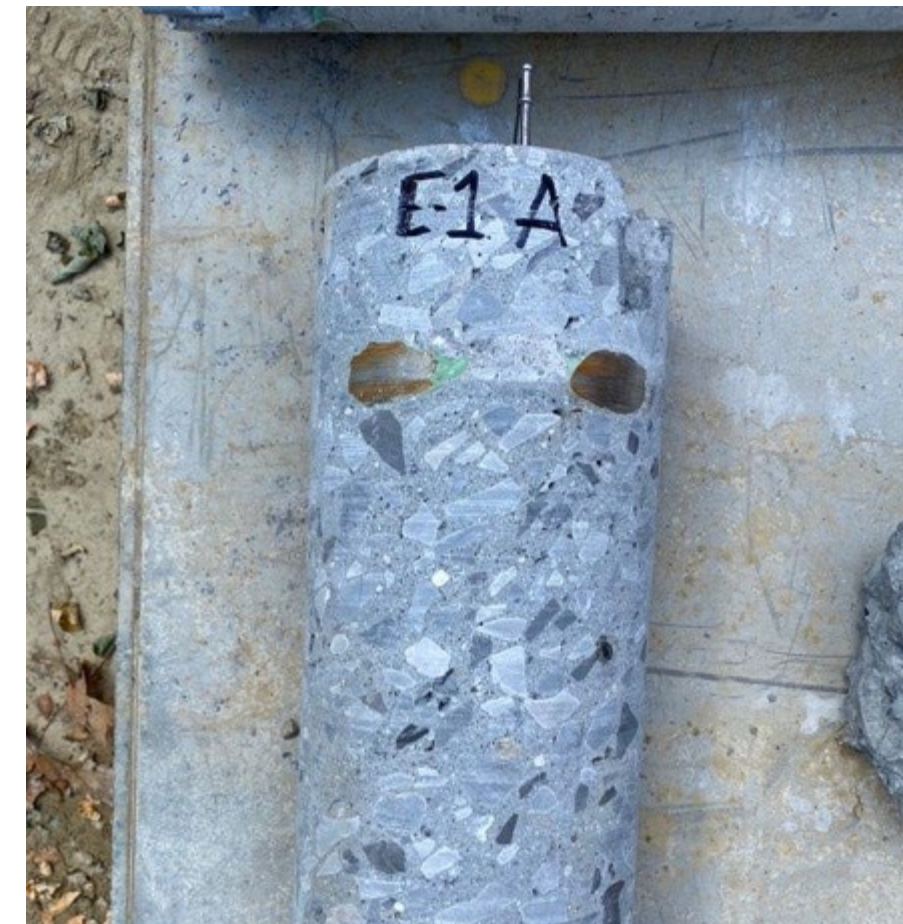
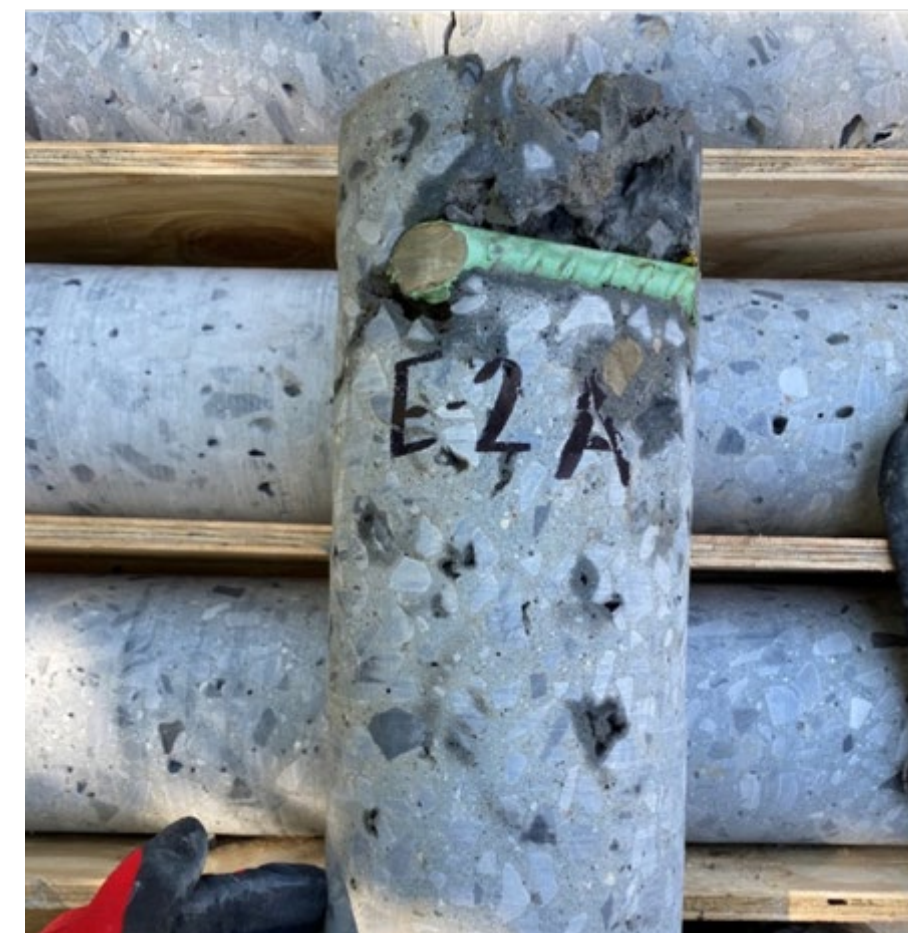
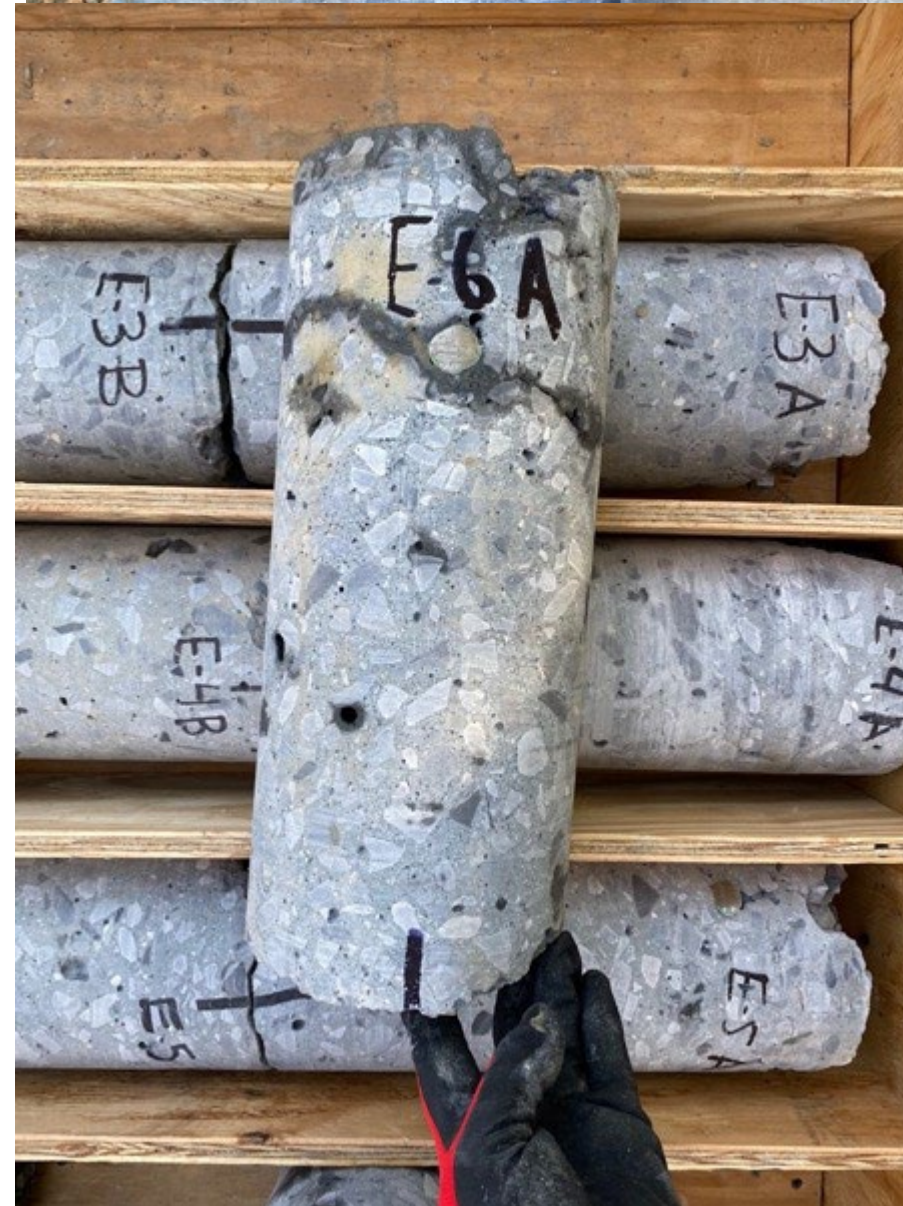
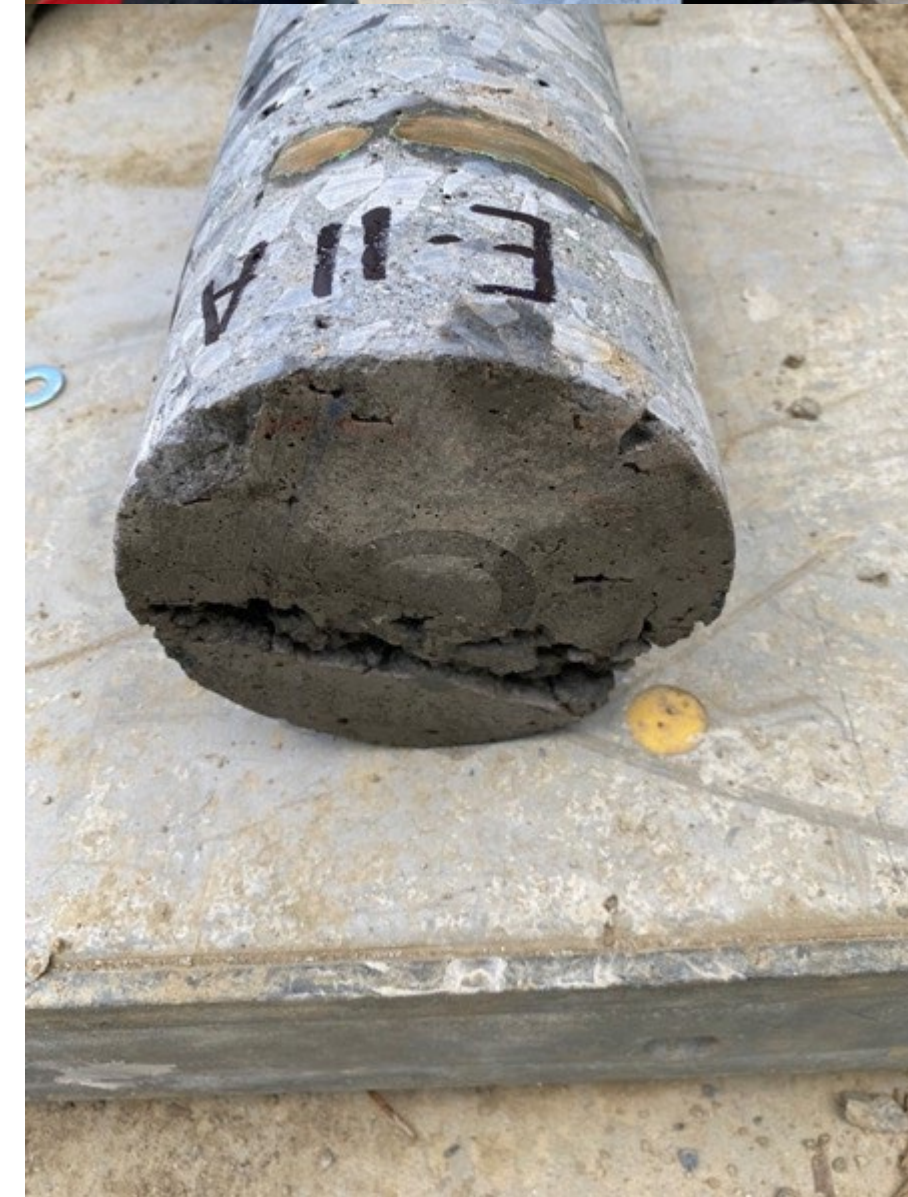
- Constructed in 2020
 - Consolidation issues in cast-in-place concrete
- Specified Service Life 75 years
 - Compressive strength, chloride penetration, etc.
- Exposure to deicing salts
 - Reinforcing steel concrete cover protection
- Investigation of the impact
 - NDT by others, coring, depth of consolidation
- Responsibility
 - Contractor
- Repair recommendations
 - Remove Remove 1" beyond rebar on both faces
 - Shotcrete repair
- Removed due to schedule impact
