2024 FALL CONVENTION

Nondestructive Evaluation (NDE) for Concrete Honeycomb/Void Detection and Imaging and Repair QA

Larry D. Olson, PE

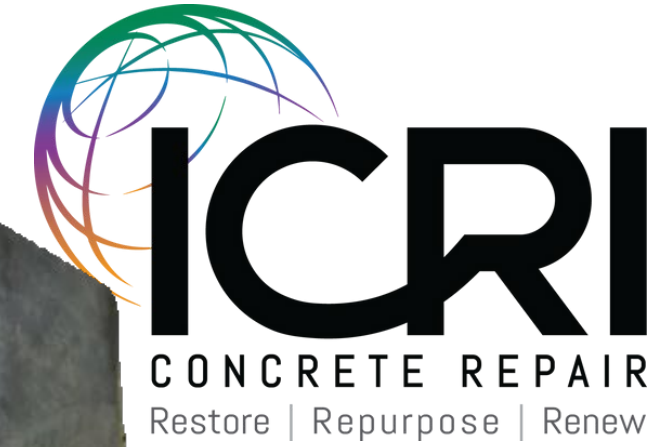
Example Photogrammetry Image of Drilled Shaft

- Collecting baseline data
 - Thermal Cracking in Drilled Shaft
 - Current cracking, moisture, efflorescence, etc.
 - Current assets
- Monitor deformations over time
- Mapping surface degradations over time

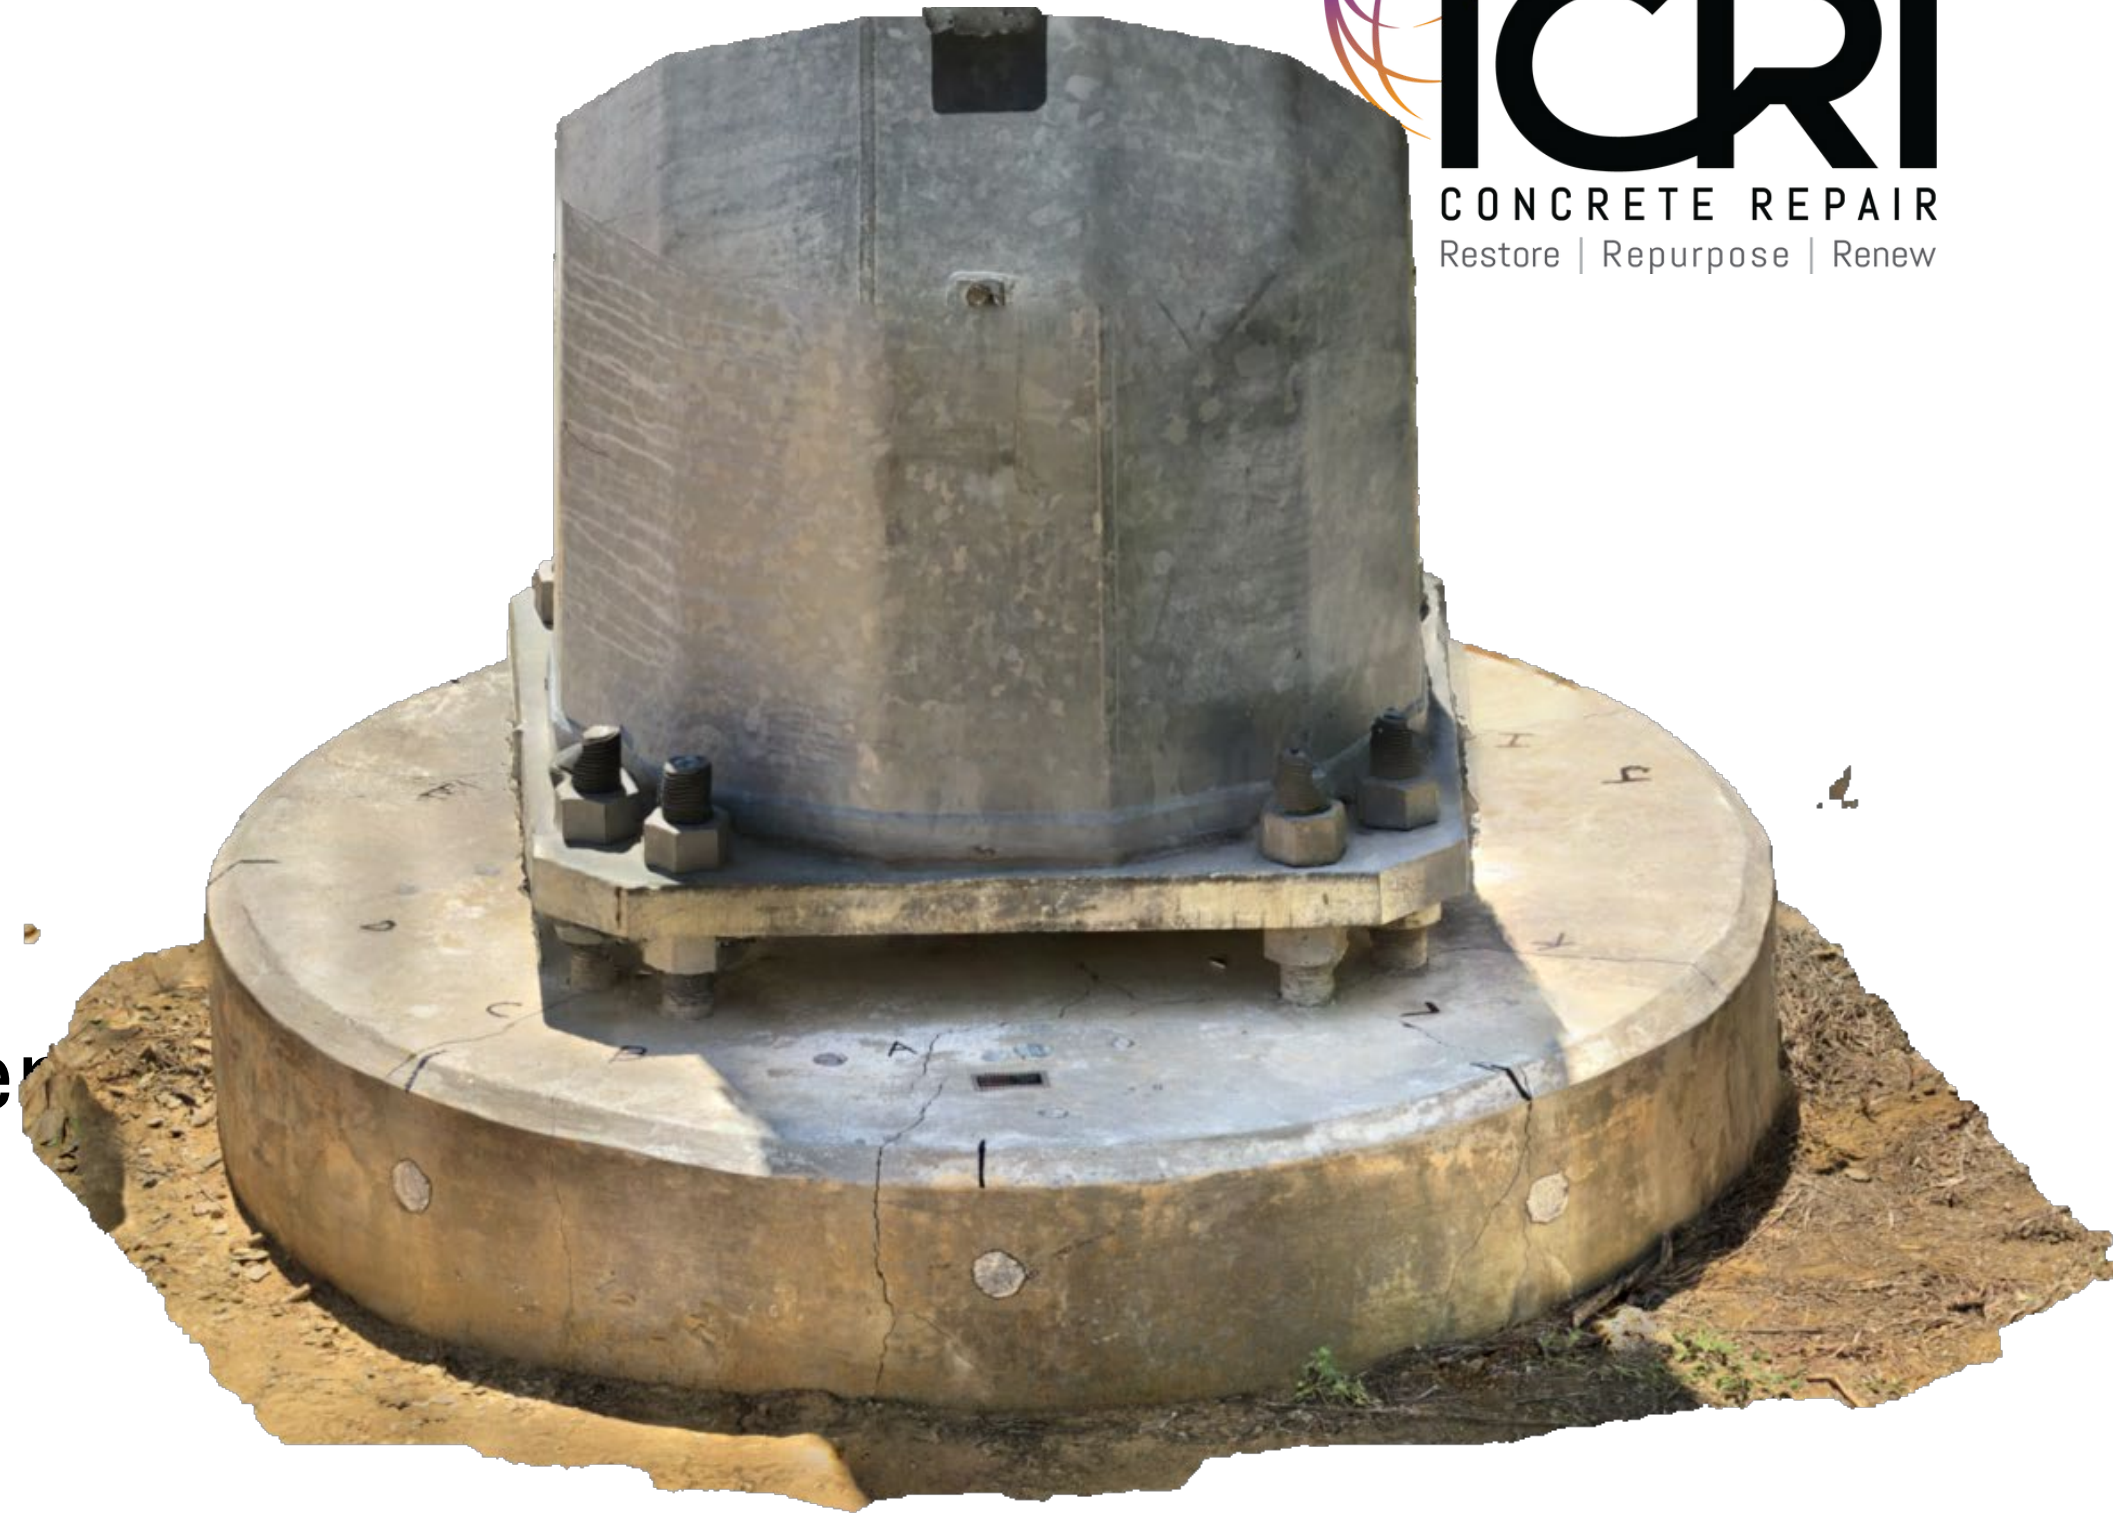
Photogrammetry Method

- ▶ Capture Raw Photographic Digital Images with high resolution phone camera at a minimum – telephoto lens camera useful for larger structures
- ▶ Identify target features that occur in multiple photographs.
- ▶ Use angle changes in target features from photograph to photograph to determine the 3D structure of the object
- ▶ Project pixels from the photos onto the 3D structure and generate texture
- ▶ Agisoft Metashape software used for bridge image processing on Windows PC with fast processor/GPU
- ▶ High resolution (0.6 to 1 mm) images took 1-2 hours of processing
- ▶ Offers 100% coverage but large data files (1 Gigabyte)

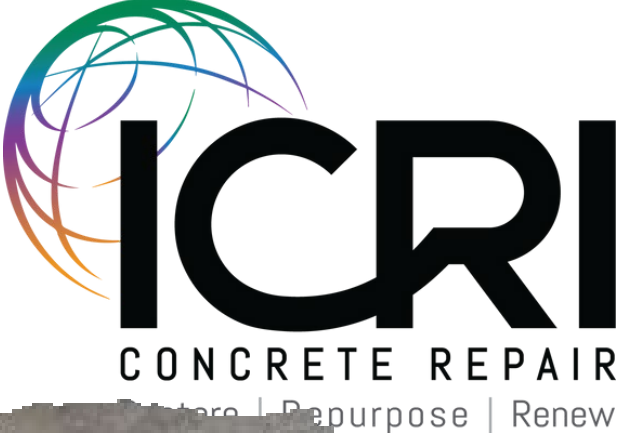
Digital Photogrammetry Example Data Bridge Girders with 6 inch NDE Grid marked out on Webs and Ends

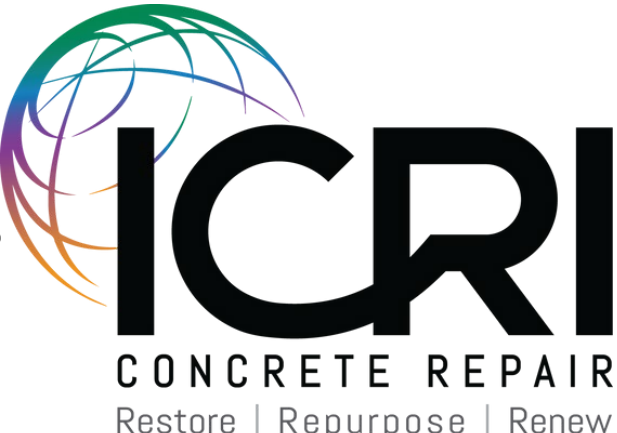
GPR scanning with GSSI StructureScan Mini XT unit (2700 MHz Antenna). Note the 6 inch “+” grid marks to guide horizontal and vertical GPR scan lines on a 3 inch grid for 3D GPR data analyses

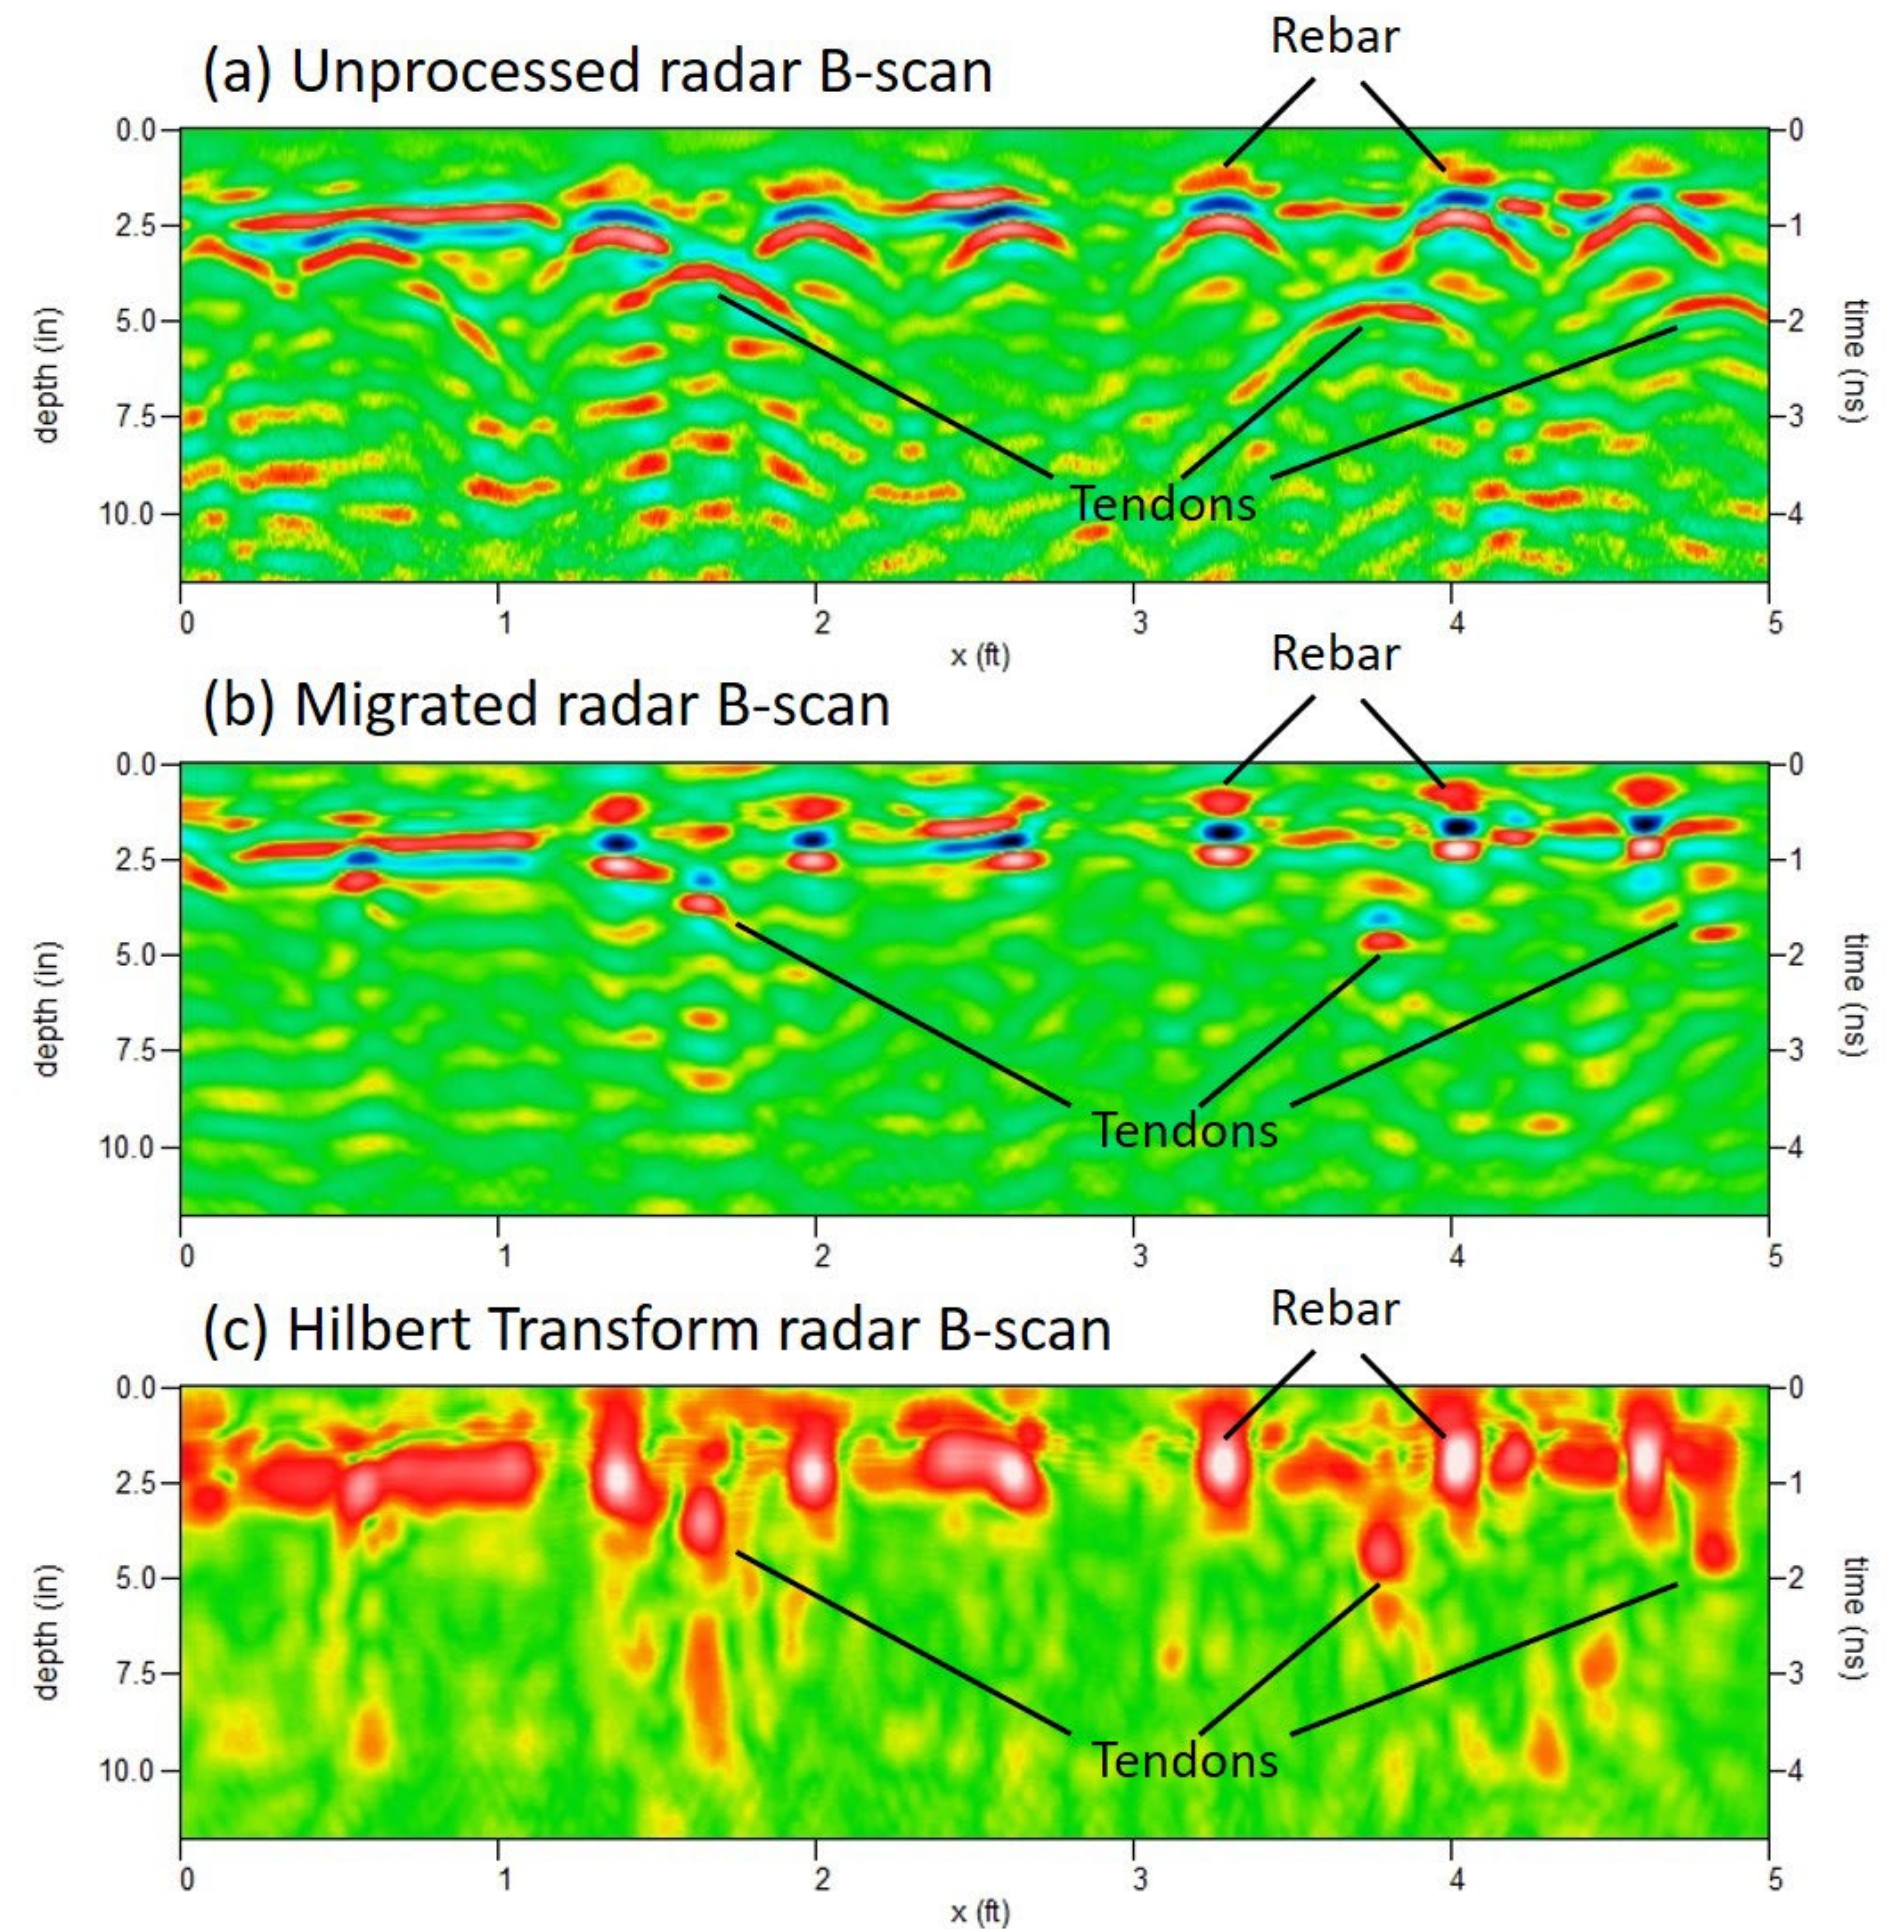
2-D GPR Scan Data Analysis

- (a) the raw GPR data is shown with the hyperbola reflections from a 2D scan across the rebar and ducts;
- (b) next the signals are migrated to collapse the hyperbola reflections from the rebar and tendon ducts to their locations
- (c) the pulses are merged into a single pulse envelope via a Hilbert Transform
- (d) the Hilbert Transformed data is then gridded in two directions and summed
- (e) both rebar and PT Tendon Ducts are noted in the data

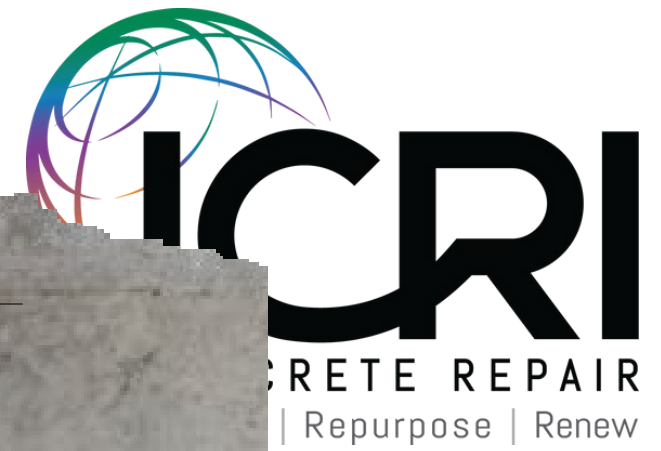
Data Fusion - 3D GPR Depth Slices for PT Ducts, Rebar and Plates

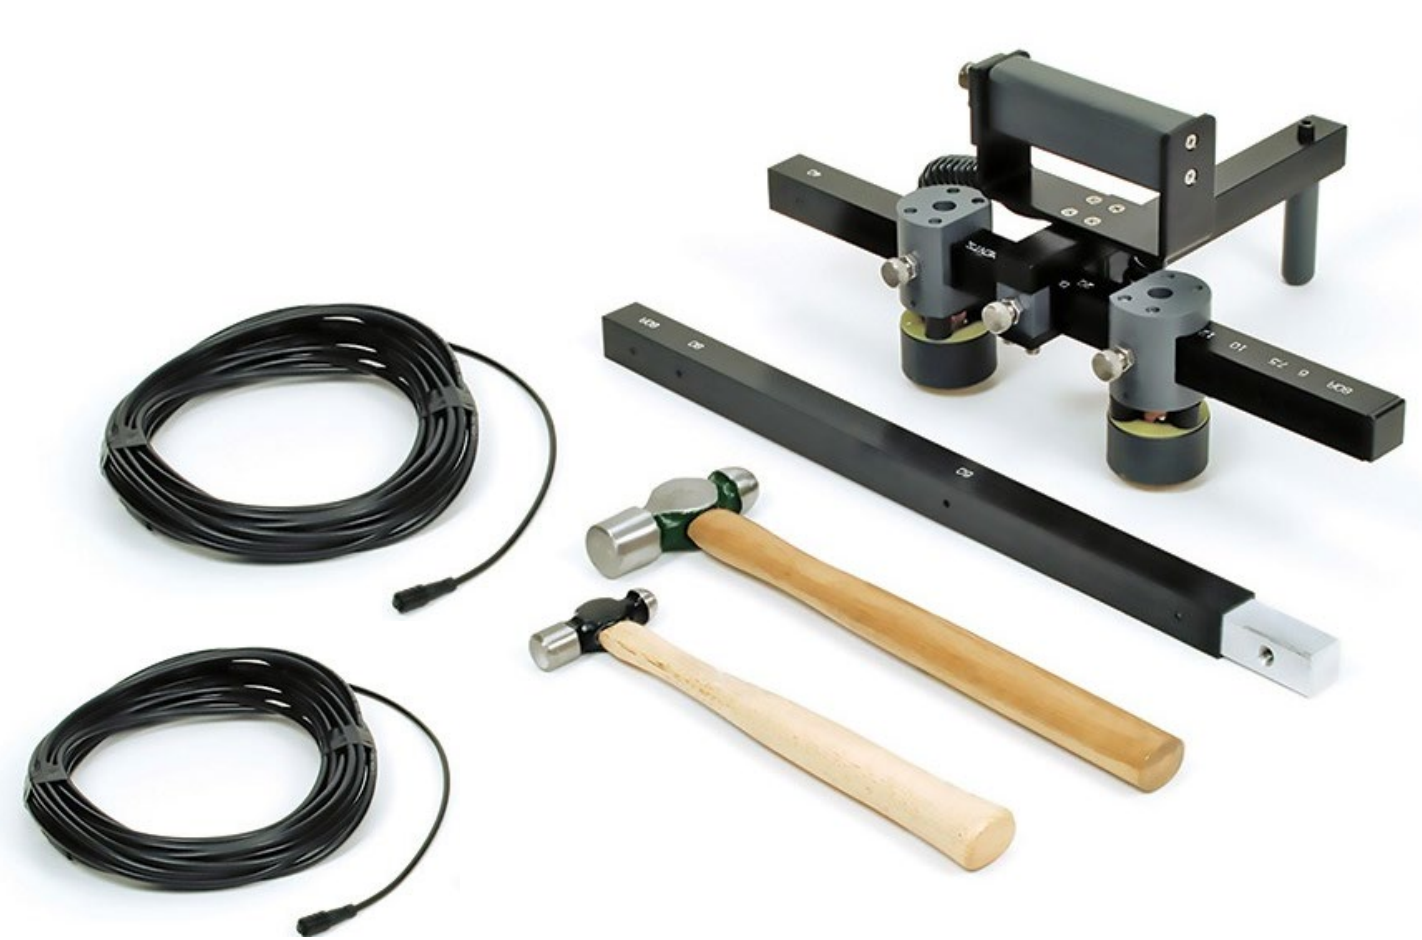
SASW-S Bar for 6 to 80 cm spacings with 2 displacement transducers and 2 small accelerometers for larger, variable spacings

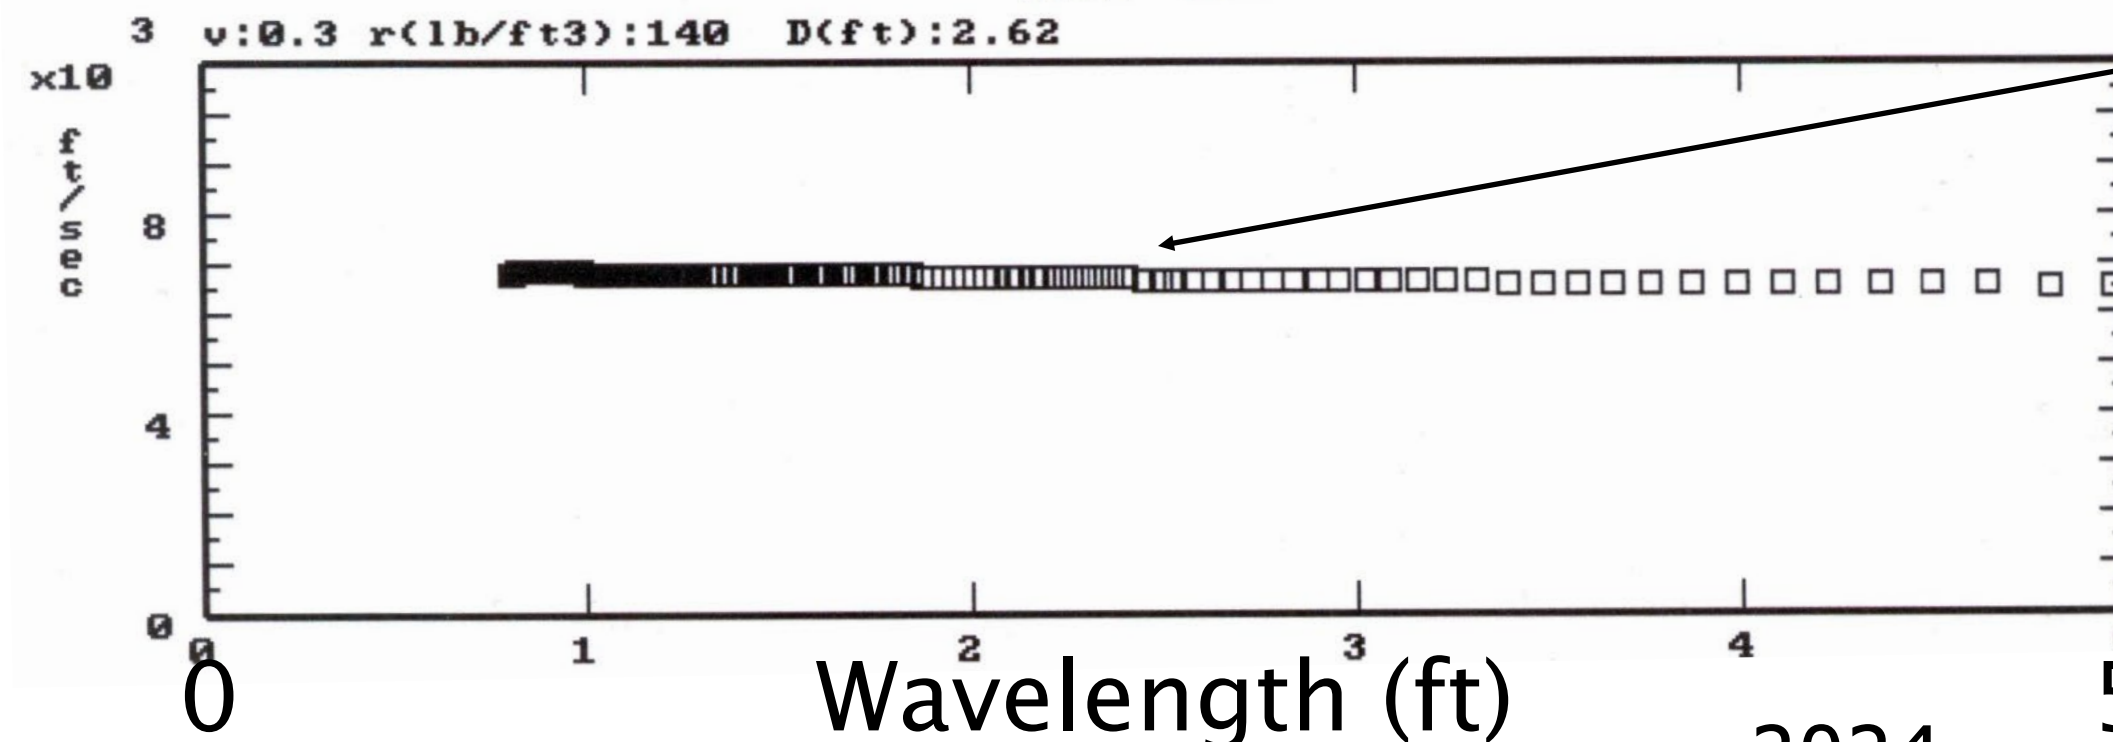
SASW Phase Plot from Sound Concrete Area

for 2.62ft SASW Bar spacing = 1 wavelength (-360° phase),
Velocity=frequency x wavelength= 2628 Hz x 2.62 ft = 6900 ft/s

$V_R = 6900$ ft/s
Surface Wave
Velocity for
Sound Concrete

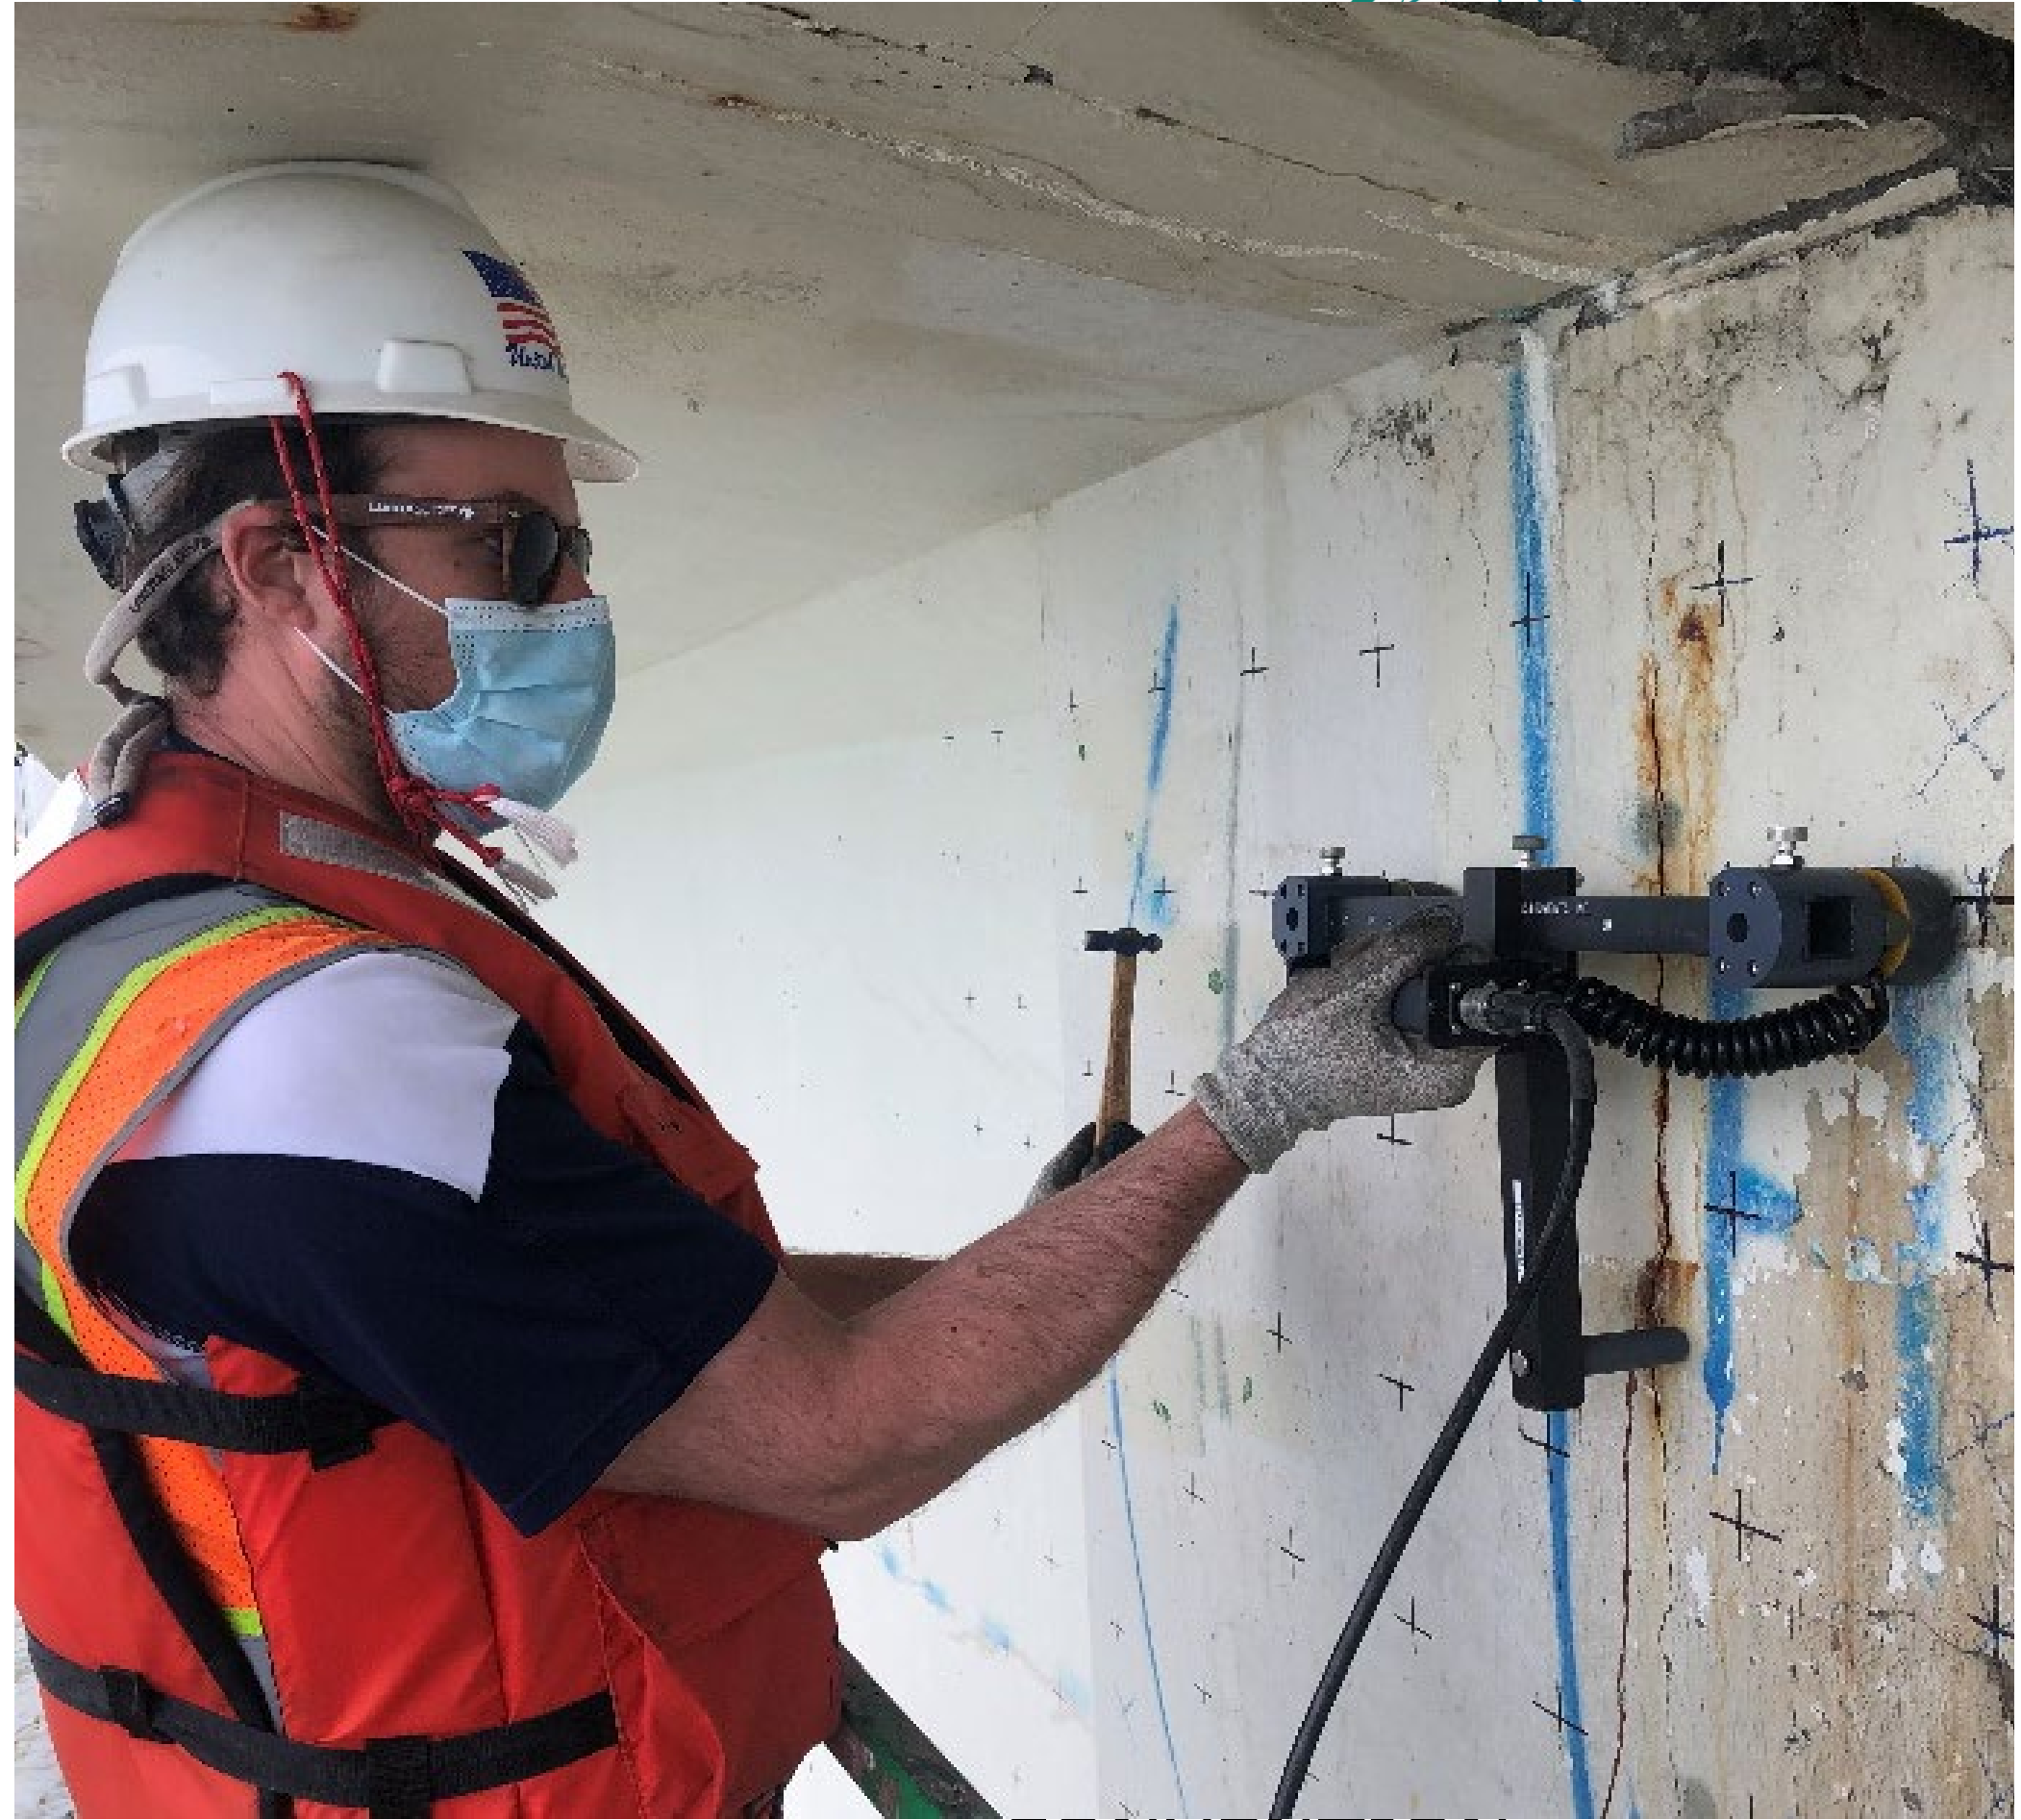
Spectral Analysis of Surface Waves (SASW) testing across crack for its depth

Note: SASW bar with two displacement transducers spaced 1.31 ft apart with a 2-oz metal ball-peen hammer impactor for in-line impacts

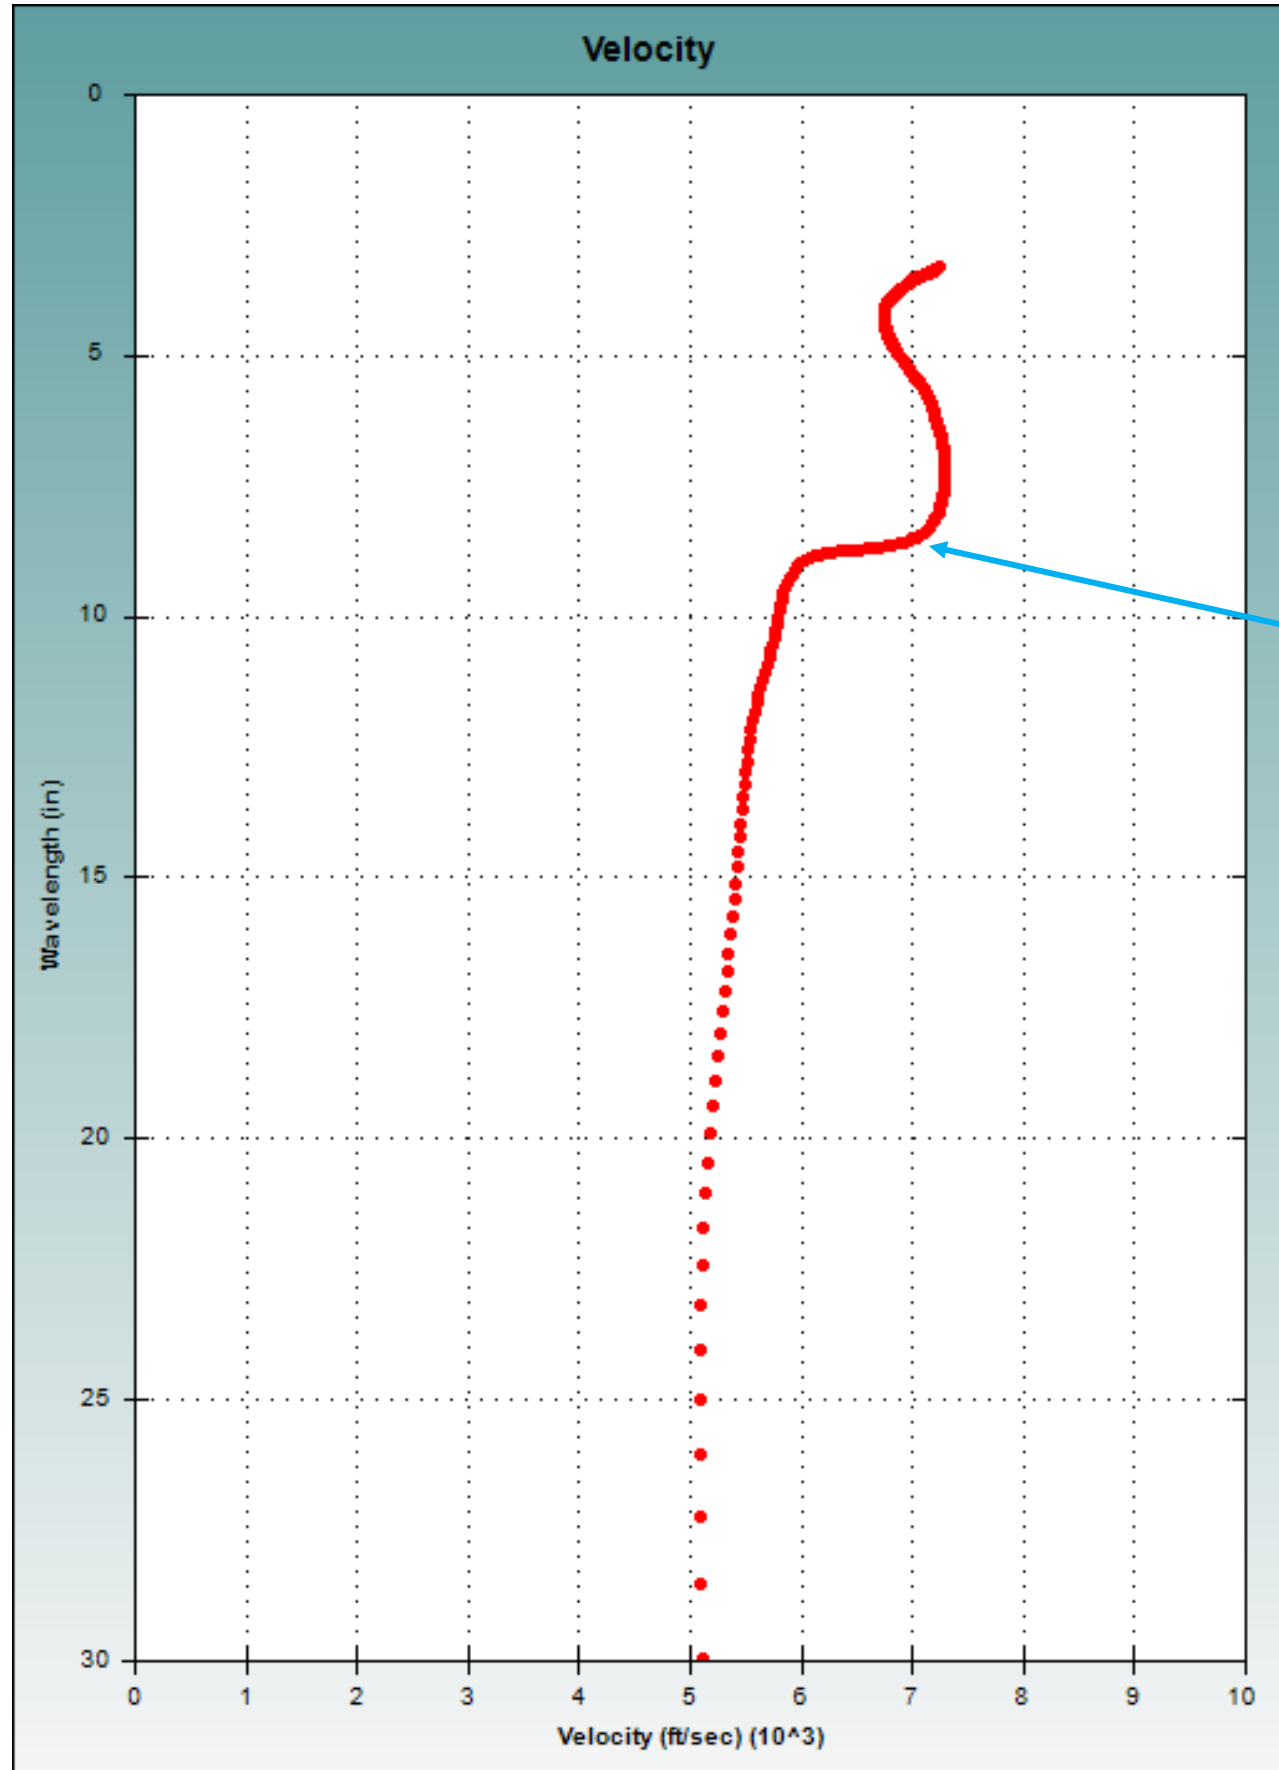
SASW Results for Sound and Cracked Concrete Girder Areas

The backside of the sound 7.5 inch thick web section is shown by the drop in surface wave velocity from ~7,000 ft/s from 4 to 8 inches to ~5,500 ft/s at a wavelength of 8 inches

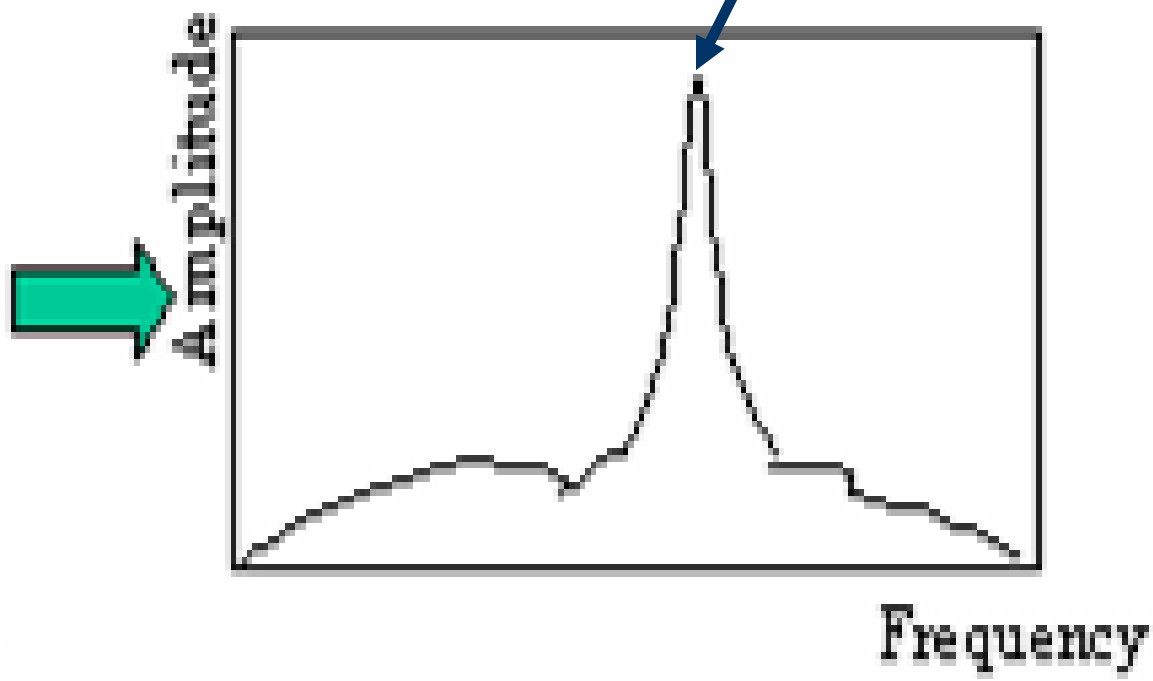
Impact Echo Data Analysis

$D = \beta V_p / (2 * f) = \text{echo depth / thickness}$
 $V_p = \text{compressional wave velocity}$
 $\beta = \text{beta factor for shape} \sim 0.96 \text{ for slab shape, lower for beams \& columns}$
 $f = \text{resonant echo peak frequency (Hz)}$

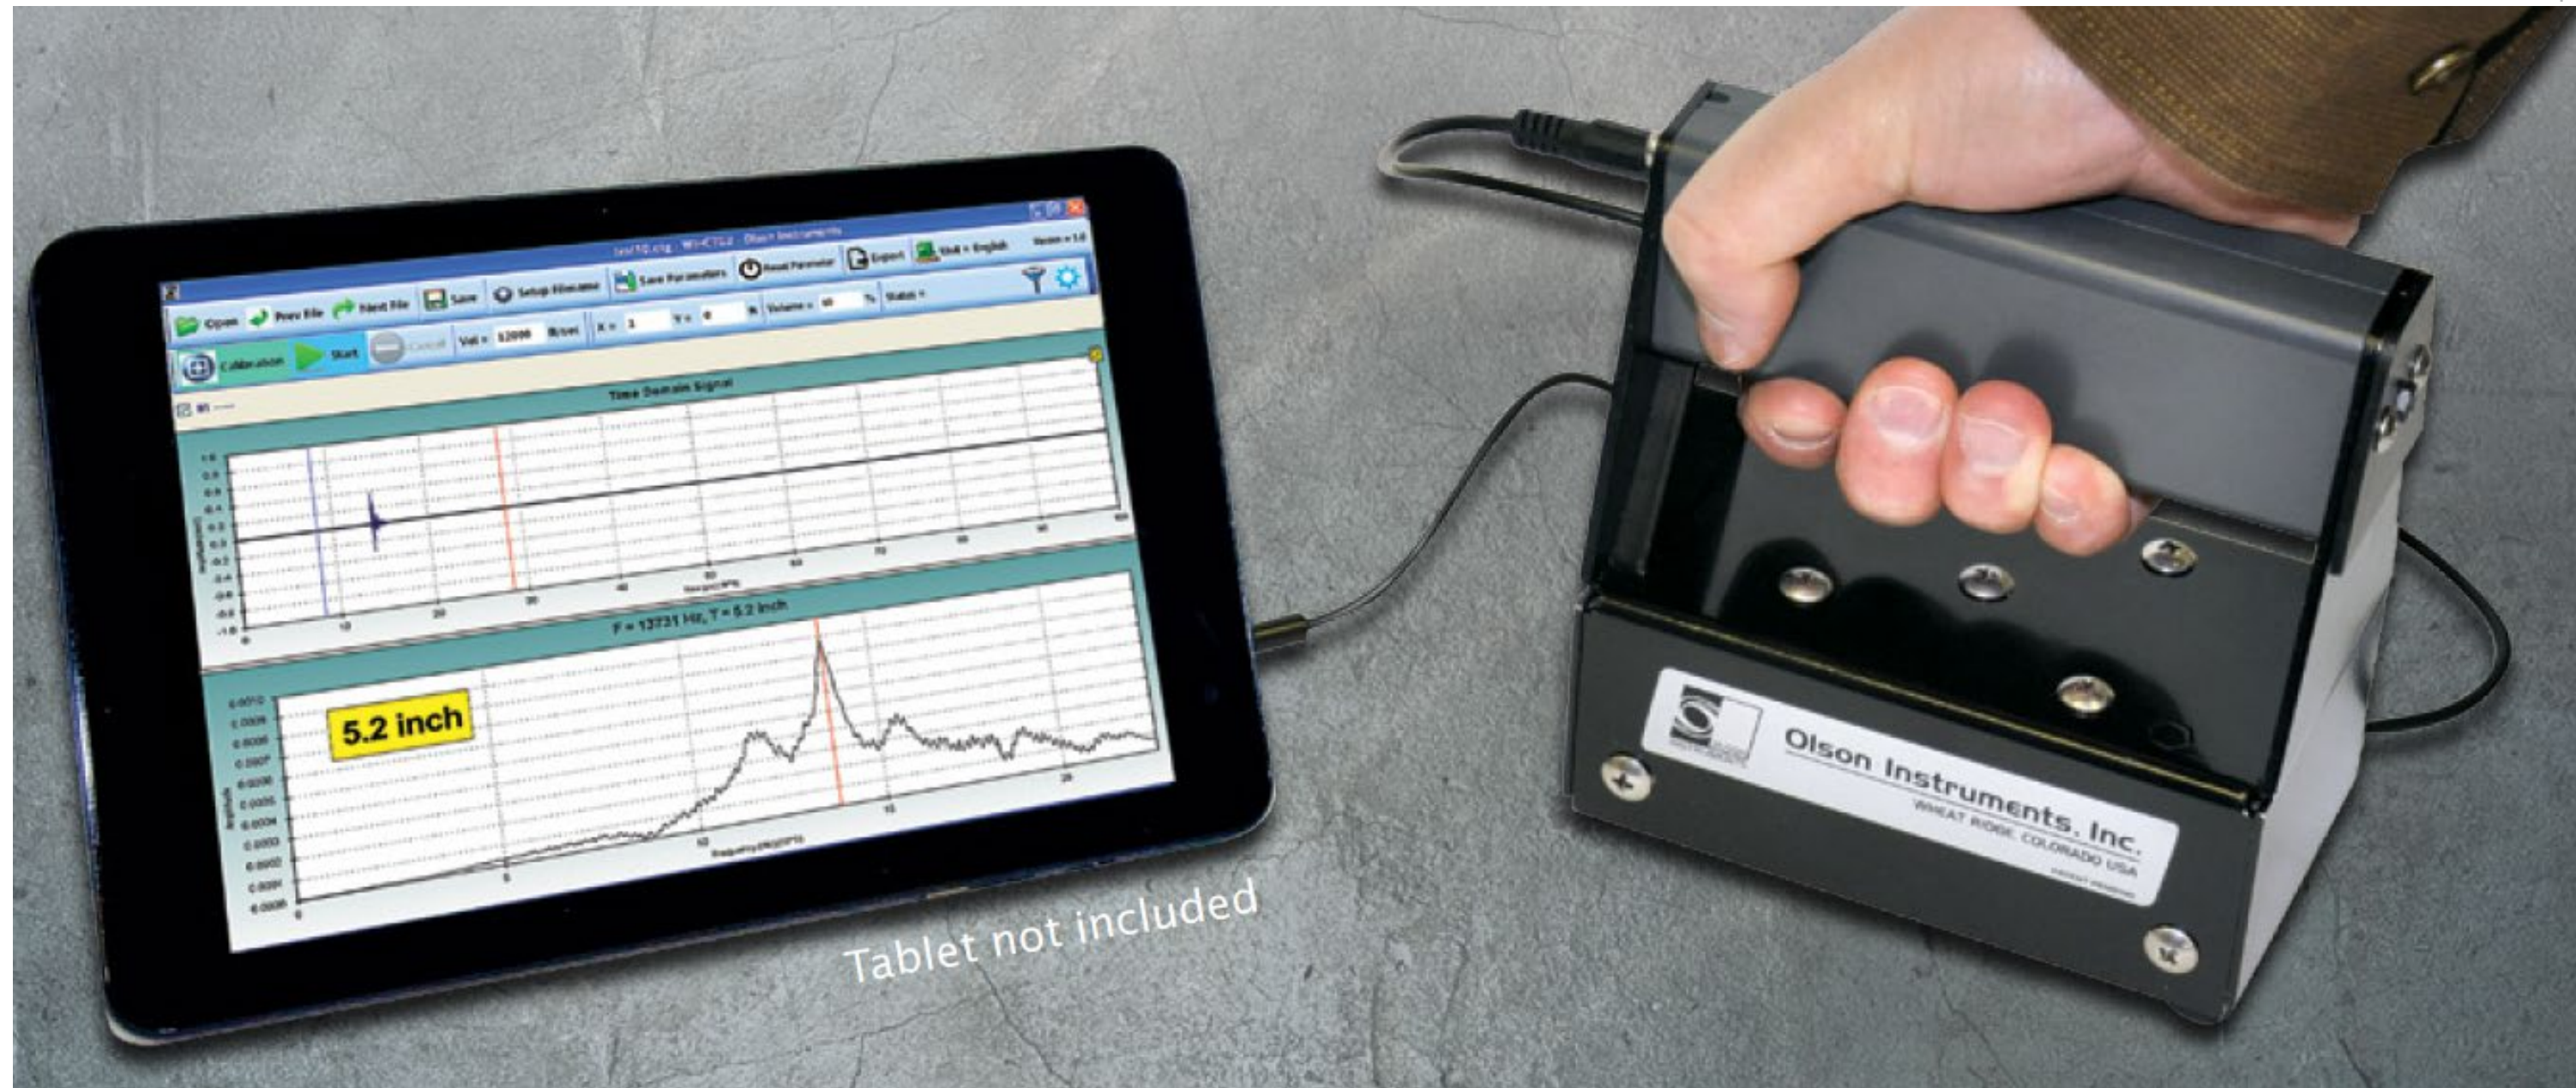
Impact Echo Gauge for 1 Sided Concrete Thickness & Flaws such as Cracks, Void, Honeycomb
