2024 FALL CONVENTION

Nondestructive Evaluation (NDE) for Concrete Honeycomb/Void Detection and Imaging and Repair QA

Larry D. Olson, PE

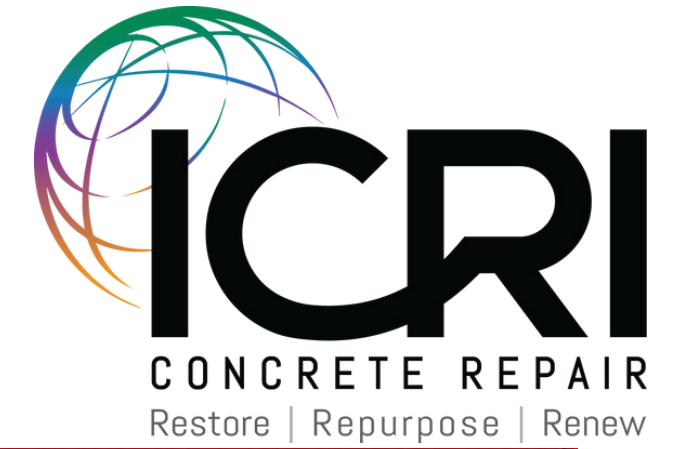
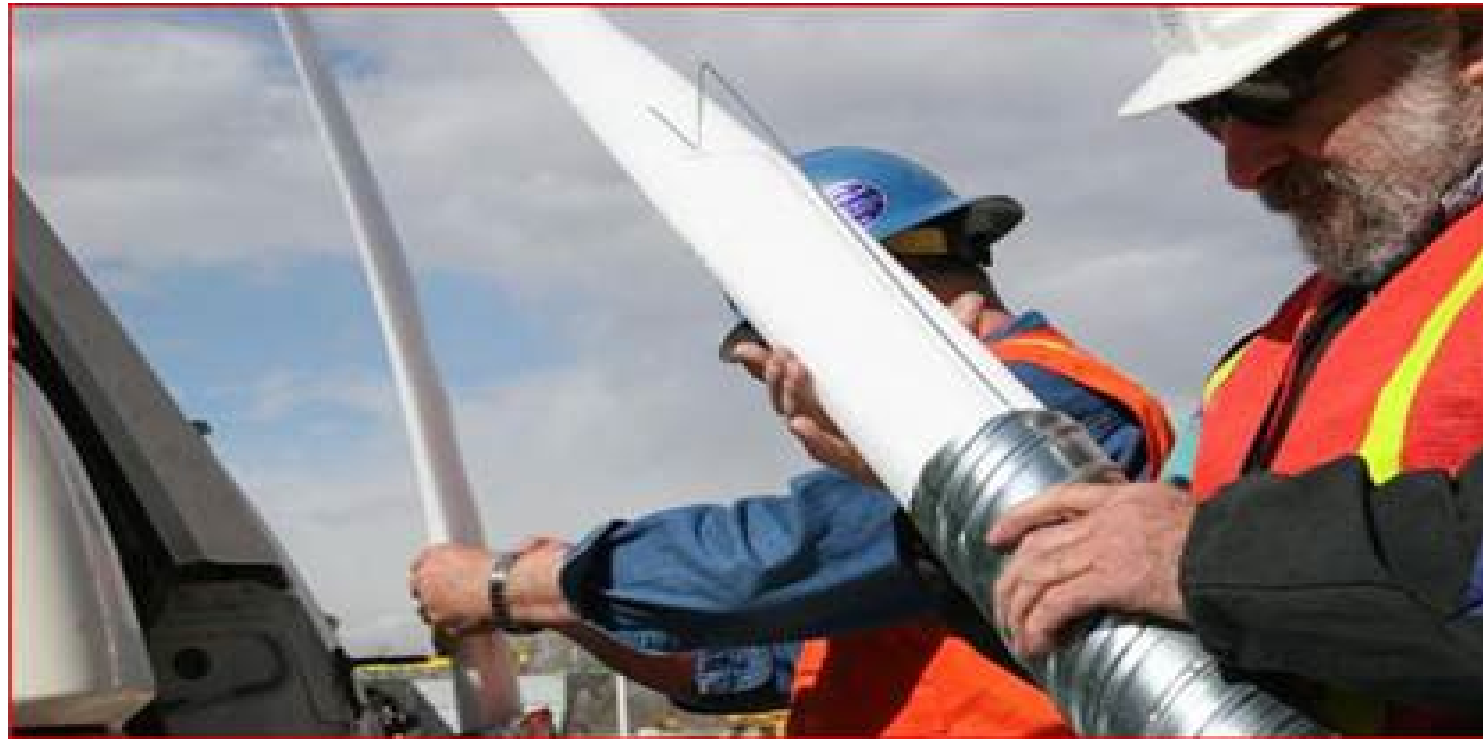
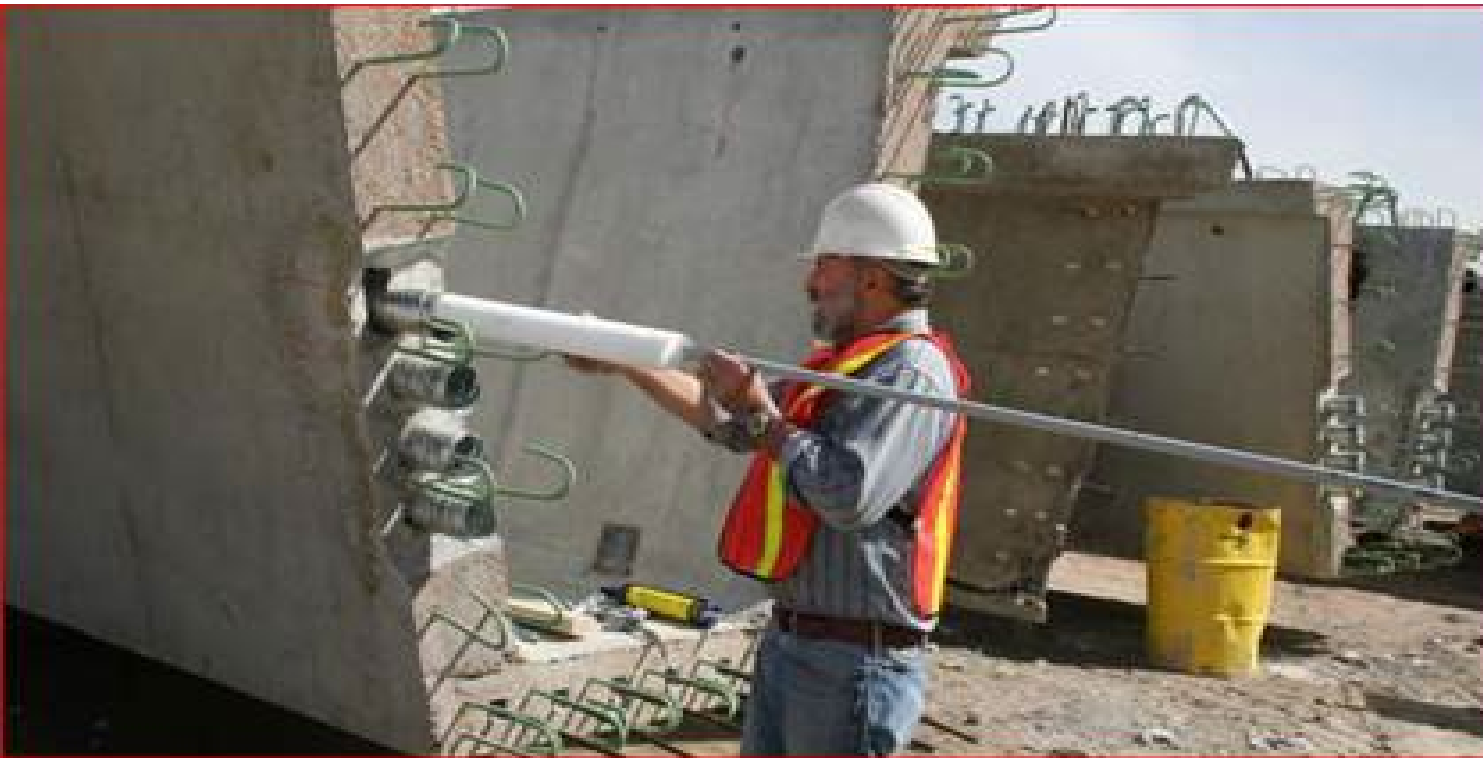
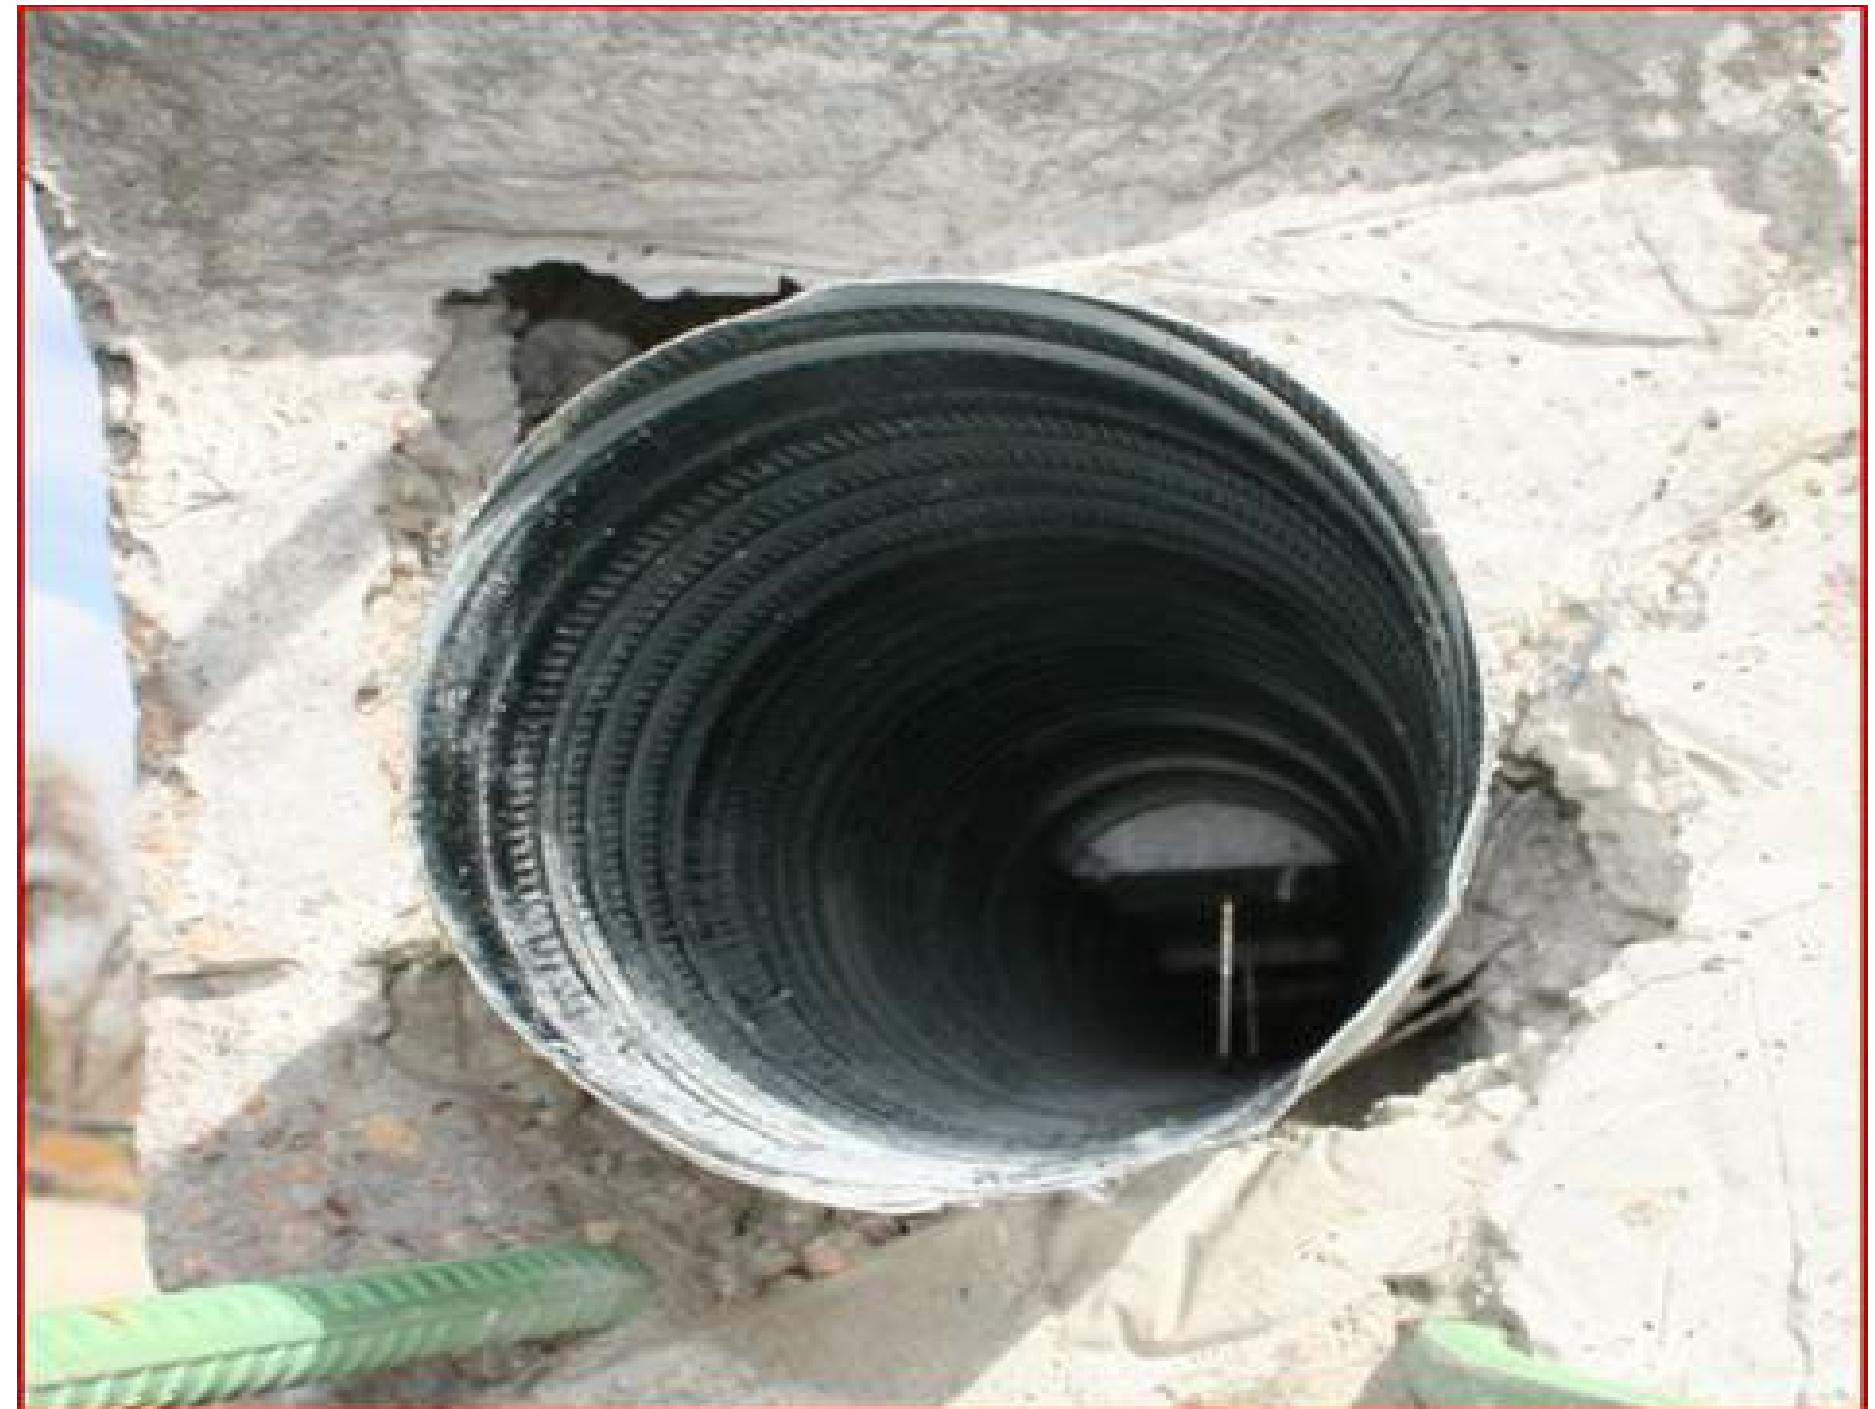
Grout Defect Simulation with Styrofoam Voids

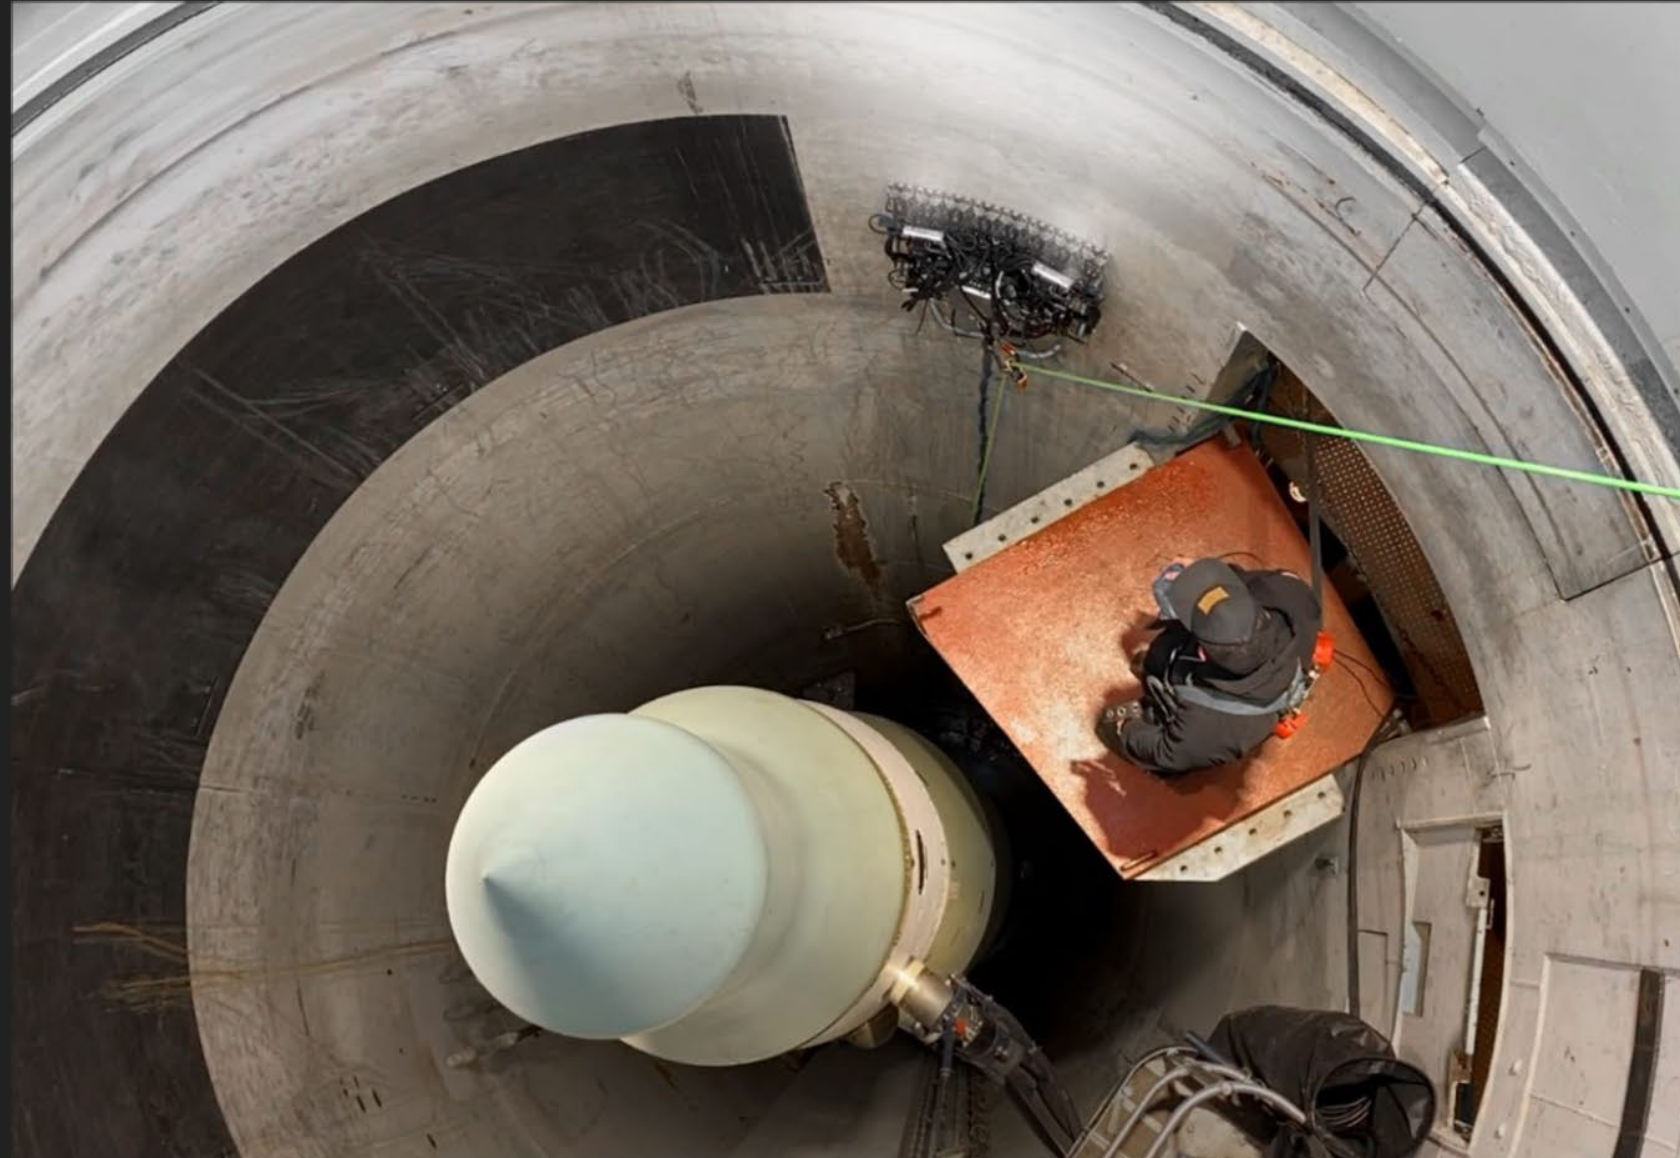
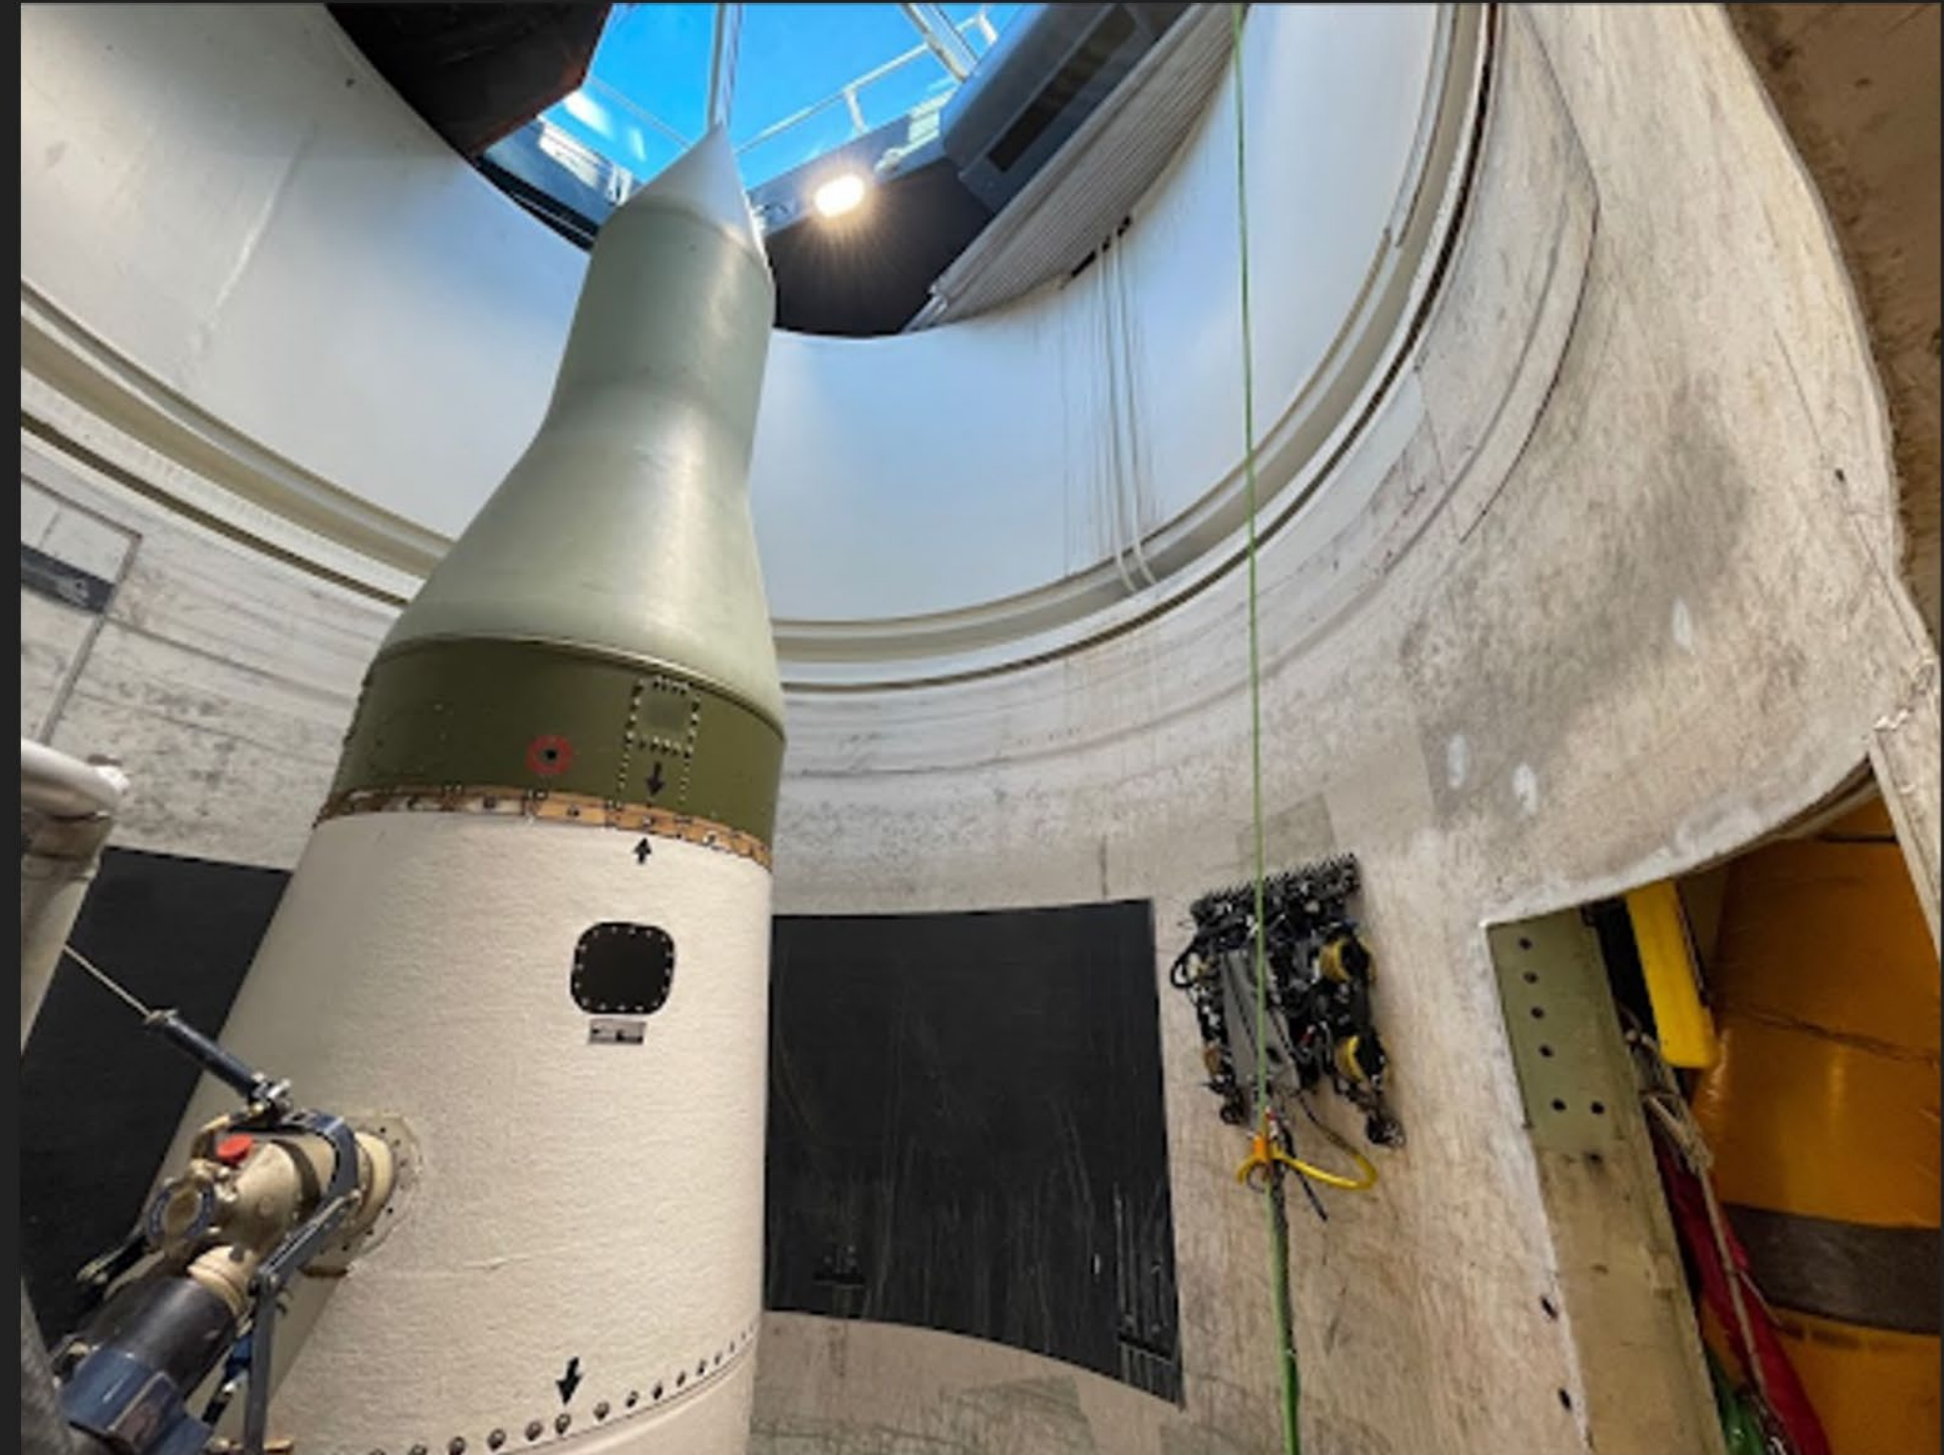
Gecko Monarch Robot with Olson Impact Echo + Surface Waves Scanning for Concrete Integrity and Flaws behind ½ inch (12.5 mm) steel plate of Wall #1 with 2 inch scan lines

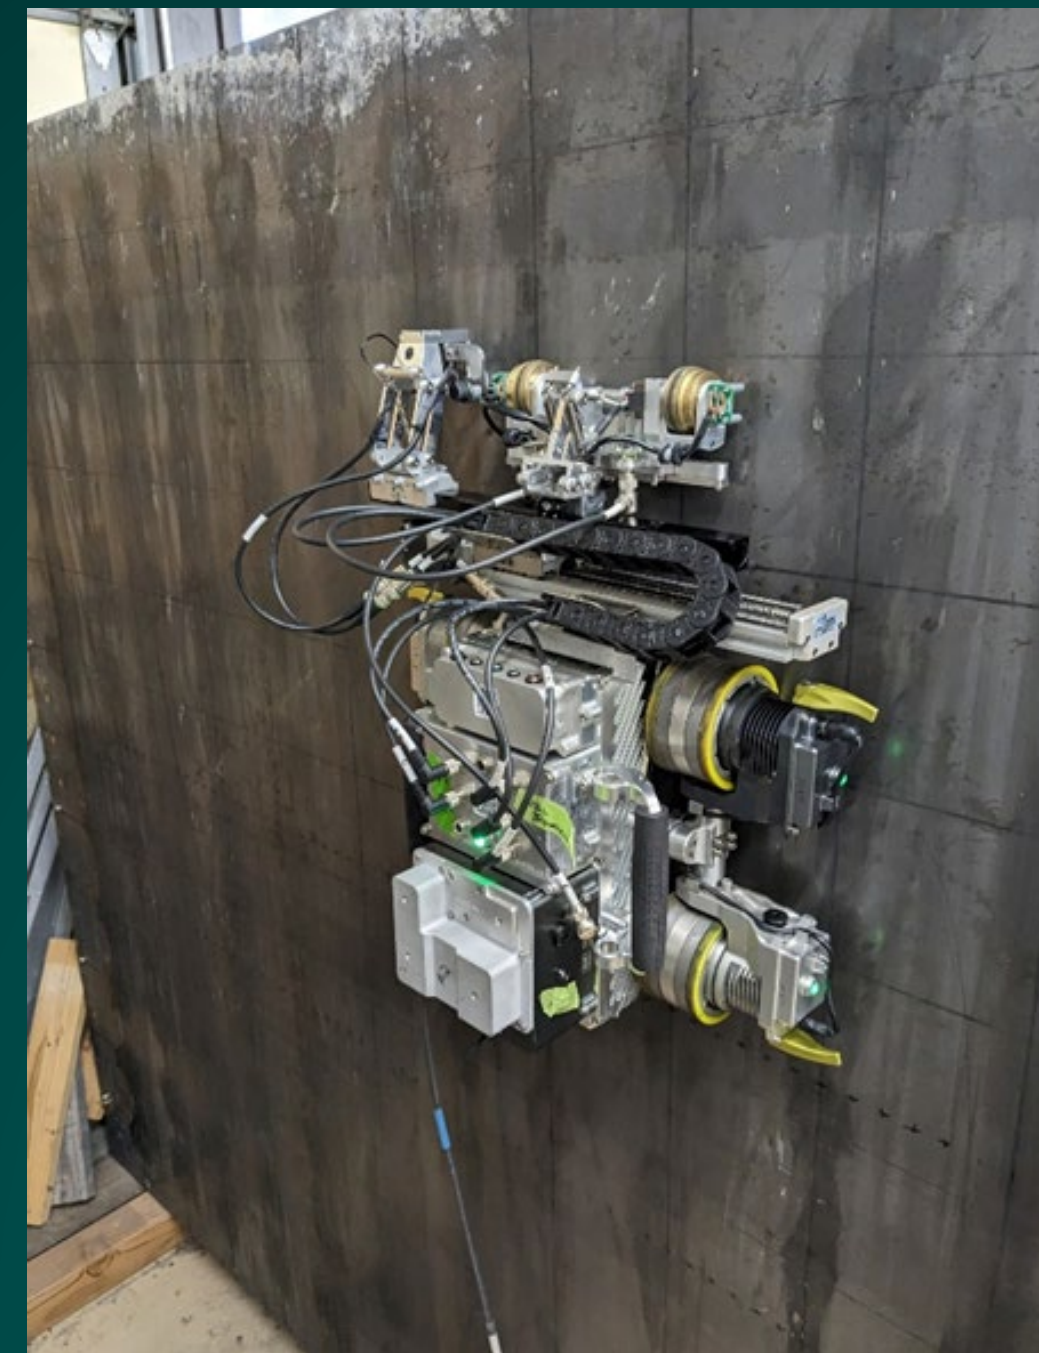
Gecko Robot – Ultrasonic Pulse Echo Scanning of Steel with 24 Sensors for thickness/integrity/corrosion – 1 inch (25 mm) spacing of scan lines

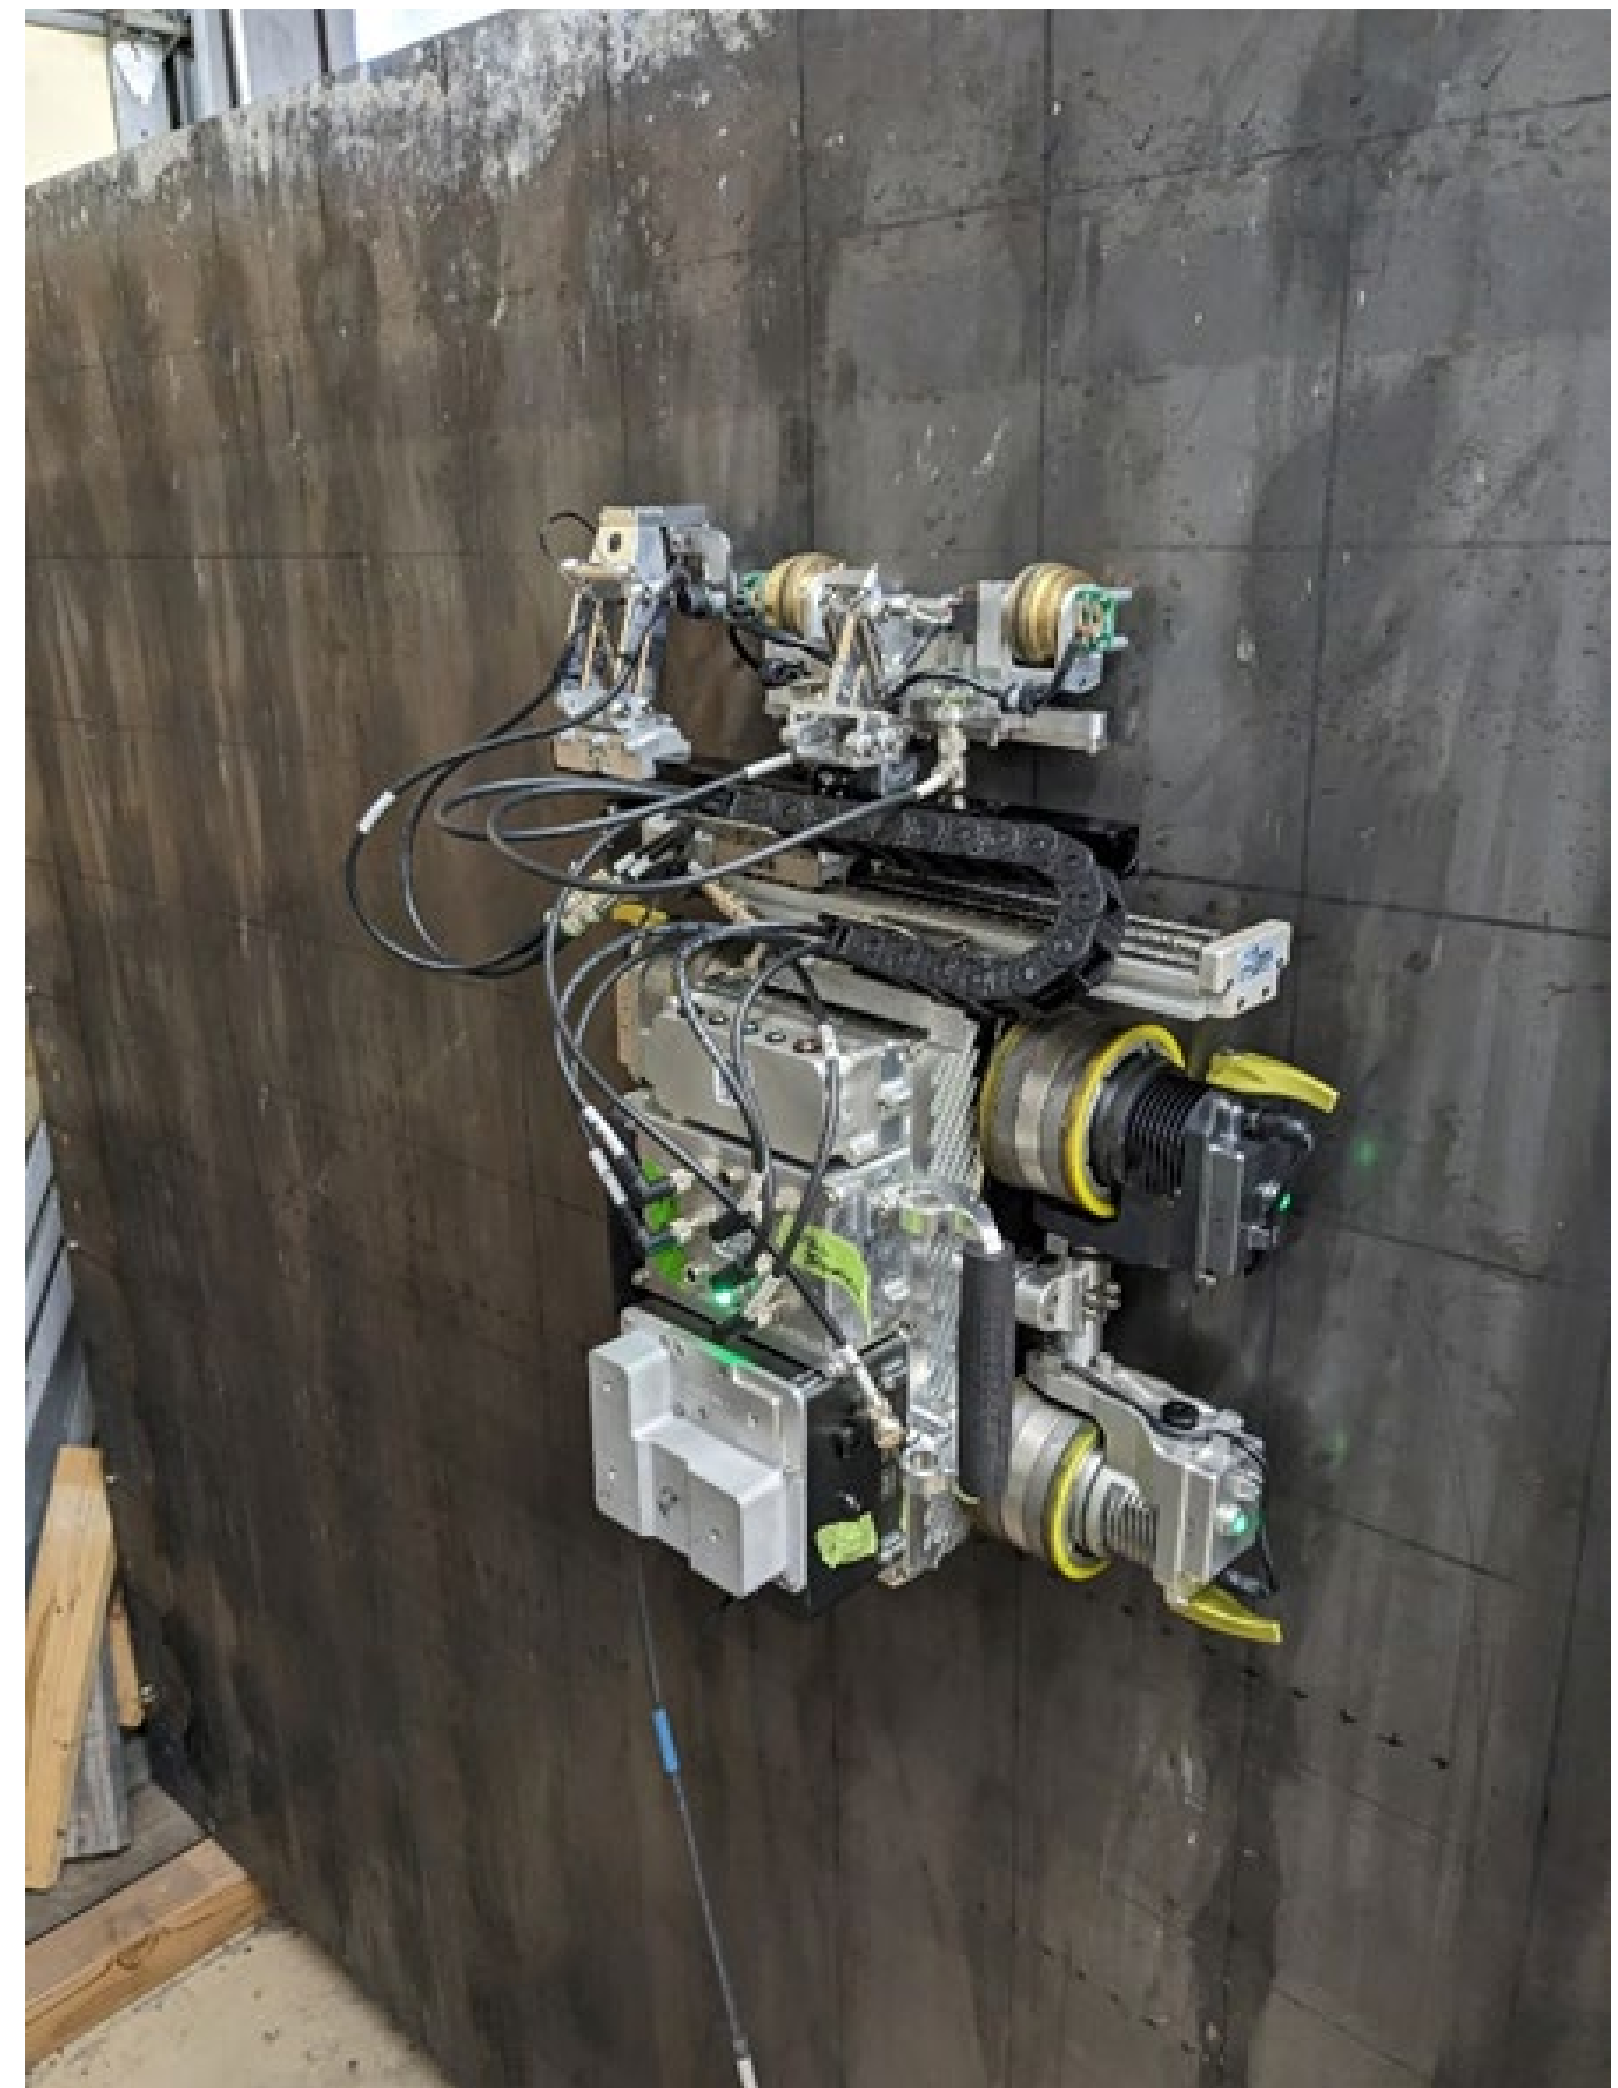
Monarch IE+SASW Scanning Robot on Wall #1 on right.
Below is a view of solenoid impactors (on the left) and two dry-coupled rolling displacement transducer wheels for tests every 1 inch (25.4 mm) with IE (left wheel) and SASW tests over 6 inches (152.4 mm) between left and right wheels

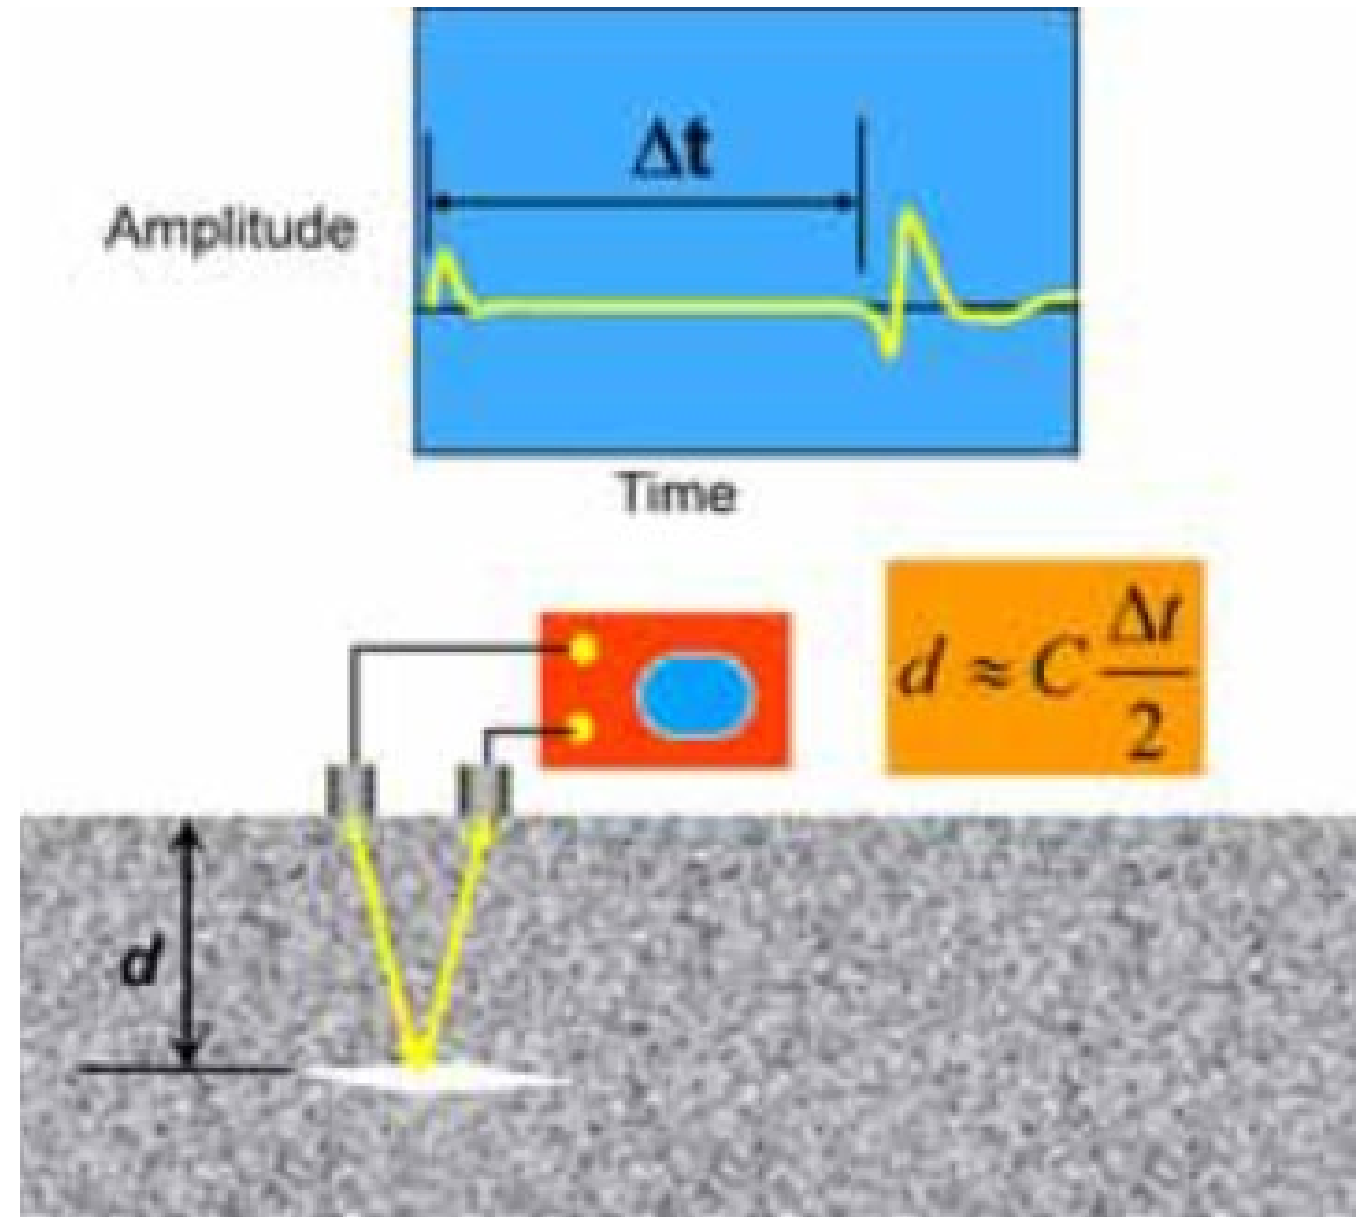
Ultrasonic Pulse Echo (UPE) – Shear Wave Tomography Method

$d = C * \Delta t / 2$ where d is echo depth, C is shear wave velocity and Δt is the echo reflection time

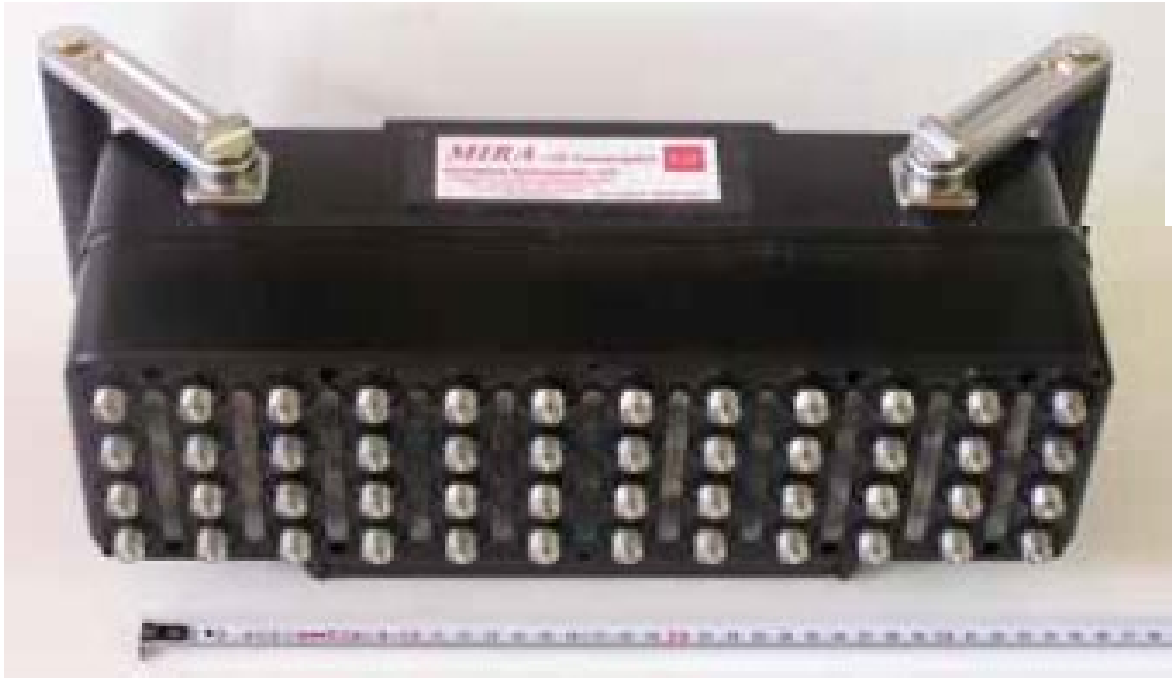
Pundit 8050 UPE system used in Stripe Scan 3D Mode with the Apple iPad for Data Acquisition performed on Surface K with the AI automatic position strip scan mode utilized along the tape mounted on the beam

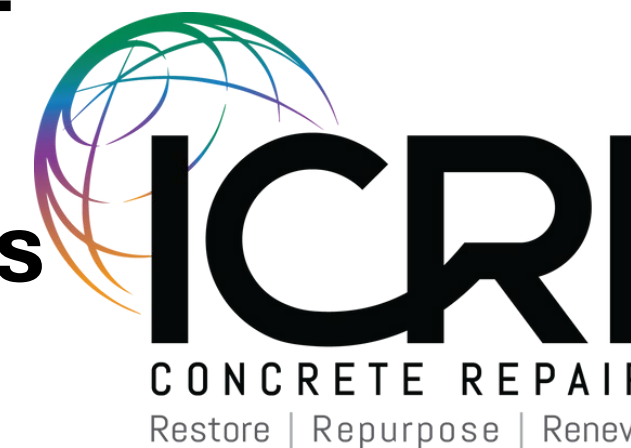
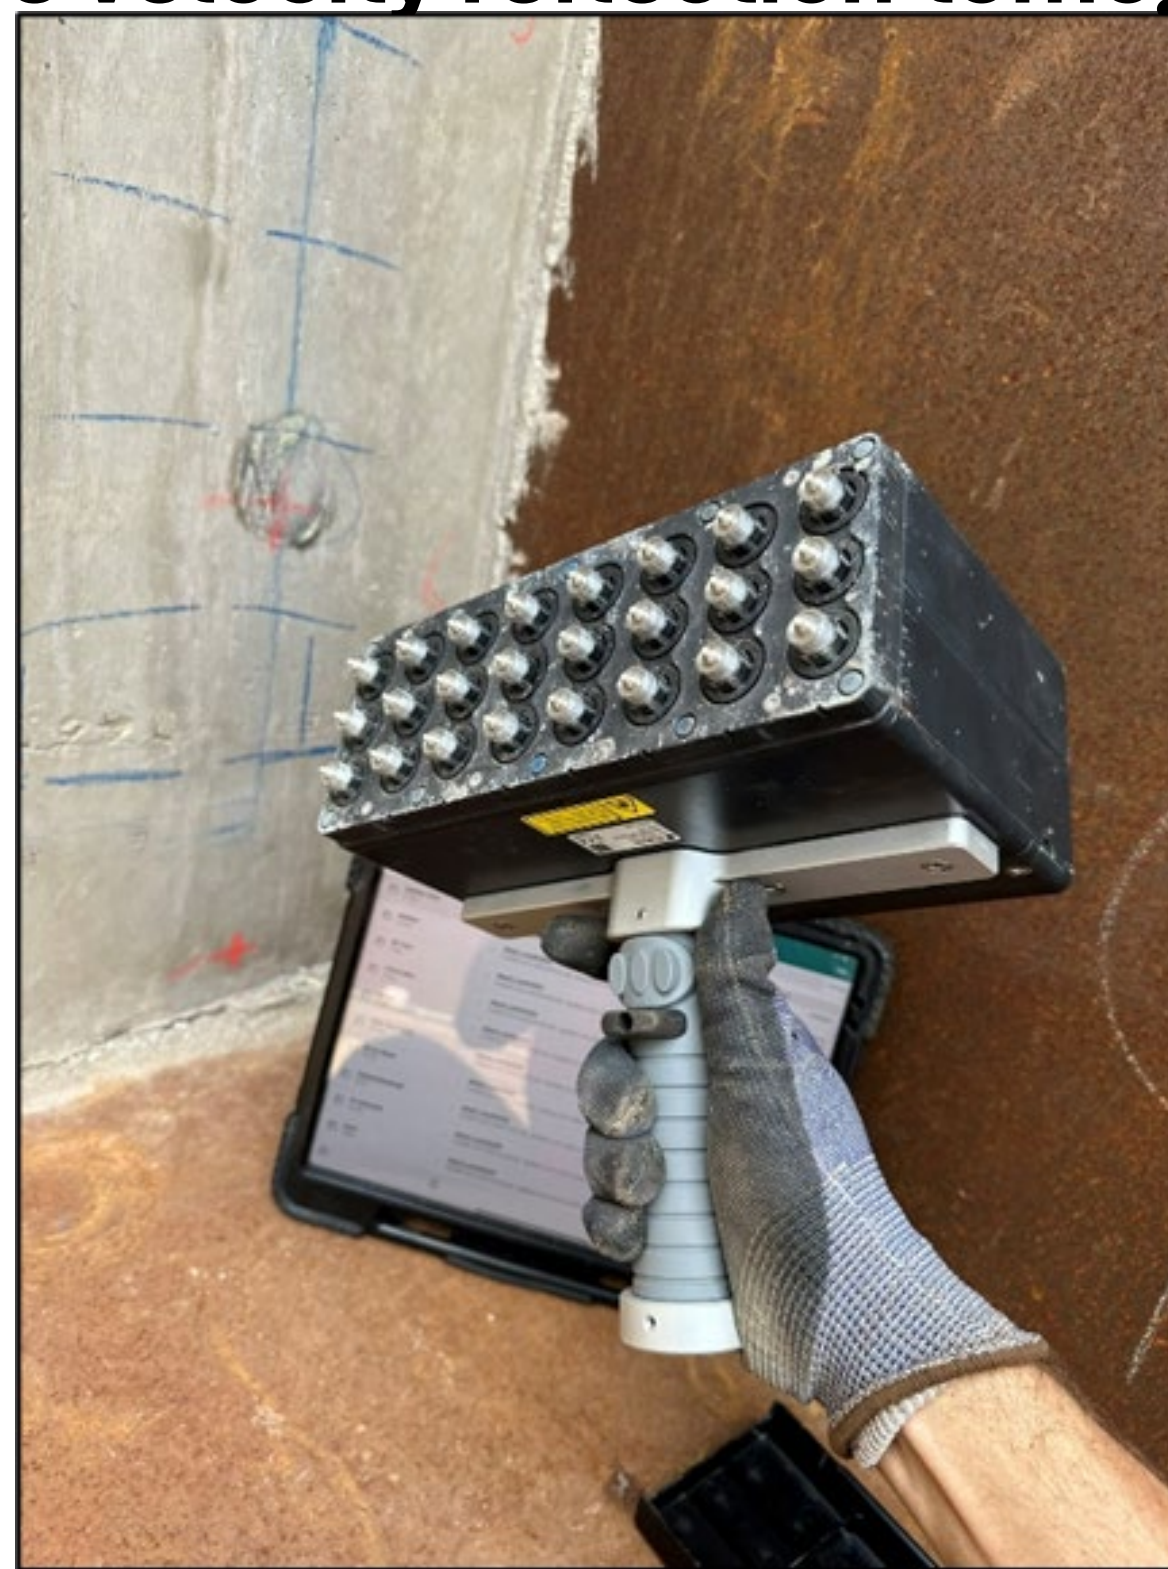
Proceq PD8050 UPE System with an Apple iPad. Note the 8 rows of 3 spring-loaded point contact transducers to generate and receive shear wave energy for the shear wave velocity reflection tomograms

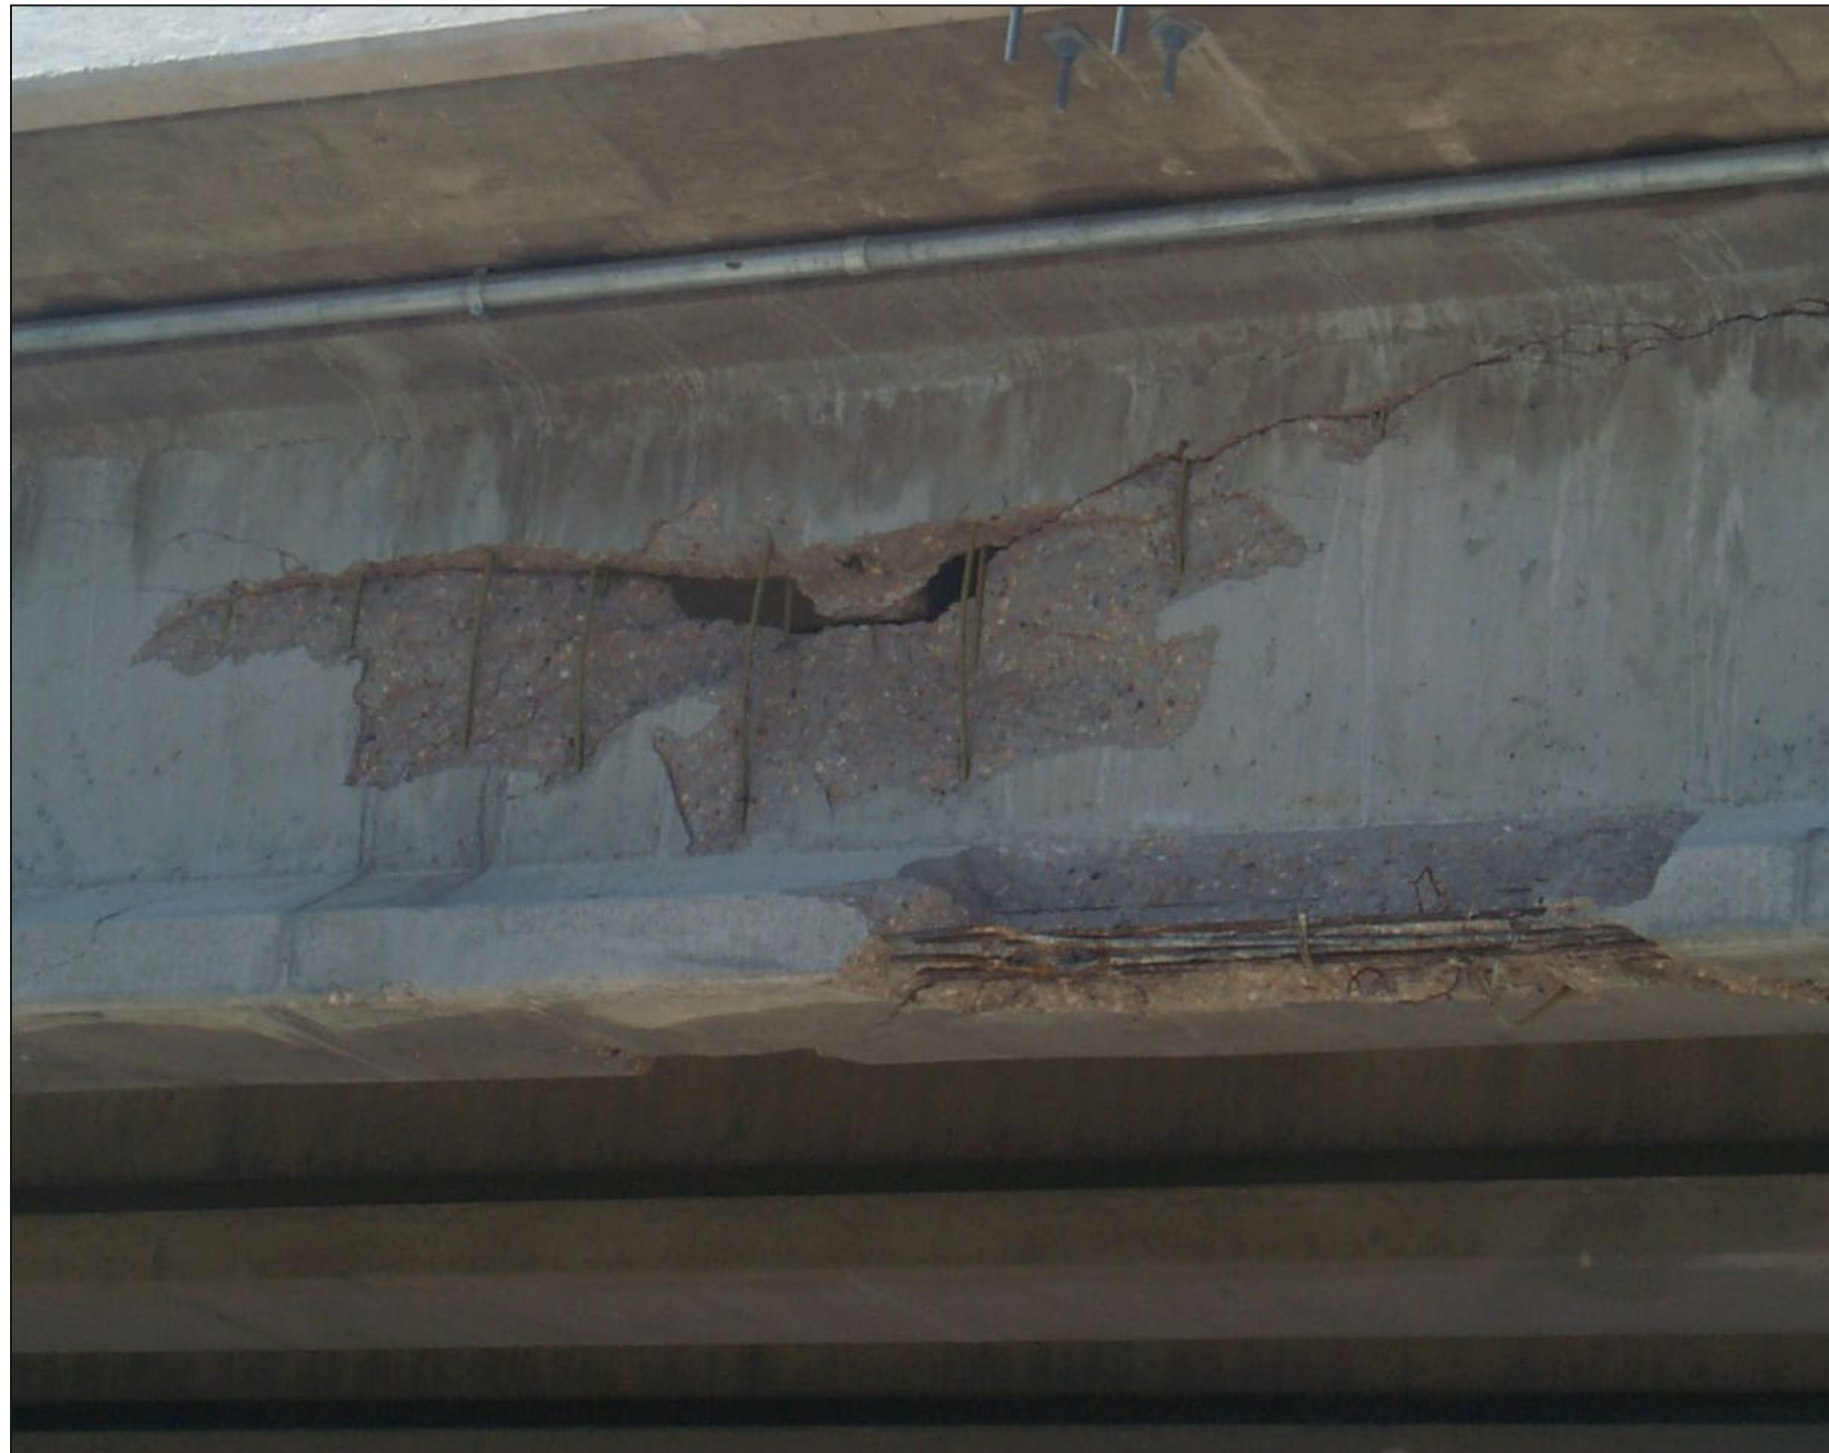
- **Concrete bridge over I-70 was impacted by a forklift carried by a truck**
- **Cracks and spalls were observed on the east side of the girder**
