2024 FALL CONVENTION

Nondestructive Evaluation (NDE) for Concrete Honeycomb/Void Detection and Imaging and Repair QA

Larry D. Olson, PE

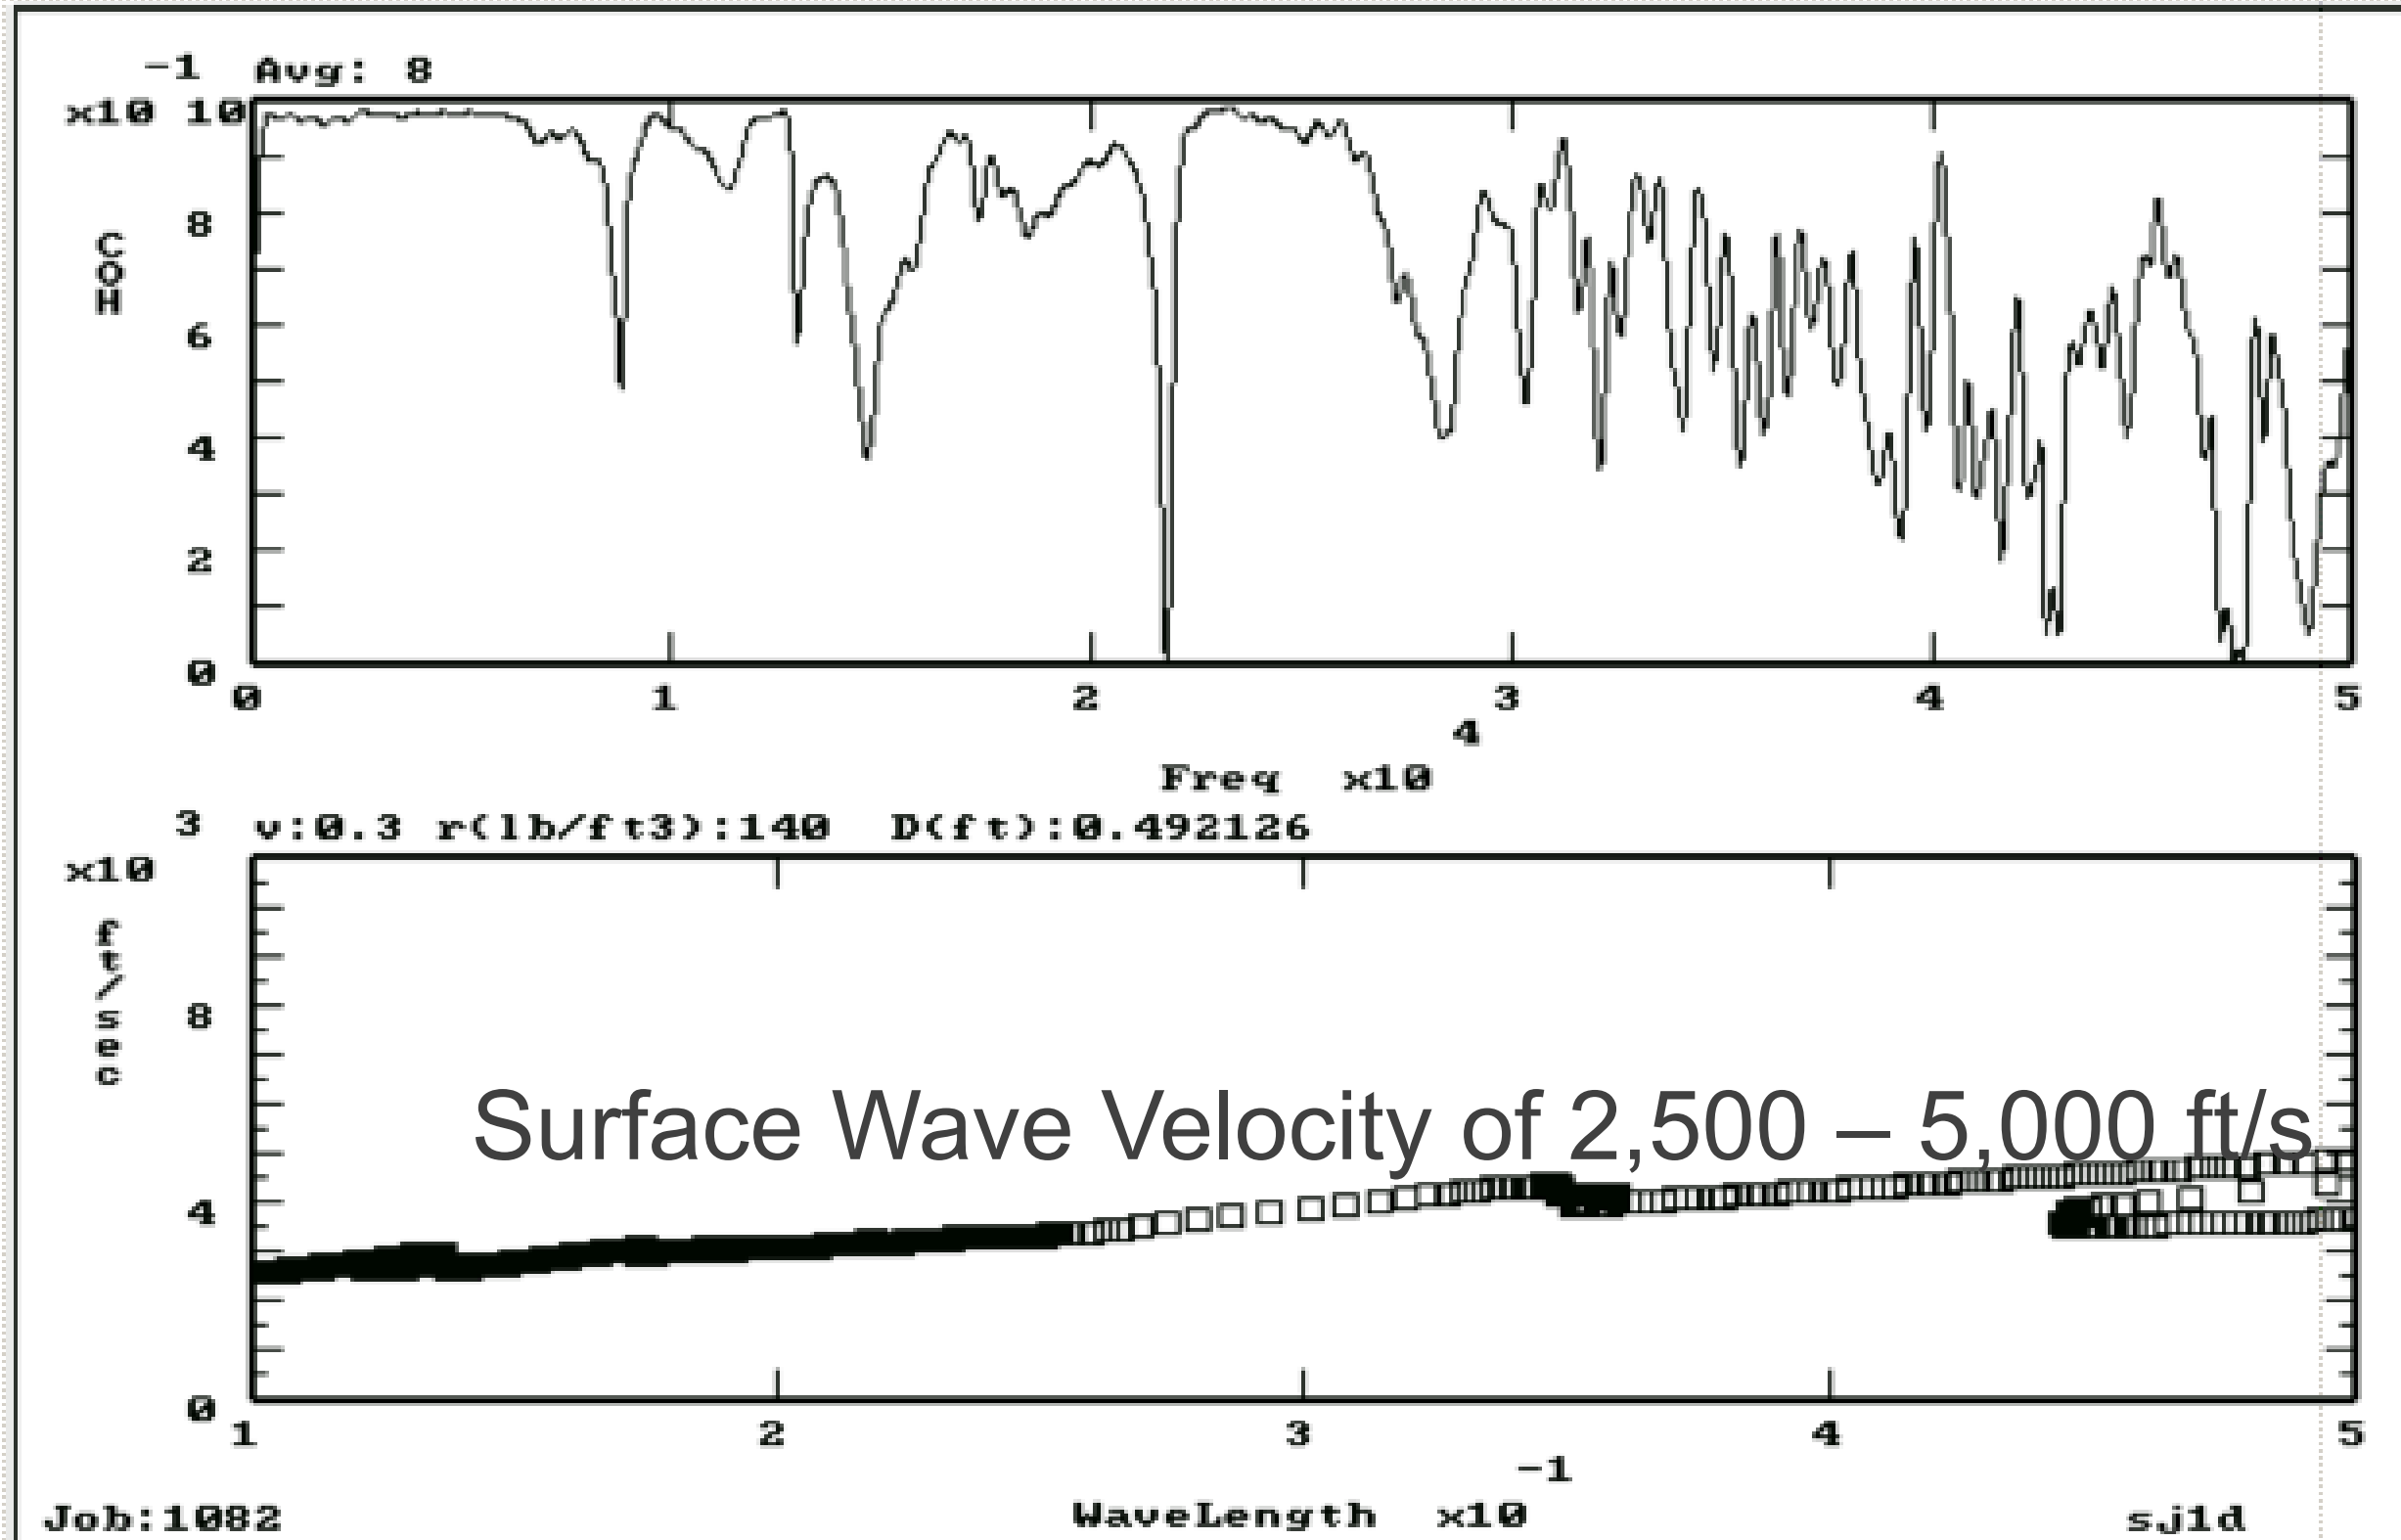
SASW Example Results of Unfilled Crack
