# 10 and 120 South Riverside Plaza Overbuild Restoration

Chicago, IL

Submitted by Carl Walker, Inc.

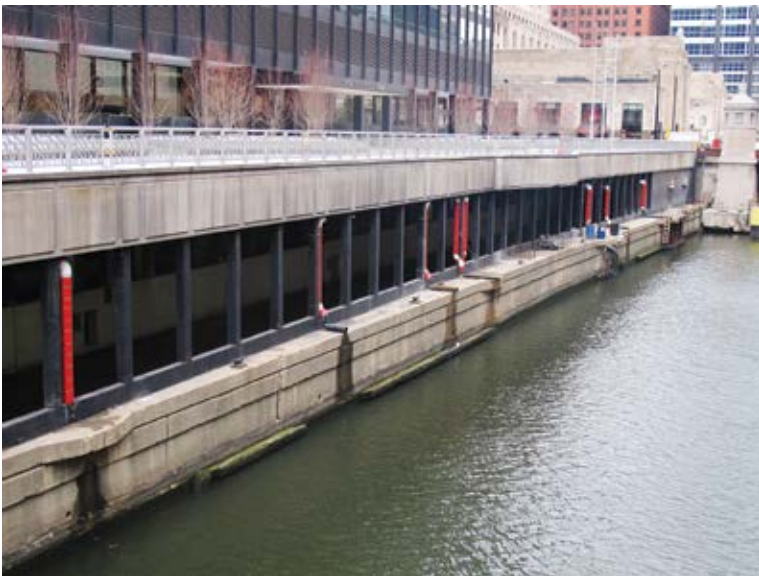
*Intensive preplanning minimized interference with pedestrian movement and railroad operations*

Intensive preplanning with building management staff minimized contractor interference with pedestrian movement and normal facility operations. Planning and scheduling of debris removal and material deliveries with City of Chicago Department of Transportation and work over the railroad right-of-way with Amtrak personnel was also required.

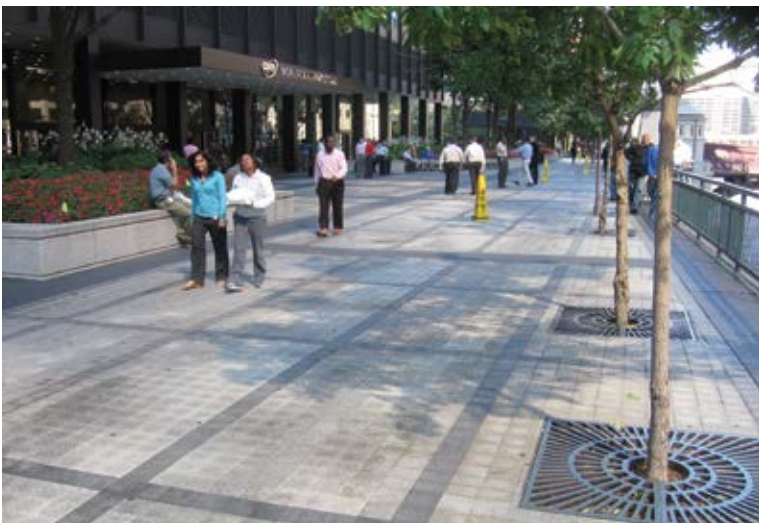
*High pedestrian traffic called for multiple phasing of project*

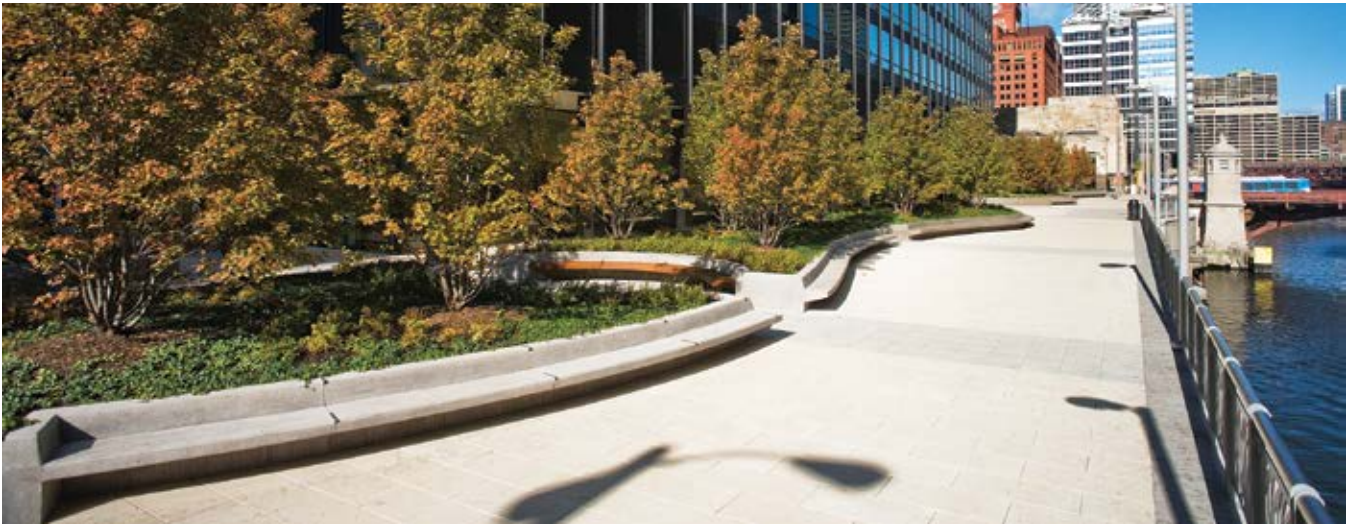
Final plaza includes curvilinear planter designs

Cast-in-place planter walls were selected in lieu of precast due to the large variety of differing conditions and configurations.
