HISTORIC CATEGORY

# Child's Restaurant at Coney Island & Seaside Park

NEW YORK, NY  
SUBMITTED BY PULLMAN

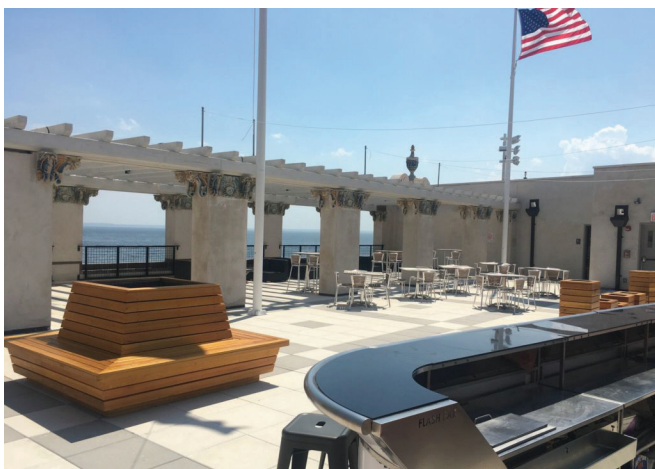
Fig. 7: New rooftop restaurant

The project is a great example of adaptive reuse. A blighted brick box, adorned with some of the most spectacular terra cotta ever conceived (much less created and installed) was renovated to become a community center, restaurant, and amphitheater. The original themes and historic fabric were honored and restored, and the original use of a restaurant incorporated into the new design (Fig. 7).
