2020
AWARD OF
EXCELLENCE

Rehabilitation of 30-Year-Old Monolithic Salt Dome

SAVAGE, MINNESOTA

SUBMITTED BY VECTOR CONSTRUCTION, INC.

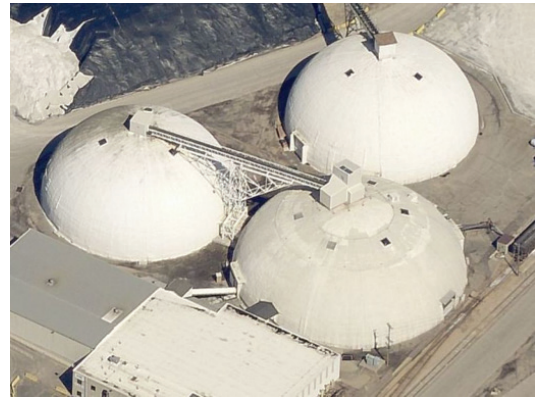
Since 1962, Cargill Salt has been one of the world's leading marketers of salt products. Cargill operates a salt storage and packaging facility on the Minnesota River south of Minneapolis, Minnesota, consisting of several monolithic concrete domes (Fig. 1) along with other site infrastructure.

Fig. 1: Overhead view of salt storage and packaging facility

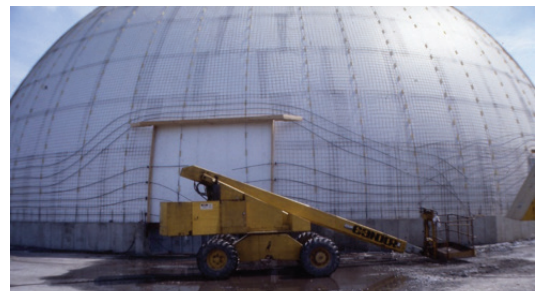
The salt dome dimensions are 173 ft (53 m) diameter by 65 ft (20 m) high. A majority of the 35,000 sf (3250 m²) shell surface area was 3 ½ in (90 mm) thick and reinforced with welded wire fabric with two stiffener rings near the crown. The shell sits on a 4 ft (1.2 m) high reinforced concrete ring beam. Post-tensioning tendons were used in lower sections of the dome between and over the door opening as part of the original structural design. Shotcrete was used on the inflated fabric form (Fig. 2 and 3).

Fig. 2: Monolithic dome reinforcing during original construction prior to shotcrete placement

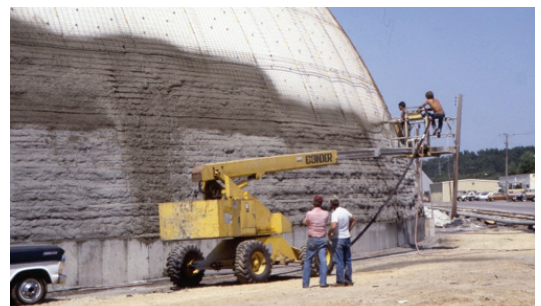
Fig. 3: Shotcrete placement over welded-wire fabric and post-tensioning tendons during original construction
