The Austonian: Slab Edge Repairs

AUSTIN, TEXAS

SUBMITTED BY PIVOT ENGINEERS

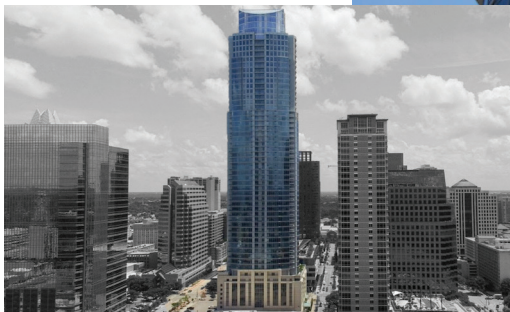
Fig. 1: The Austonian building

The Austonian is a 59-story, 683 ft (208 m) tall high-rise condominium that was completed in 2010 and is located in downtown Austin, Texas (Fig. 1). The building is comprised of reinforced concrete structural elements and unbonded, post-tensioned (PT) concrete slabs. The majority of the slab edges in a typical floor are covered with aluminum cladding, while the remaining slab edges are exposed to the elements. The building has approximately 1.75 linear miles (2.8 km) of exposed slab edges distributed over the entire height of the structure (Fig. 2).
