FINALIST—
2020
PROJECT OF
THE YEAR

DAYTON ART INSTITUTE

DAYTON, OHIO

SUBMITTED BY LRT RESTORATION TECHNOLOGIES

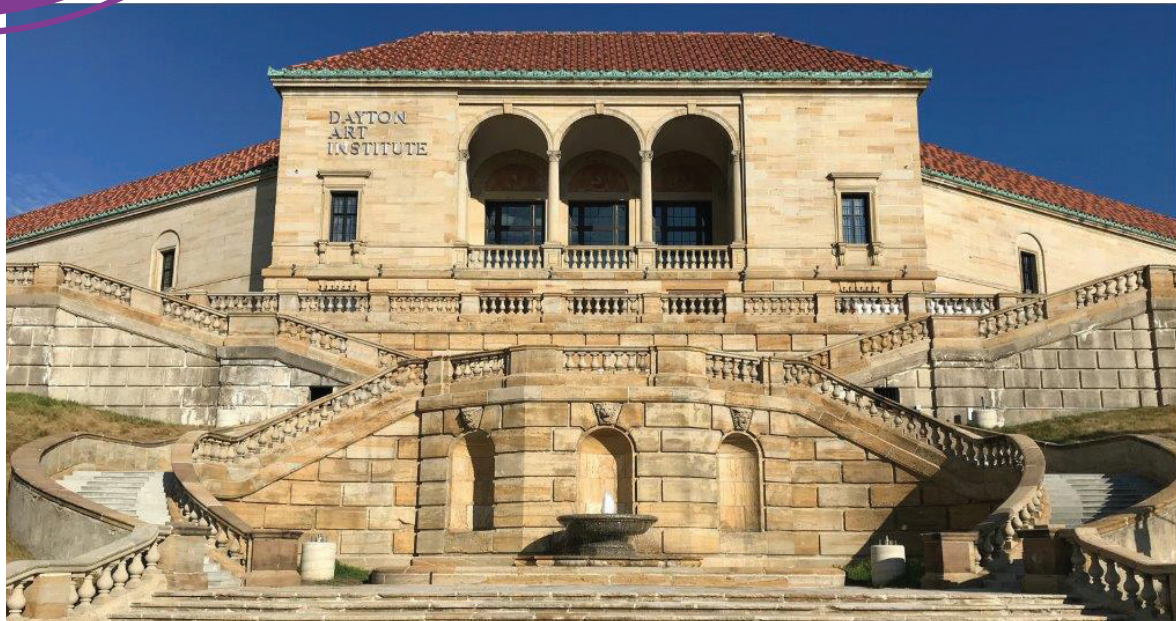
Fig. 1: Grand entry staircase project at the Dayton Art Institute

The Dayton Art Institute is Dayton, Ohio's art museum. The Dayton Art Institute project (Fig. 1) was brought to light to revitalize a historic structure in the heart of Dayton. The project sought to revamp the grand staircase that once saw the foot traffic of hundreds of patrons throughout its lifetime since the 1930s.

A program was designed to repair the structural slab, install new stair topping slabs, clean and repair the masonry, install new fountain equipment, and perform adjacent landscaping work to clear the overgrown hillside. The fountains had not been operational since the late 1960s.

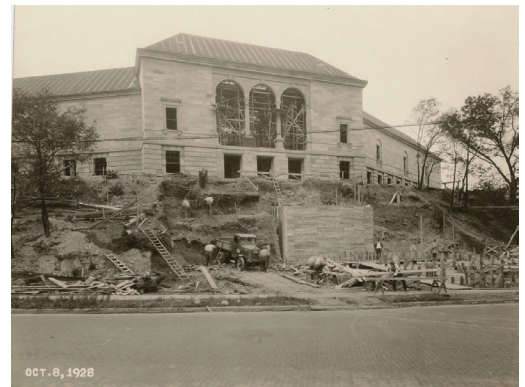
The original construction included a grand entry staircase into the original main entry (Fig. 2). The entry stair was originally constructed with a board formed, square bar reinforced, concrete structure with a variety of structural masonry blocks and masonry veneer panels. The stairs were constructed on a stair-stepped structural slab with original flagstone stair treads and risers.

Fig. 2: Original staircase during construction
