PARKING STRUCTURES CATEGORY

The Phoenician Resort— Post Tension Garage Repair

SCOTTSDALE, AZ

SUBMITTED BY TADJER-COHEN-EDELSON ASSOCIATES, INC.

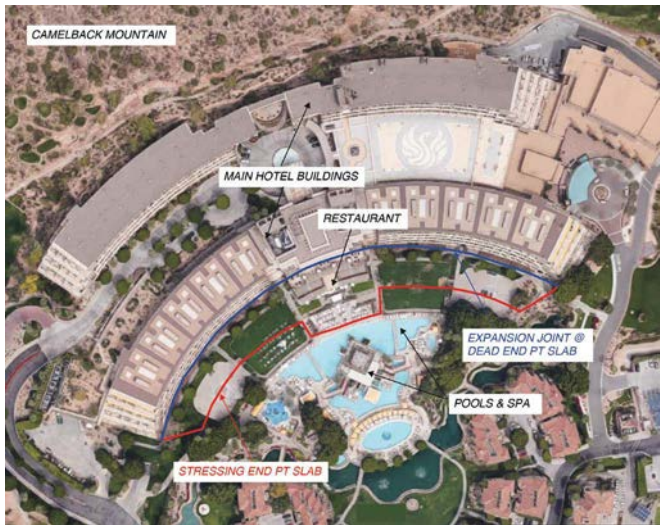
A single-level subgrade parking garage is located below the hotel with the south side of the garage extending beyond the main hotel structure (Fig. 2). The segment

that extends in front of the main building has an elevated post-tension concrete slab above the parking level with approximately 6 ft (1.8 m) of soil, landscaping and event space concrete pads above the buried slab. The post-tension slab is 15 in (381 mm) thick, approximately 62.5 ft (19 m) wide and runs the length of the crescent shaped building—approximately 900 ft (274 m). The post-tension cables are 0.5 in (12.7 mm) diameter, monolithic, unbonded cables consisting of seven (7) wire strands wrapped in plastic sheathing. The center segment below the restaurant extends almost to the nearby swimming pools. On the south end of the garage, the post-tension slab is supported on a 10 in (254 mm) wide reinforced concrete foundation wall that extends to the bedrock below the garage. On the north end, the post-tension slab is supported by concrete beams and columns along the expansion joint.

Fig. 2: Overhead view of subgrade garage
