Repair of Concrete Utility Poles With the Use of Migrating Corrosion Inhibitors

Ashraf (Ash) Hasania Nov. 2018

Concrete Lighting Poles

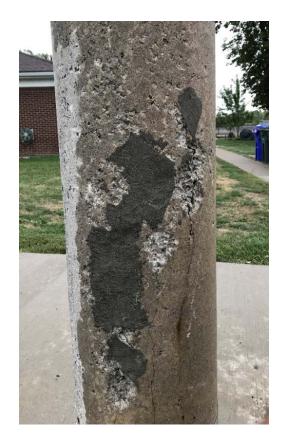
- Thin Structure (Shallow Cover)
- Hollow Core
- Helical Reinforcement
- Saw Cutting Prohibited
- Effective Corrosion Rate Testing
- Other Challenges:
 - Low \$\$\$
 - Time window for these repairs (due to traffic control)
 - Previous patching work failed

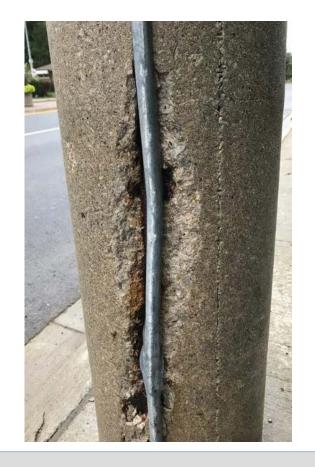
Results (Pole 2)

Х	Υ	Current Y	Rp(Y)	Corr Rate(Y)	Conc Res (Y)	Temp	Humidity	R ² (Y)
10	90	4.76E-01	14734	20	182	22	85%	0.92
10	80	3.09E-01	15097	20	197	22	86%	0.96
10	60	3.42E-01	7480	40	116	22	85%	0.99
10	50	2.79E-01	30946	9.7	116	22	85%	1
10	20	1.75E-01	82871	3.6	477	22	86%	0.99
10	10	1.26E-01	77191	3.9	377	22	86%	0.99
20	50	1.15E-01	55809	5.4	819	22	87%	0.97
30	95	2.44E-01	29372	10	343	22	88%	1
20	95	3.25E-01	4667	65	168	22	89%	0.94
20	80	3.84E-01	10273	29	186	22	89%	0.97
20	60	1.82E-01	44620	6.8	737	22	88%	0.99
30	60	1.24E-01	91916	3.3	957	22	88%	0.99
30	90	3.53E-01	15142	20	168	22	88%	0.99
30	75	1.89E-01	73655	4.1	792	22	89%	0.99
40	50	1.83E-01	84805	3.6	492	22	88%	1
40	60	2.10E-01	86878	3.5	977	22	88%	0.98
	Average		45341	15.5	444	22	87%	0.98

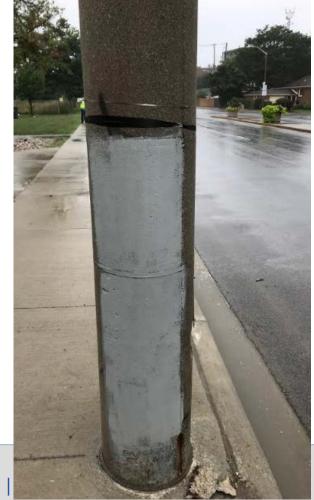
Results (Pole 3)

Х	Υ	Current Y	Rp(Y)	Corr Rate(Y)	Conc Res (Y)	Temp	Humidity	R ² (Y)
50	90	3.63E-01	39644	7.6	1095	22	88%	0.95
50	75	1.64E-01	918348	0.33	1568	22	89%	0.9
50	50	1.40E-01	309868	0.97	1196	22	88%	1
30	95	3.93E-01	22377	13	271	22	89%	0.96
40	75	2.13E-01	20304	15	204	22	89%	0.81
40	25	1.05E-01	388795	0.78	6903	22	89%	0.87
Average		283223	6.3	1873	22	89%	0.915
