Supplemental Post-Tensioning for Concrete Dome Repairs

Travis Marman, Cody Mitchell, Josh Brewster

Vector Construction, Inc.
Fargo, ND

Simpson Gumpertz & Heger
Chicago, IL

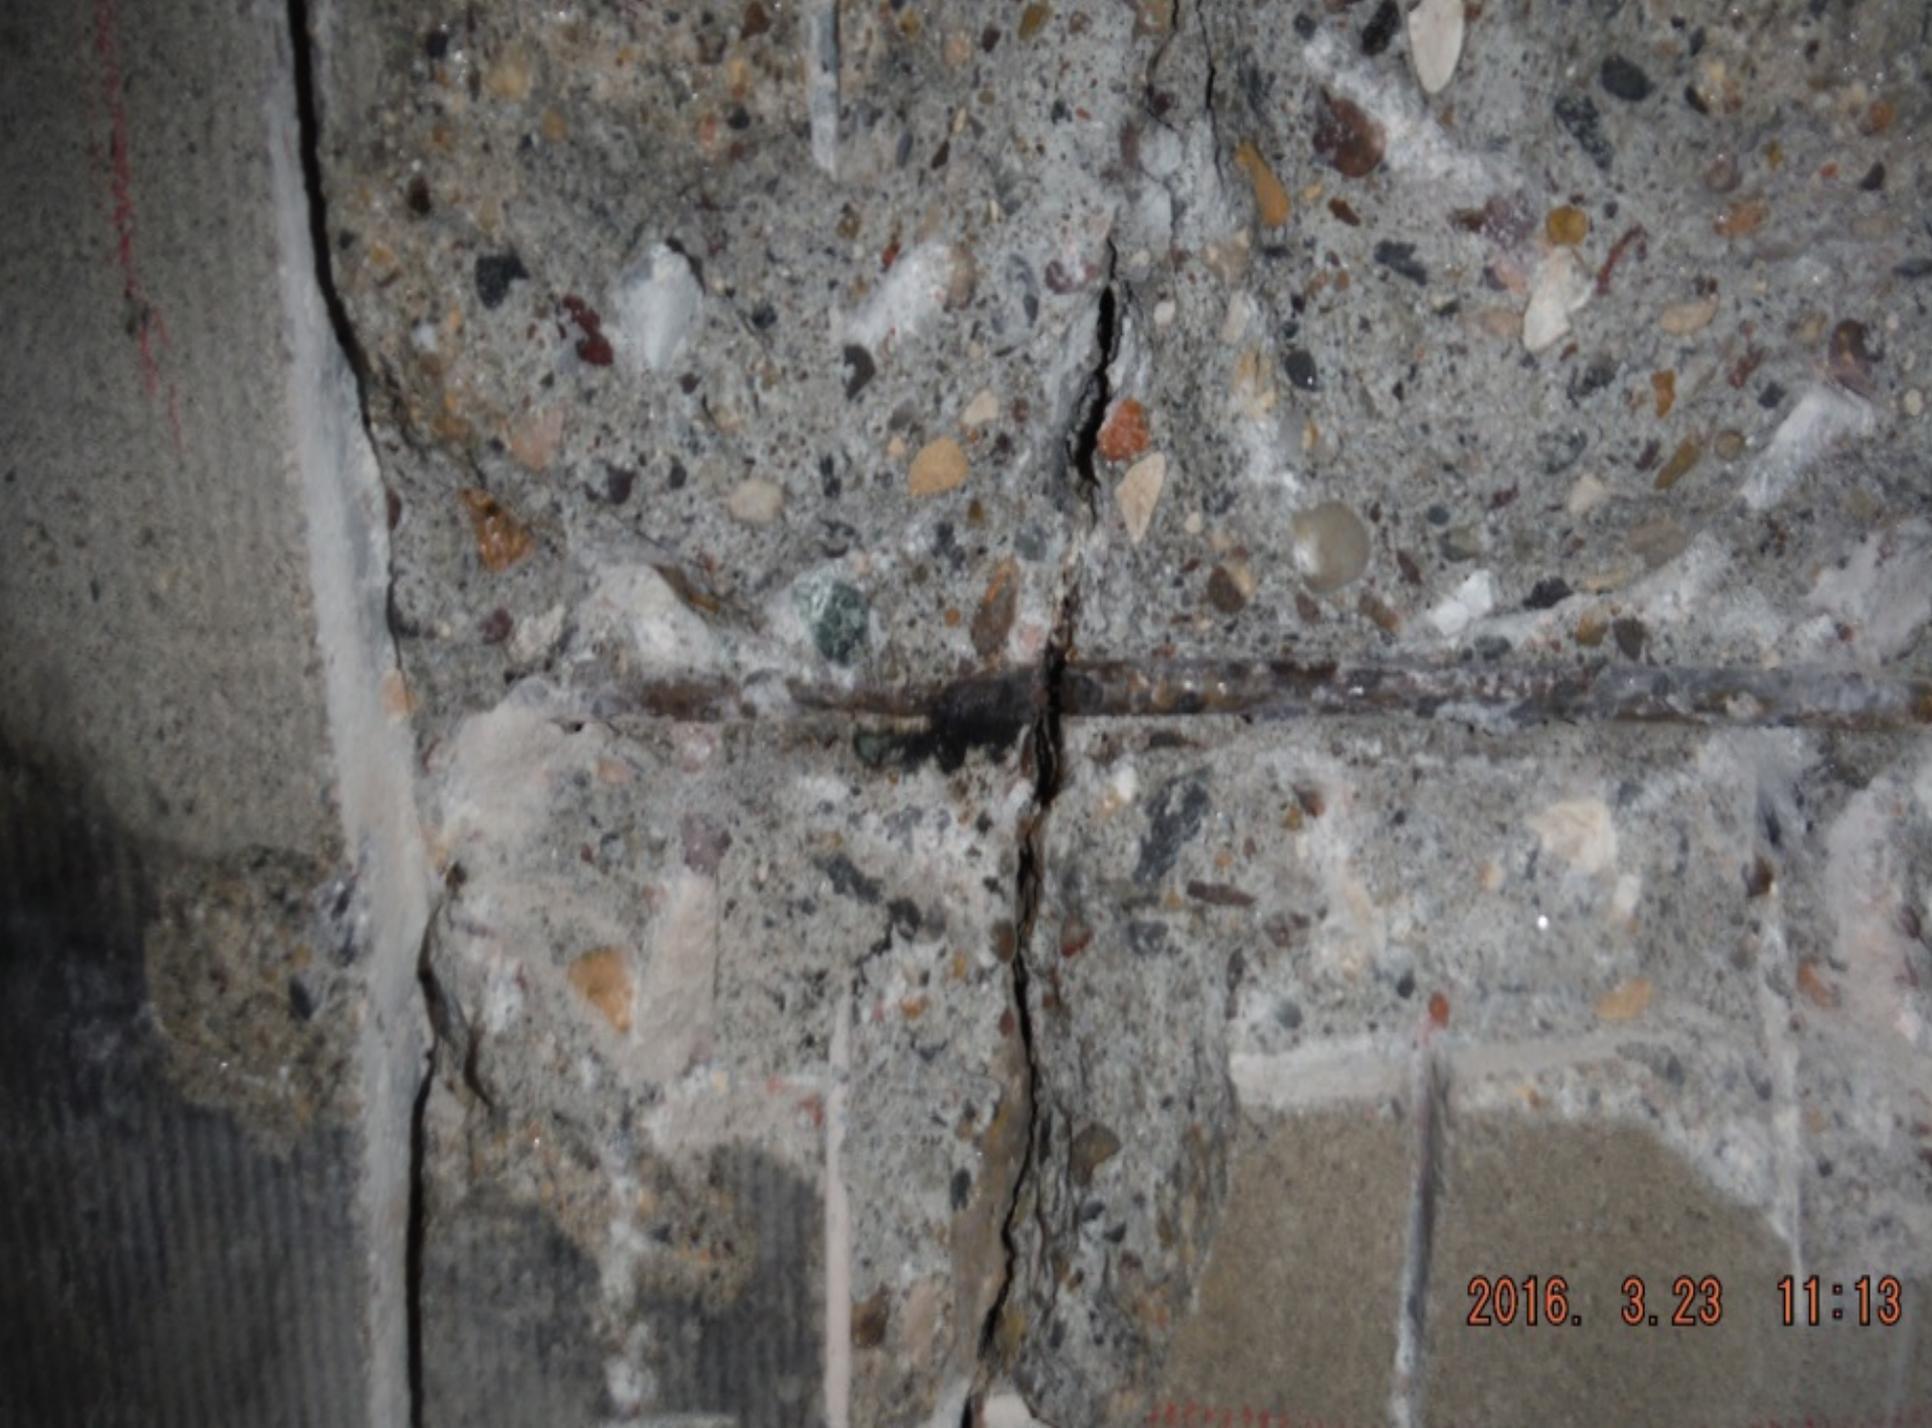
PLAN VIEW

Notes:

- The majority of corrosion potentials taken at the top of the dome showed very passive conditions at the reinforcing steel. There were a select few localized active areas of corrosion indicated in the area between the two openings. This area is exposed from above and below with no waterproofing on top and is exposed to the humidity from outside the top penthouse. This entire area will be treated with a corrosion mitigation system to prevent against future corrosion.
