**ICRI 2014 Fall Convention,
Kansas City, MO**

**University of Missouri Health Care
Parking Garage Structural Repairs,
Columbia, MO**

Richard McGuire, P.E.,

Structural Engineering Associates Inc.

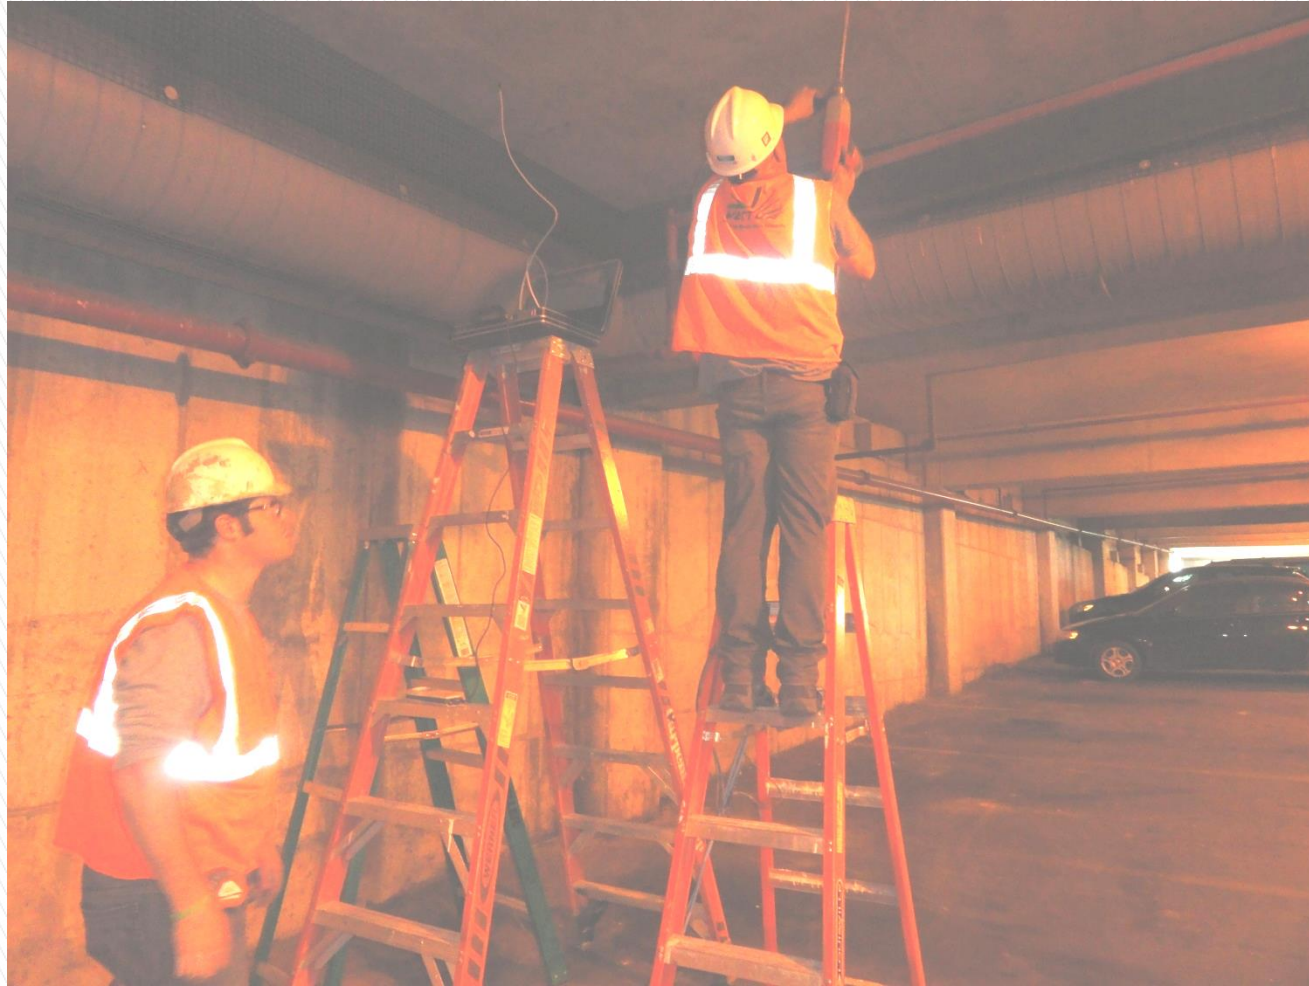
PT Corrosion Potential Evaluation

- ▶ The tendons were made from stuffed cables, in which voids between the sheath and the strands are present.
- ▶ 25 out of 497 strands that were exposed are broken, and in addition two sheaths with no strands at the location of drilling were detected in Phase II. 5 out of 6 breaks are in Level 1.
- ▶ 65% exposed strands are in good to fair conditions.
- ▶ 62% exposed cables have either no grease or deteriorated grease.
- ▶ 100% of the Level 1 tested cables have excessive moisture in the tendon sheath, 39 out of 40 Level 2 and 3 tested cables have excessive moisture, while cables in Levels 2 and 3 are drier than those in Level 1.
- ▶ 30% of the 41 half cell potential readings are in the active corrosion category while only 25% of the tendons have no active corrosion

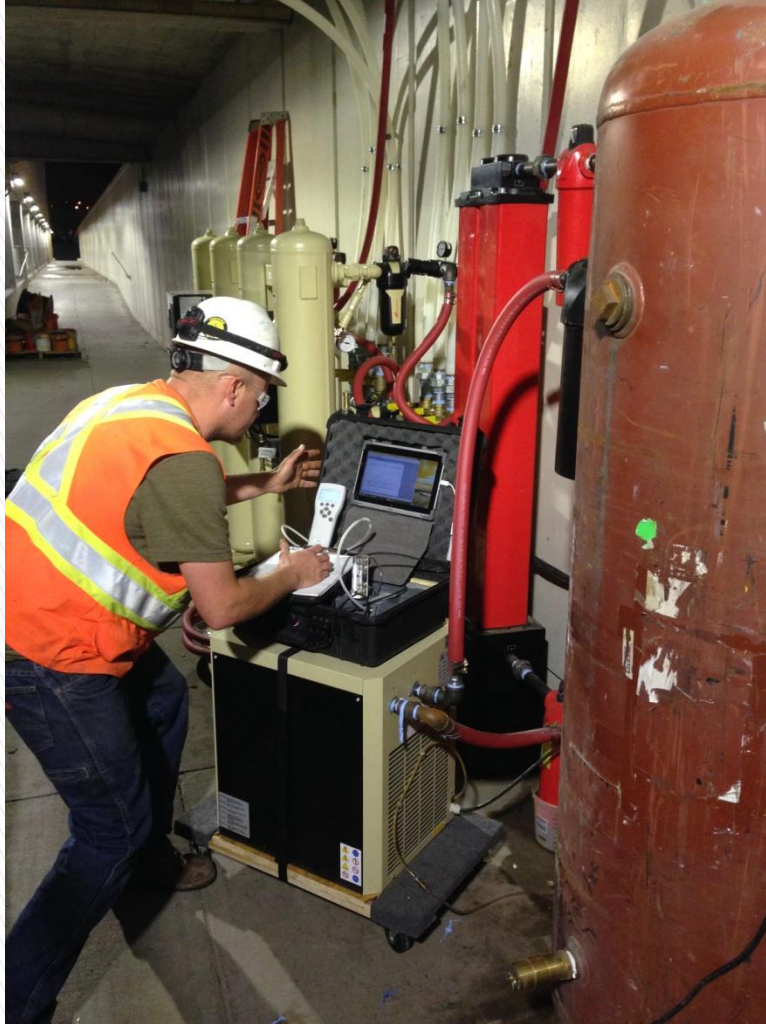
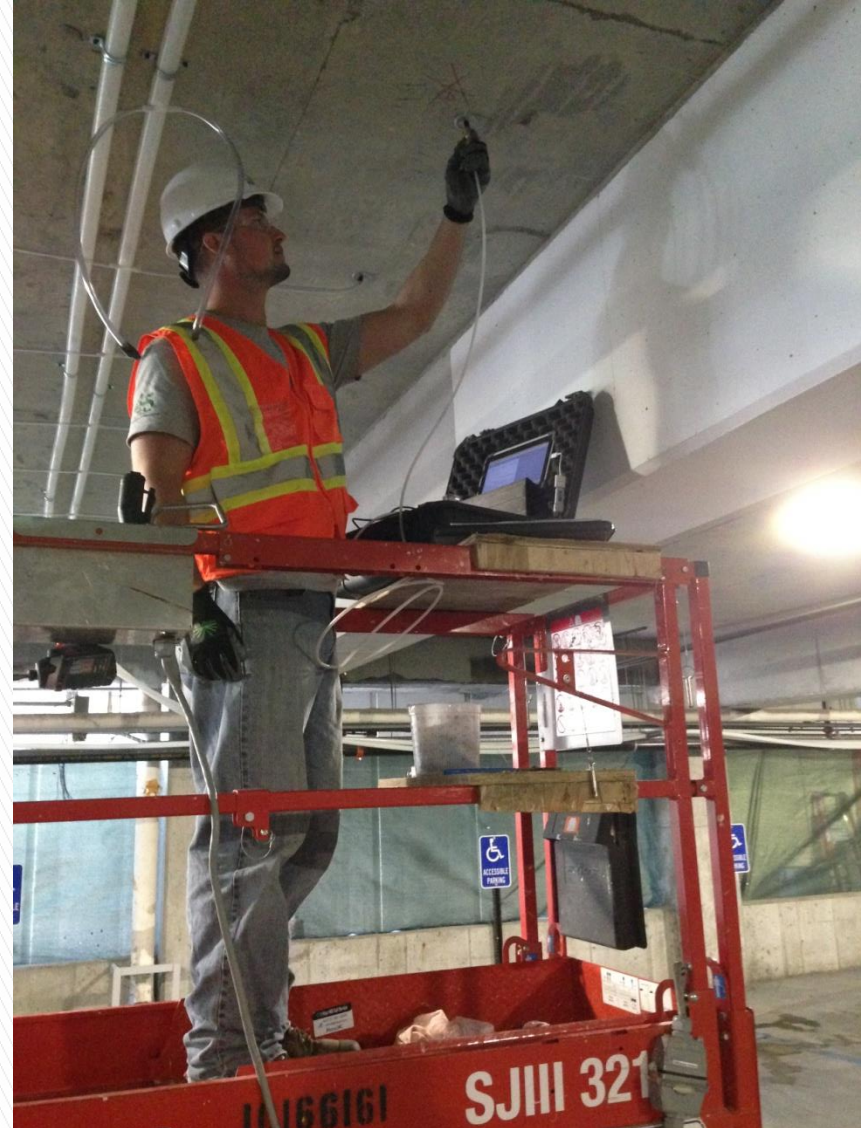
Monitoring Drying Data and Performance

FILE:		Post-Tech CE* TEST & GRADING							AMBIENT		LINE														
PRJCT: Project: MUHC PARKING GARAGE		SURVEYED BY: TYLER BROWN, CHARLES WHITE							COND.		READING														
AREA: LEVEL 2		DATE: 9/9/2014							% RH																
CPE RDGS		Initial __X__		Progress _____		Final _____		Deg. C																	
		INPUT DATA							WET/DRY BOUNDARY		0.007Kg/Kg Dry Air														
CABLE Set		CABLE No.		Cable Reading Deg C %RH		Pws		MC "W"		CE		Max M.C		Wet or Dry		DRY/WET GRADE		Flow		CPE GRADE DISTRIBUT'N					
2N1		0NA										BIN		DIST		% TTL		% TESTED							
		1		26.8 95.8		3.46		0.0210		3		0.0210		WET		30		0		0		0.0		N/A	
		2NT																2		0		0.0		0.0	
		3		28.4 64.2		3.78		0.0153		3		0.0153		WET		30		3		275		100.0		100.0	
		4		28.4 66.2		3.78		0.0157		3		0.0157		WET		30									
		5		28.4 65.7		3.78		0.0156		3		0.0156		WET		30		TTL QUANT		275		100.0			
		6NT																TTL TESTED		275

7		28.4 63.9		3.78		0.0152		3		0.0152		WET		30									
		8		28.4 62.1		3.78		0.0148		3		0.0148		WET		30									
		9		28.4 60.7		3.78		0.0144		3		0.0144		WET		30									
		10NT																		DRY/Wet Cable Distribution					
		11		28.5 61.9		3.78		0.0147		3		0.0147		WET		30		10		0		DRY CABLES		0.0	
		12		28.8 96.0		3.89		0.0238		3		0.0238		WET		30		20		0		DRY/WET CABLES		0.0	
		13		27.8 65.8		3.67		0.0152		3		0.0152		WET		30		30		245		WET CABLES		100.0	
		14		28.4 61.0		3.78		0.0145		3		0.0145		WET		30				245					
		15NT																							
		16		28.6 62.6		3.89		0.0153		3		0.0153		WET		30		DRY/WET Grades		Dry = 10		Dry <		0.003	
		17		28.6 63.7		3.89		0.0156		3		0.0156		WET		30				Dry/Wet = 20		Dry/Wet <		0.007	
		18		28.7 61.5		3.89		0.0150		3		0.0150		WET		30									
		19NT																		Wet = 30		Wet ≥		0.007	
		20		28.7 64.1		3.89		0.0157		3		0.0157		WET		30		CPE Grades		0 = No Test				NT=NO TEST

21		29.1 95.0		4.01		0.0243		3		0.0243		WET		30				1 = Dry				NA=NO ACCESS	
		22		20.5 68.1		2.34		0.0099		3		0.0099		WET		30				2 = Moist				NP=NO PORT	
		23NT																		3 = Wet				NF=NO FLOW
