RENO NV LEEWENS CORPORATION

SPOKANE (WA) GREENE STREET BRIDGE LOAD RATING REPAIR

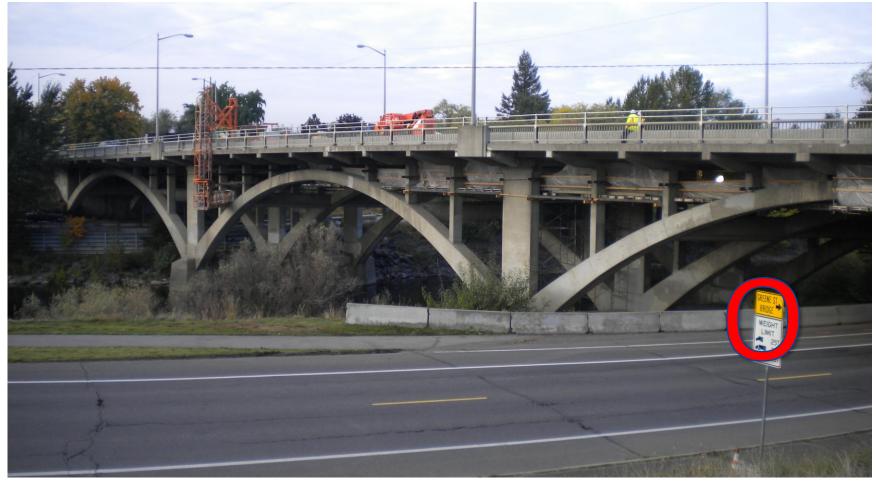
Aging Bridge, built to codes of 1950's No Fire Trucks, No Heavy Trucks on major Route.

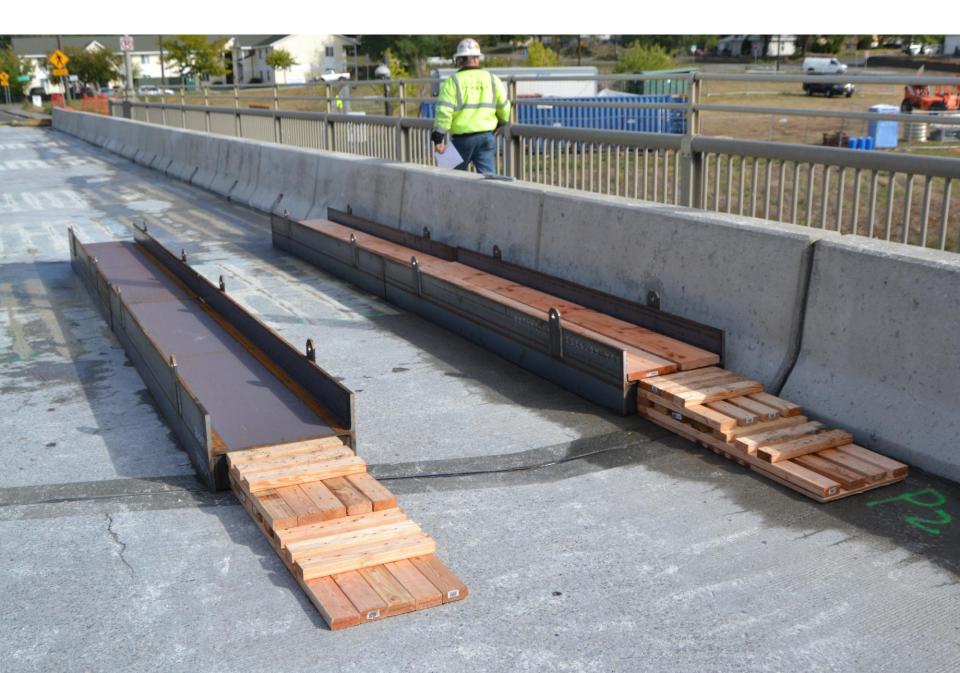
OF THE TWO UBITS THAT WERE BROUGHT TO THE JOB, ONLY ONE COULD BE MADE TO FIT.

WE HAD TO RAISE THE UBIT UP SAFELY 4'' - 4 SECTIONS 1200 LBS EA.

SHORT OF USING A BARGE FOR A PLATFORM, THE UBIT WAS THE ONLY WAY TO BUILD ACCESS ON THE CENTER 35% OF THE BRIDGE WHERE THE BOOM LIFTS COULD NOT REACH. A 130 FOOT BOOM LIFT DOES NOT REACH OUT 130 FEET !!! AT MOST, 80 FEET. OUR WORKING PLATFORM WAS CUSTOM ENGINEERED, CUSTOM BUILT, COMPLETELY OUT OF PARTS THAT HAD TO BE HAND PLACED UNDER THE BRIDGE. MANY PIECES HAD TO BE CUSTOM FIT DUE TO COLUMINS, ARCHES, UTILITIES, AND THE FACT THAT THE BRIDGE WAS SKEWED. THE ARCHES AND COLUMINS WERE NOT IN LINE WITH EACH OTHER.

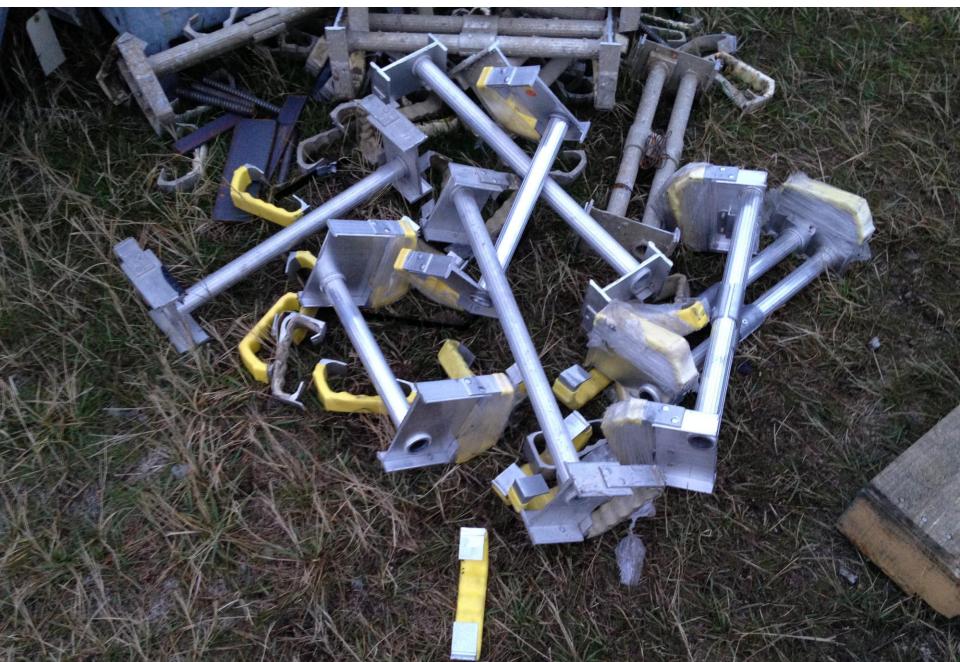
THIS RESULTED IN MANY PARTS AND PIECES CUT OFF AND LEFTOVER !

WE DECIDED TO DO THE ACCESS OURSELVES BECAUSE WE HAVE DONE THIS BEFORE, BECAUSE THE BIDS WE RECEIVED WERE VERY HIGH AND CONSUMED MOST OF THE SCHEDULE JUST FOR PUTTING IT UP, NEVERMIND ACCOMPLISHING THE WORK AND REMOVING IT. THIS WAS A KEY RISK FACTOR TO THE ENTIRE PROJECT. YOU NEED TO HAVE A COMPETENT PROFESSIONAL ENGINEER WHO UNDERSTANDS ALL OF THE REQUIREMENTS ALONG WITH THE MANY RESTRICTIONS IN THE FIELD. WE NEEDED TO ACCESS AN AREA 56 FEET WIDE AND 458 FT LONG AND 40 FT HIGH OVER WATER, ROADS AND COMPLETELY UNDER A DECK.

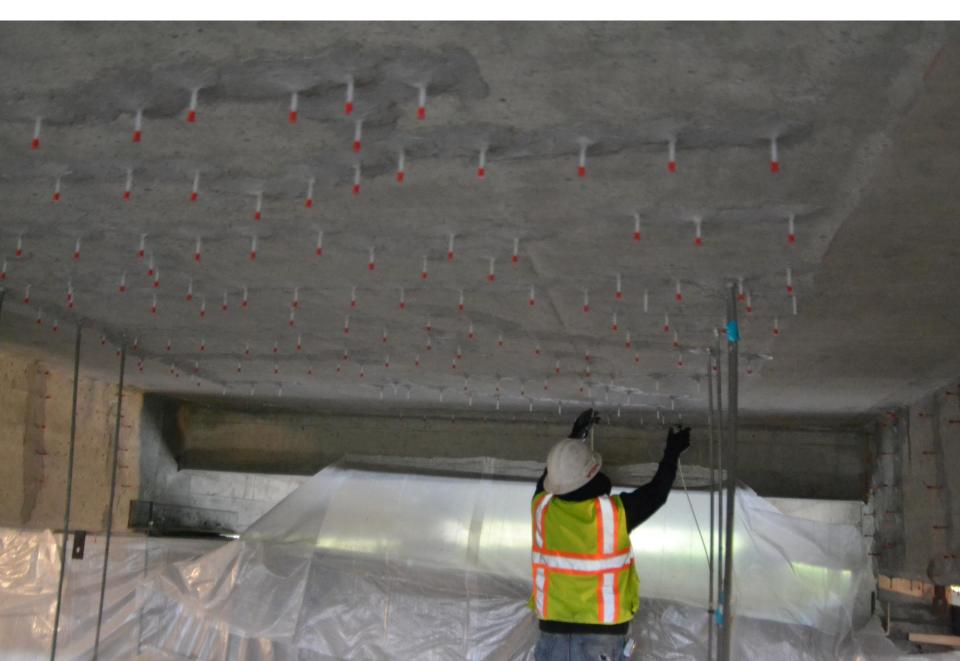
TOTAL CRACKS INJECTED WERE OVER 6,000 LINEAL FEET.

THIS ADDED SEVEN DAYS OF DELAY, AND ADDED OVER THIRTY WORK DAYS TO THE JOB. WE NOW NEEDED A LARGER QUANTITY OF WORK DECK TO KEEP UP ALL THE ACTIVITIES. THE JOB WAS PUSHED INTO DECEMBER, REQUIRING HEAT TO KEEP THE SUBSTRATE AND MATERIALS WARM. GENERATORS AND 480 VOLT HEATERS WERE MOBILIZED JUST IN TIME FOR VERY COLD WEATHER. TEMPERATURES WERE AS LOW AS 6 DEGREES F.

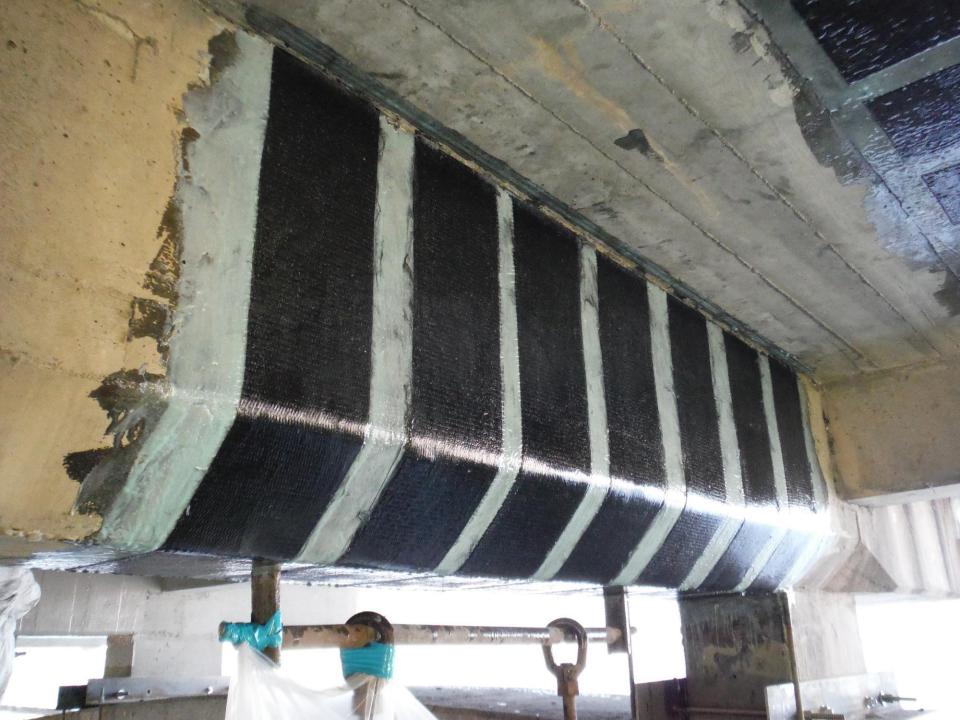
TOP COATING STARTED ON LEFT

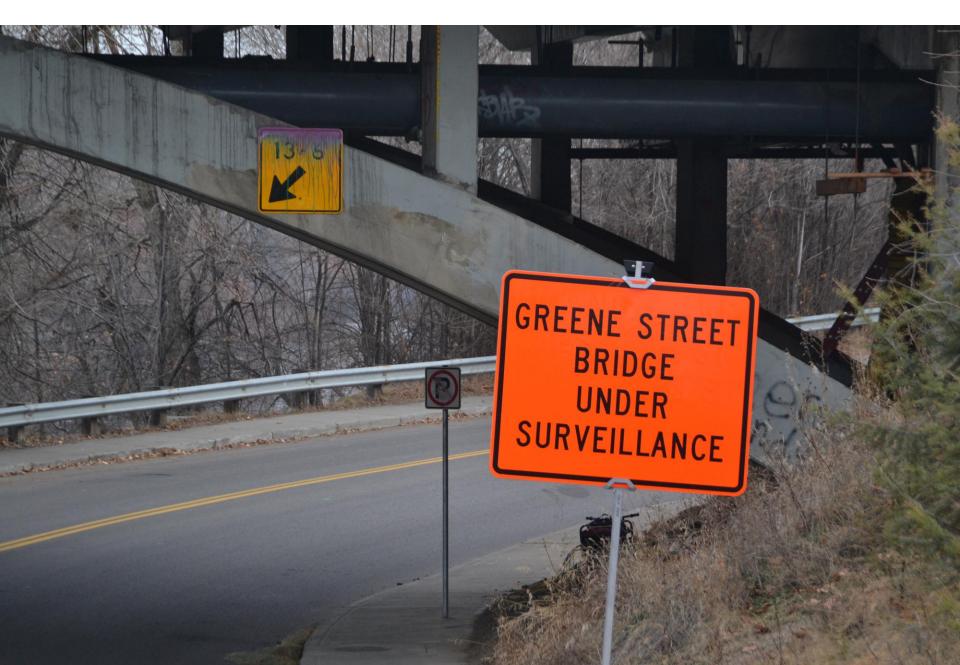
THEFTS EVERY NIGHT !!! DIESEL BATTERIES CORDS PUMPS
