Advanced Pile Encapsulation

Solutions for the Repair and Protection
of Underwater Structures

Hazem Jadallah

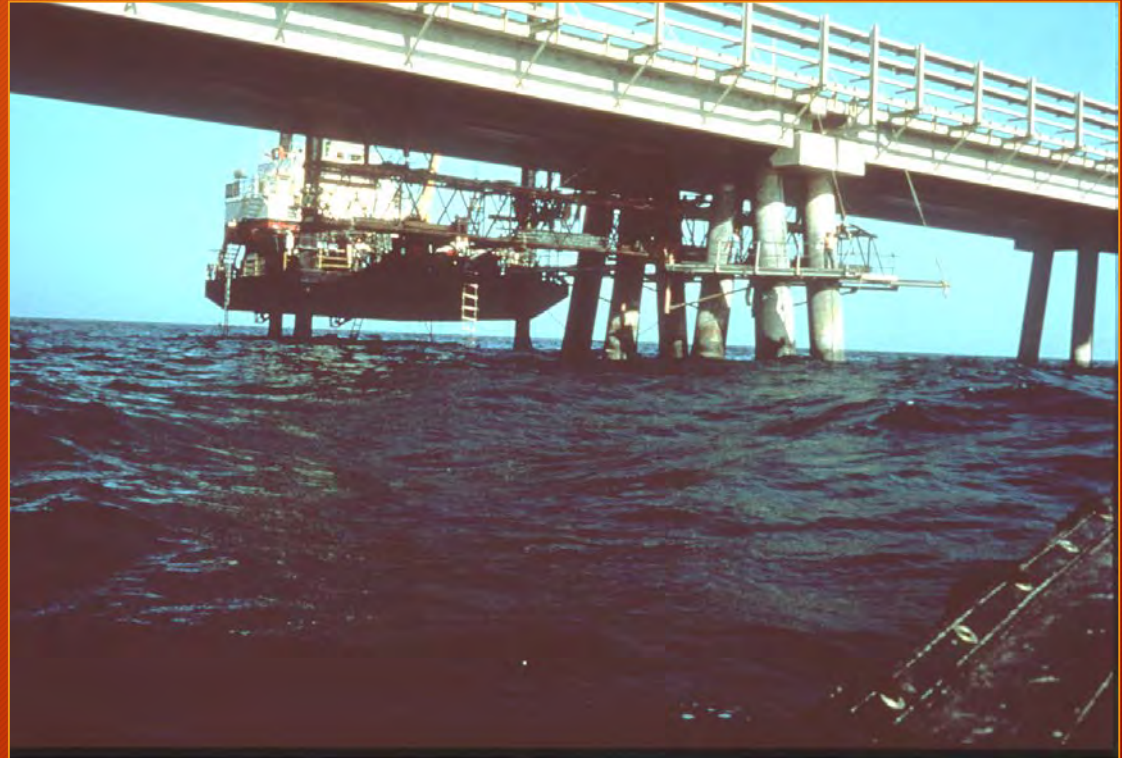
LPG Trestle, Ju'Aymah, Saudi Arabia

- Routine inspection in 1983 (3 years after construction) revealed severe marine borer attack
- 616 piles affected

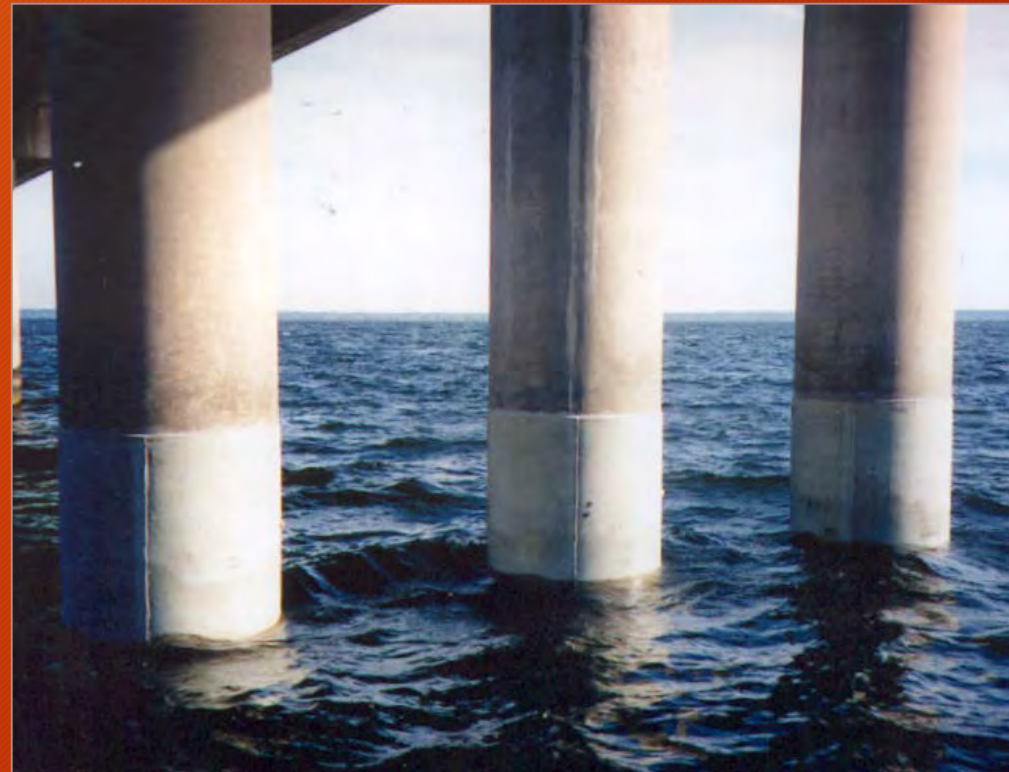
Lake Pontchartrain Causeway, New Orleans, Louisiana

- Pile Encapsulation
 - Encapsulations soon after completion in 1989

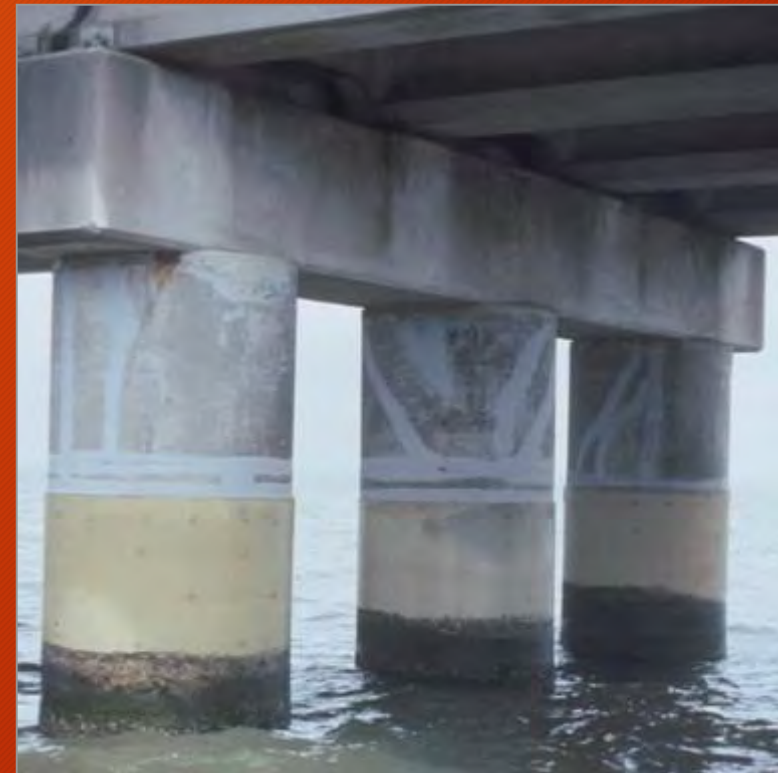
Lake Pontchartrain Causeway, New Orleans, Louisiana

- Encapsulations in 2002

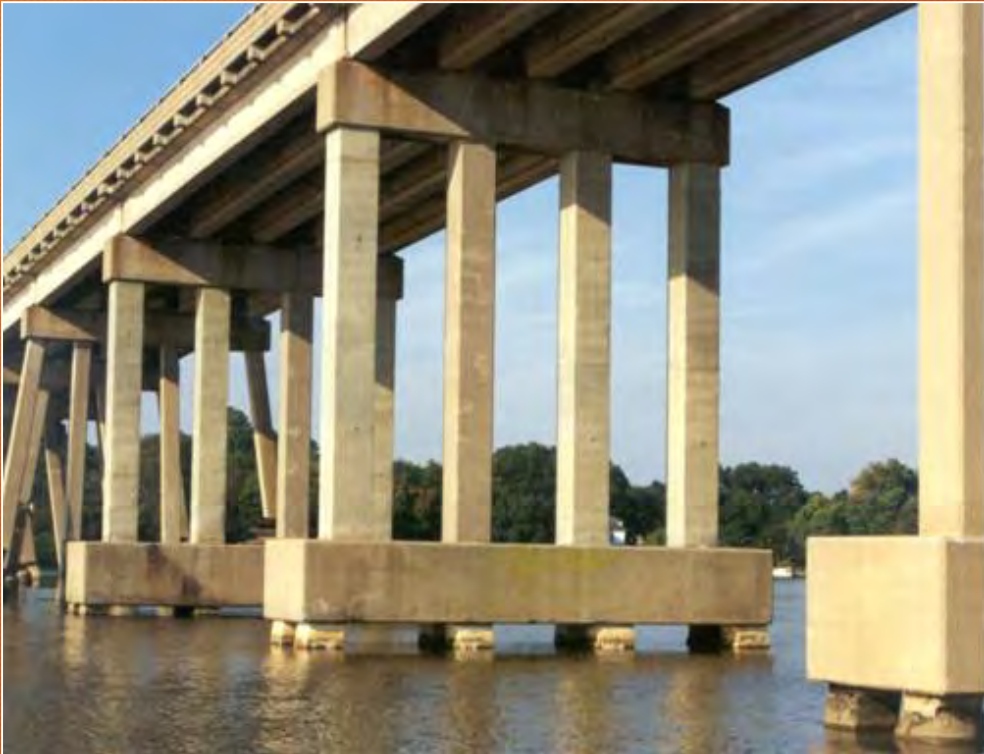
Rappahannock River Bridge, Tappahannock, Virginia

- Completed Encapsulation

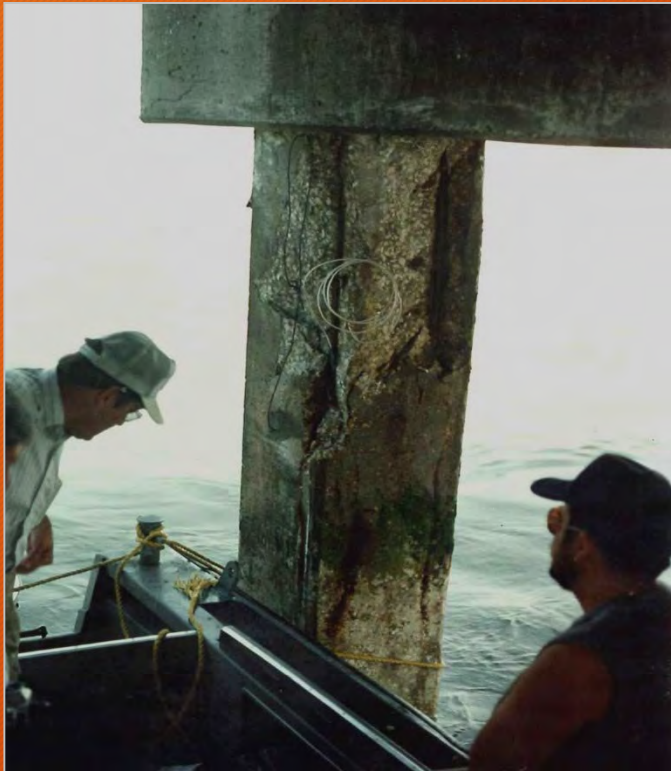
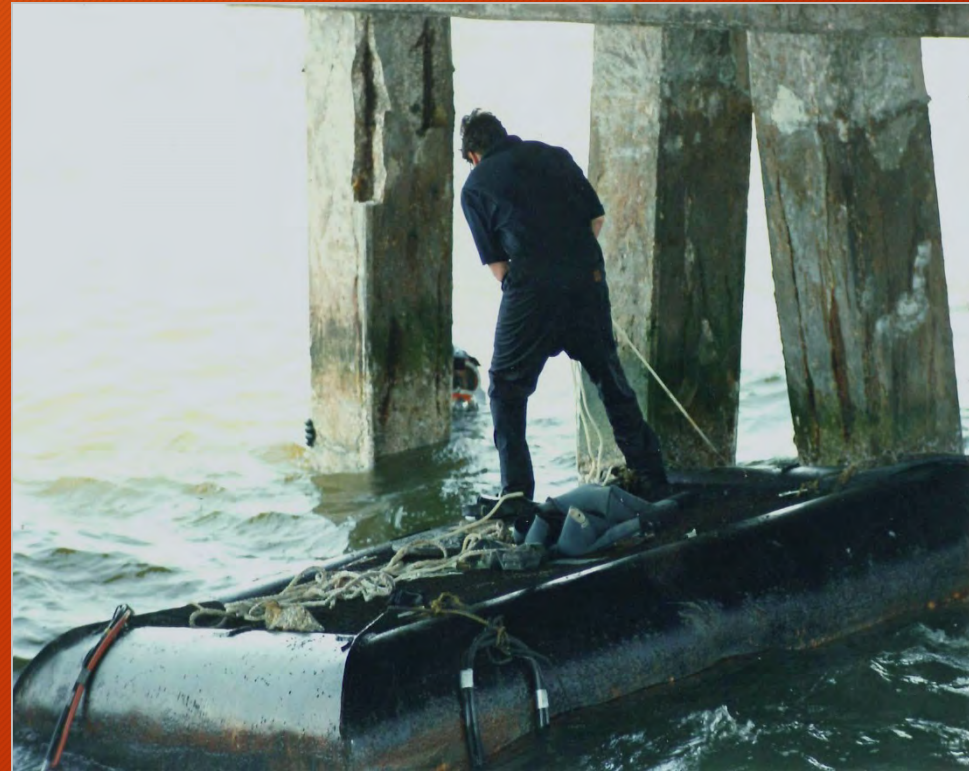
Gandy Bridge Tampa Bay, FL USA

- Condition Survey
- First Encapsulated in 1987

The repair and protection via Advanced Pile Encapsulation remains in place and continues to provided protection without any maintenance
