Carbon Fiber Reinforced Polymer (CFRP) Systems Prove Effective for Drinking Water Pipe Repairs

HJ3 Composite Technologies

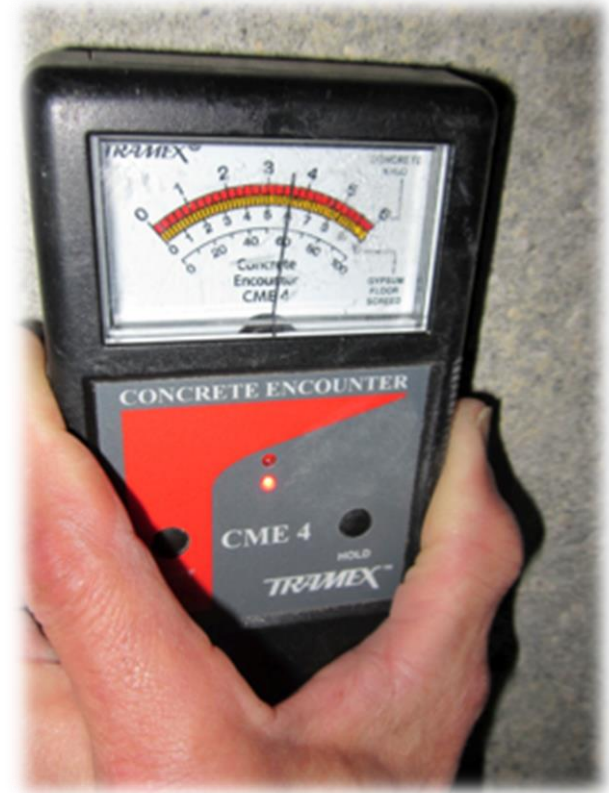
- Condition Assessment:
 - Acoustic test
 - ACI-546 “Concrete Repair Guide” standards referenced for crack repairs
 - Visual inspection found joints had lost 50-75% of circumferential grout covers

- Surface:
 - High pressure sandblasting
 - Minimum ICRI 03732 CSP#3 Concrete Surface Profile
 - Moisture and dust test
 - Steel cylinder prepared to SSPC SP-10/NACE #2 Near White Metal with hand tools
