October 17, 2023
ICRI 2023 Fall Convention

Rehabilitation of O'Hare International Airport Parking Garage

**Predrag L. Popovic
Dunja Vla**
Wiss, Janney, Elstner Associates, Inc.

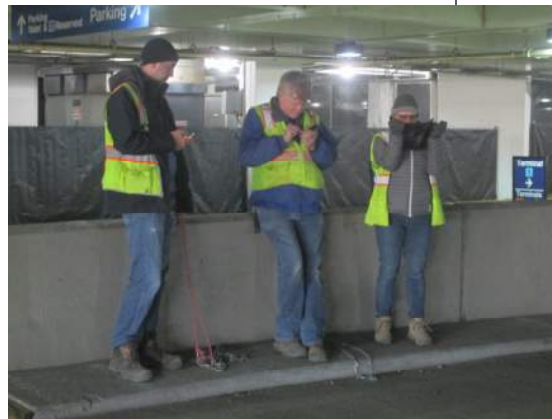
Condition Assessment

- Investigation performed in 2018
 - 15° F temperatures
 - Delamination survey (13%)
 - Visual survey
 - Cores for chloride testing and compressive strength
 - Inspection openings to review condition of post-tensioning

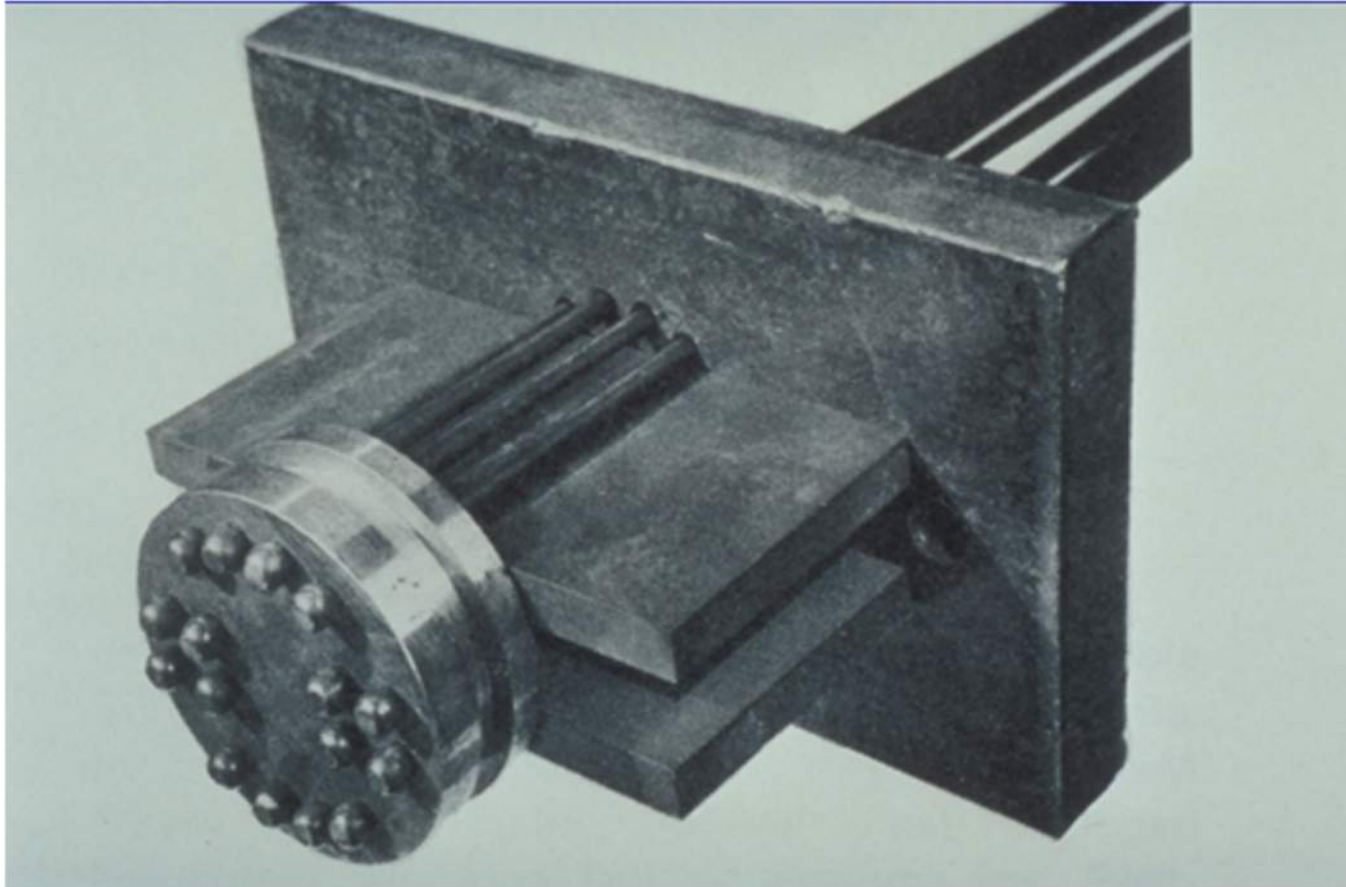
Button-Head Tendon Anchor

- 170 ft. of 20 wire tendon
- 8 tendon repairs with rebuilding of live end anchorages

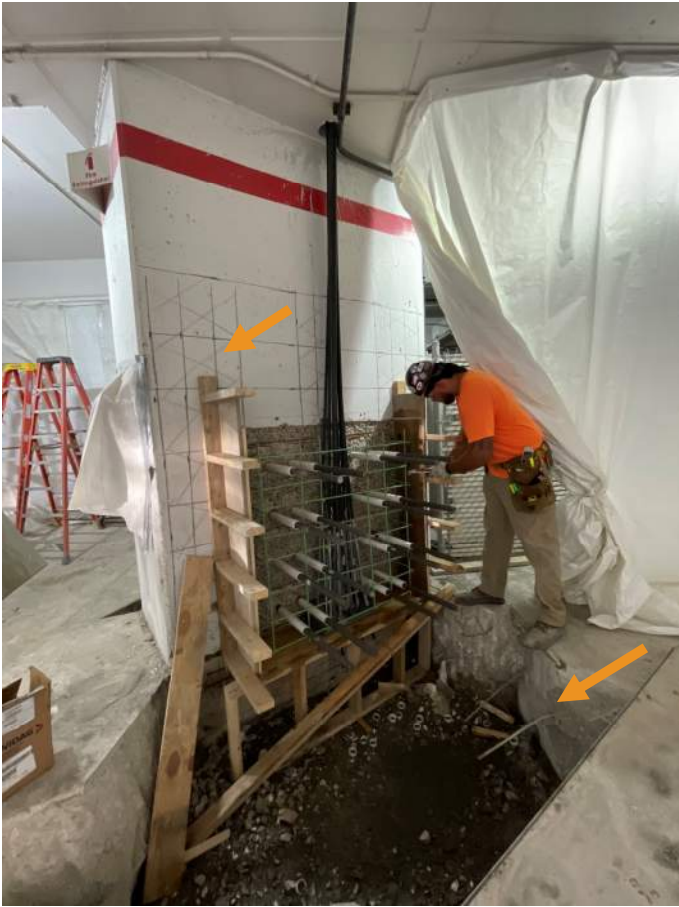
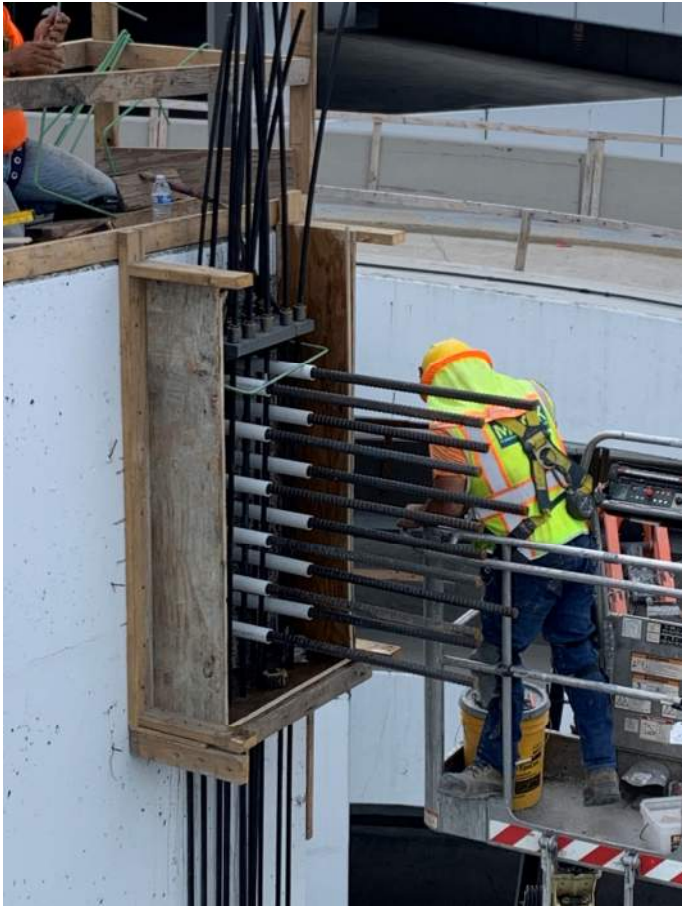
External PT Column Repair

- Original PT
 - 3 tendons with 42 wires each
 - ~1,000,000 lbs of PT force
 - At least 10 wires were failed, unknown condition of remaining wires
 - Difficult access to investigate
 - Continued deterioration
- External PT Repair
 - (13) 0.6 in. diameter 7-wire strands in each new tendon
 - (12) 1 ¼ in. diameter Dywidag bars in anchor blocks to transfer new force
