# Arizona Veterans Memorial Coliseum Roof Repairs

*ICRI Award of Merit 2009*

Dennis Wipf P.E.

Gervasio & Assoc. Inc.  
Consulting Engineers  
Phoenix, AZ

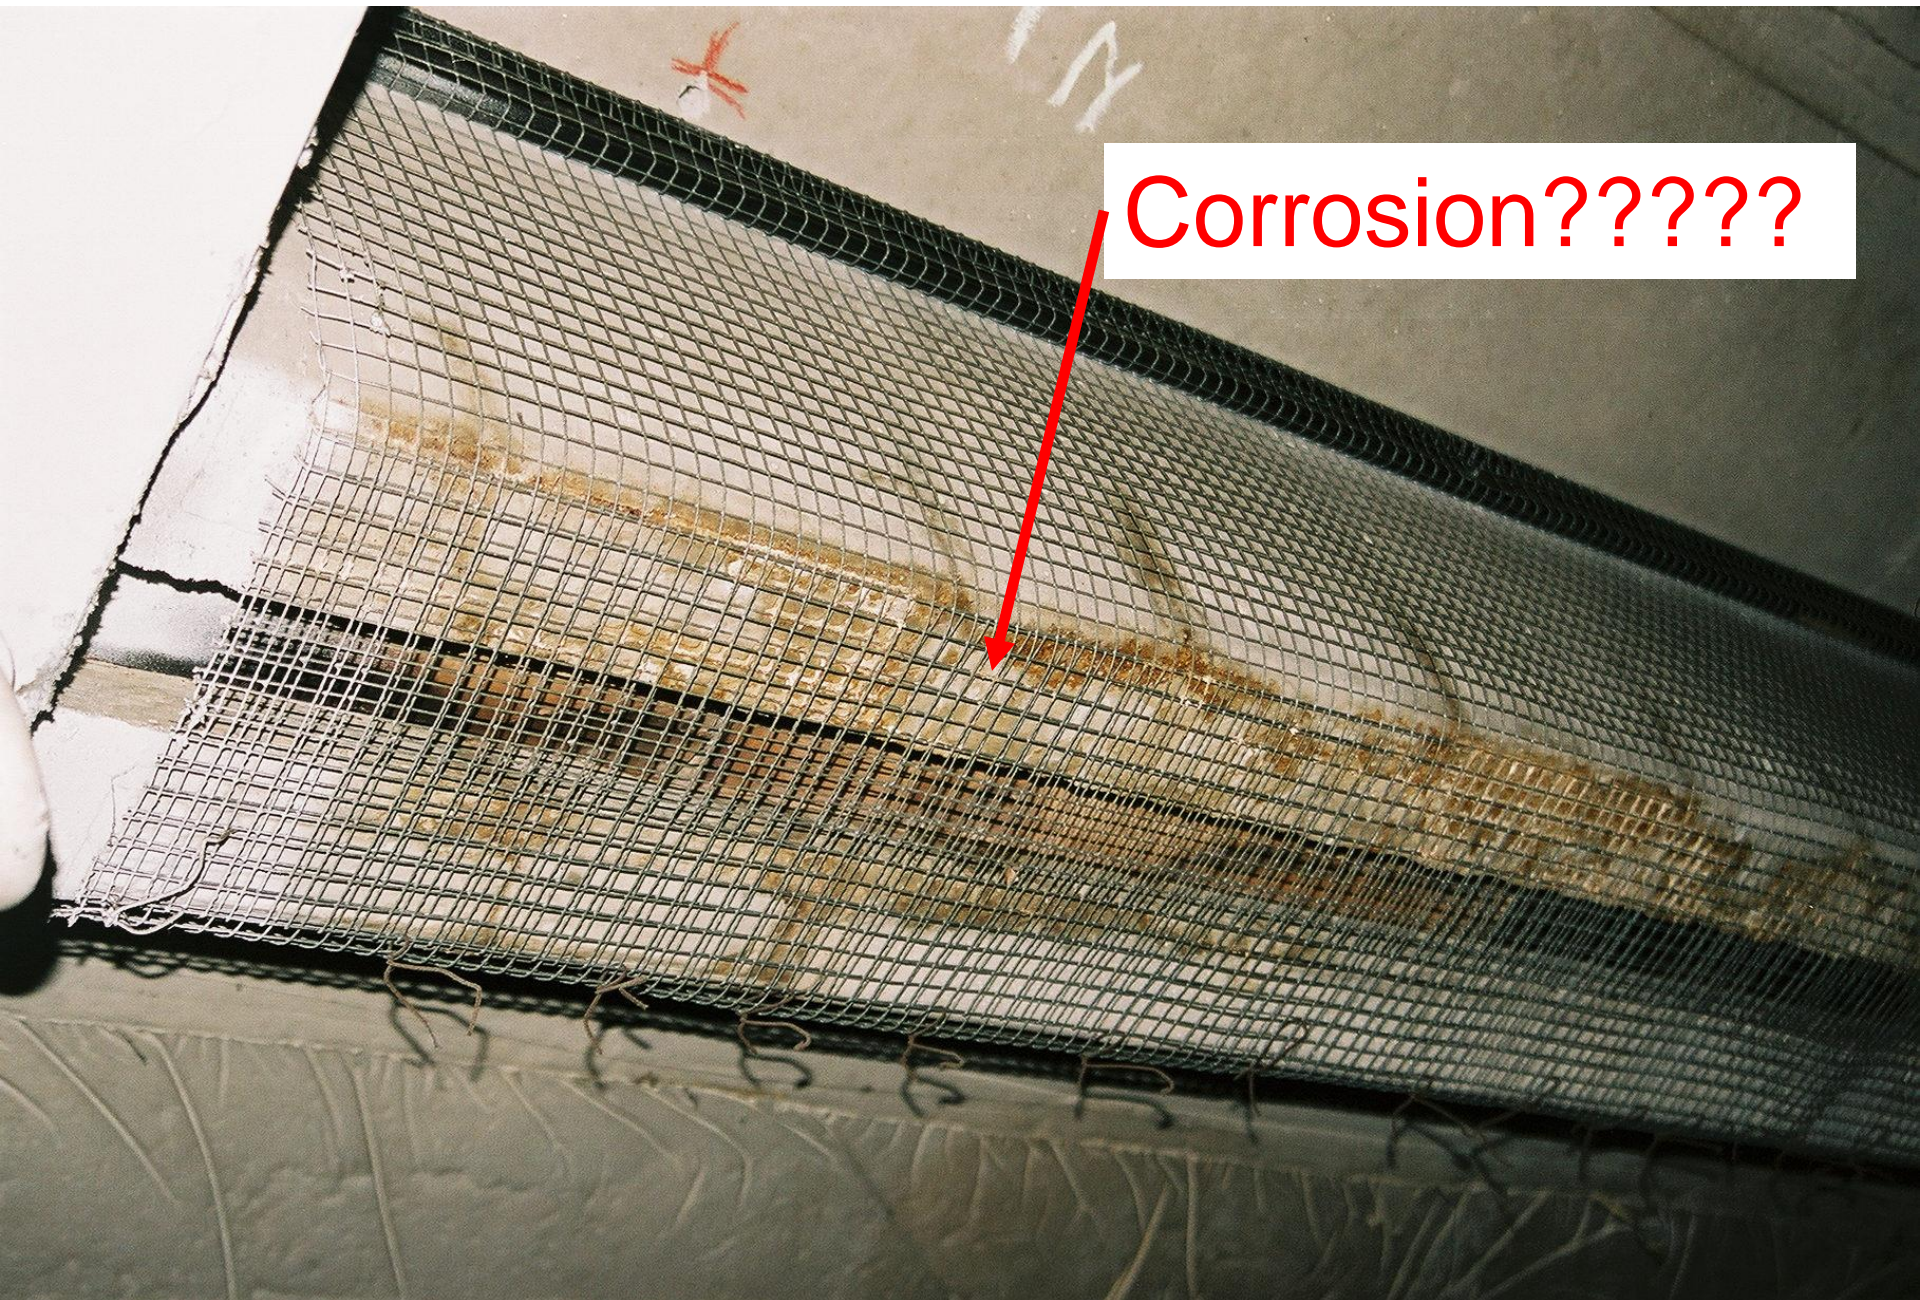
Dip in Roof

Corrosion?????

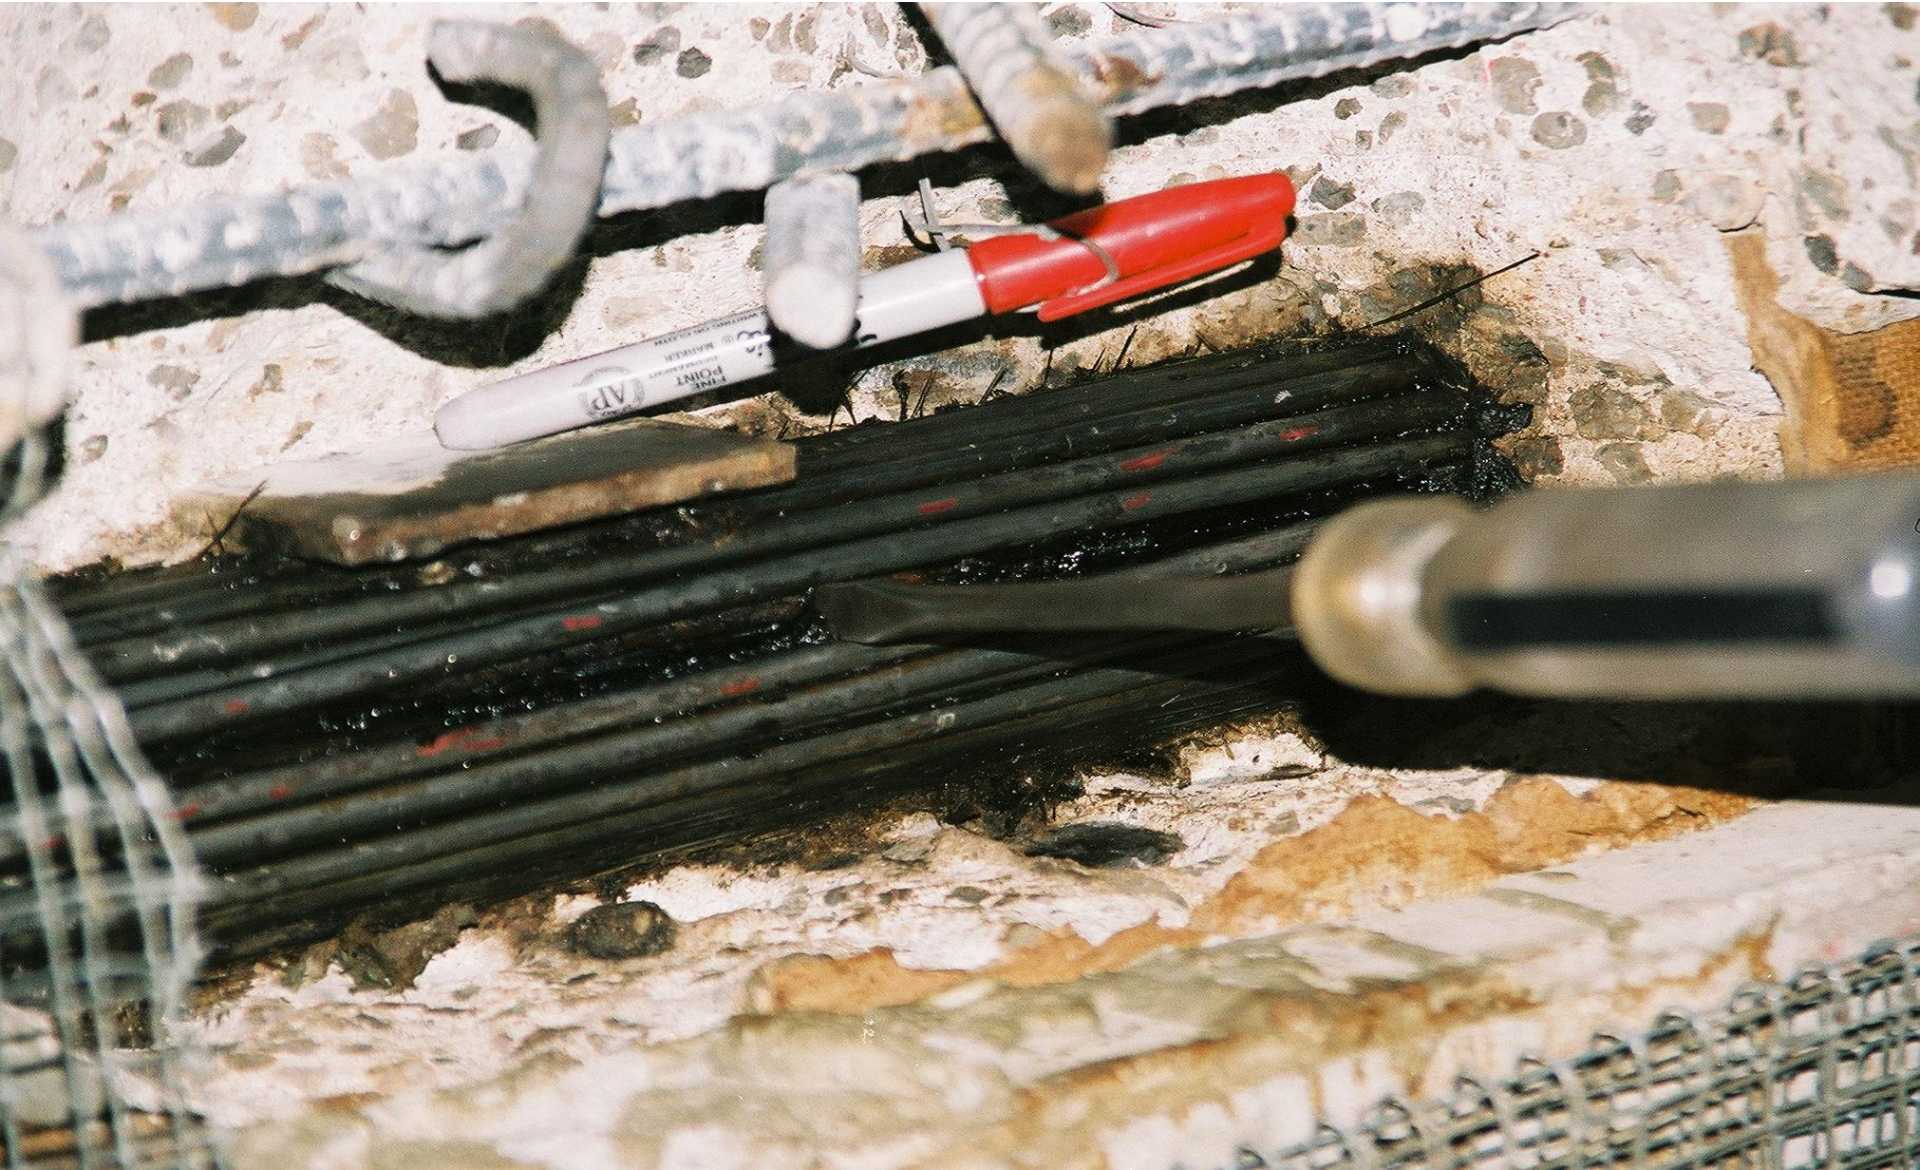
# Screwdriver Penetration Test

## *Is there Still Tension on the Tendons?*

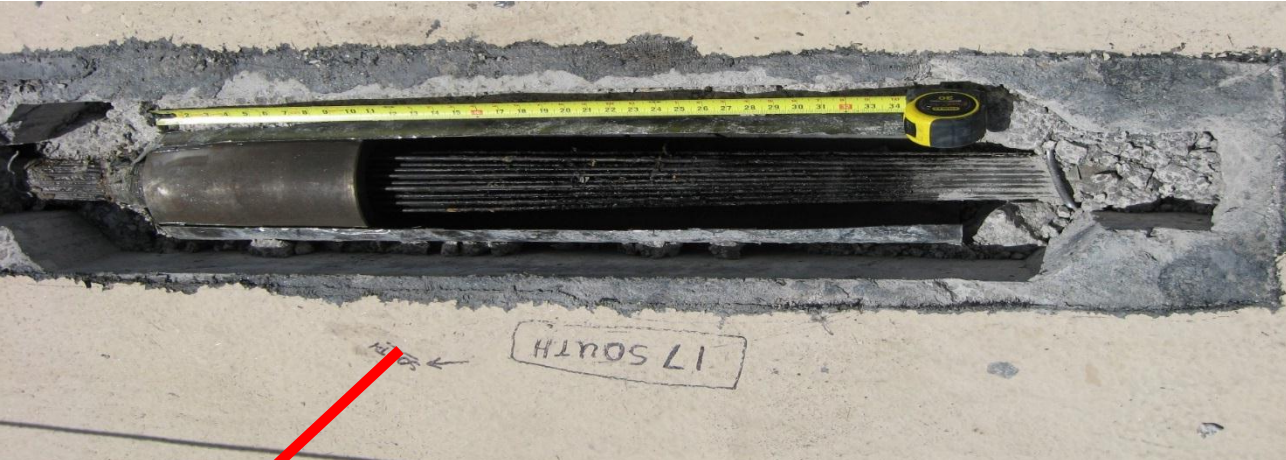
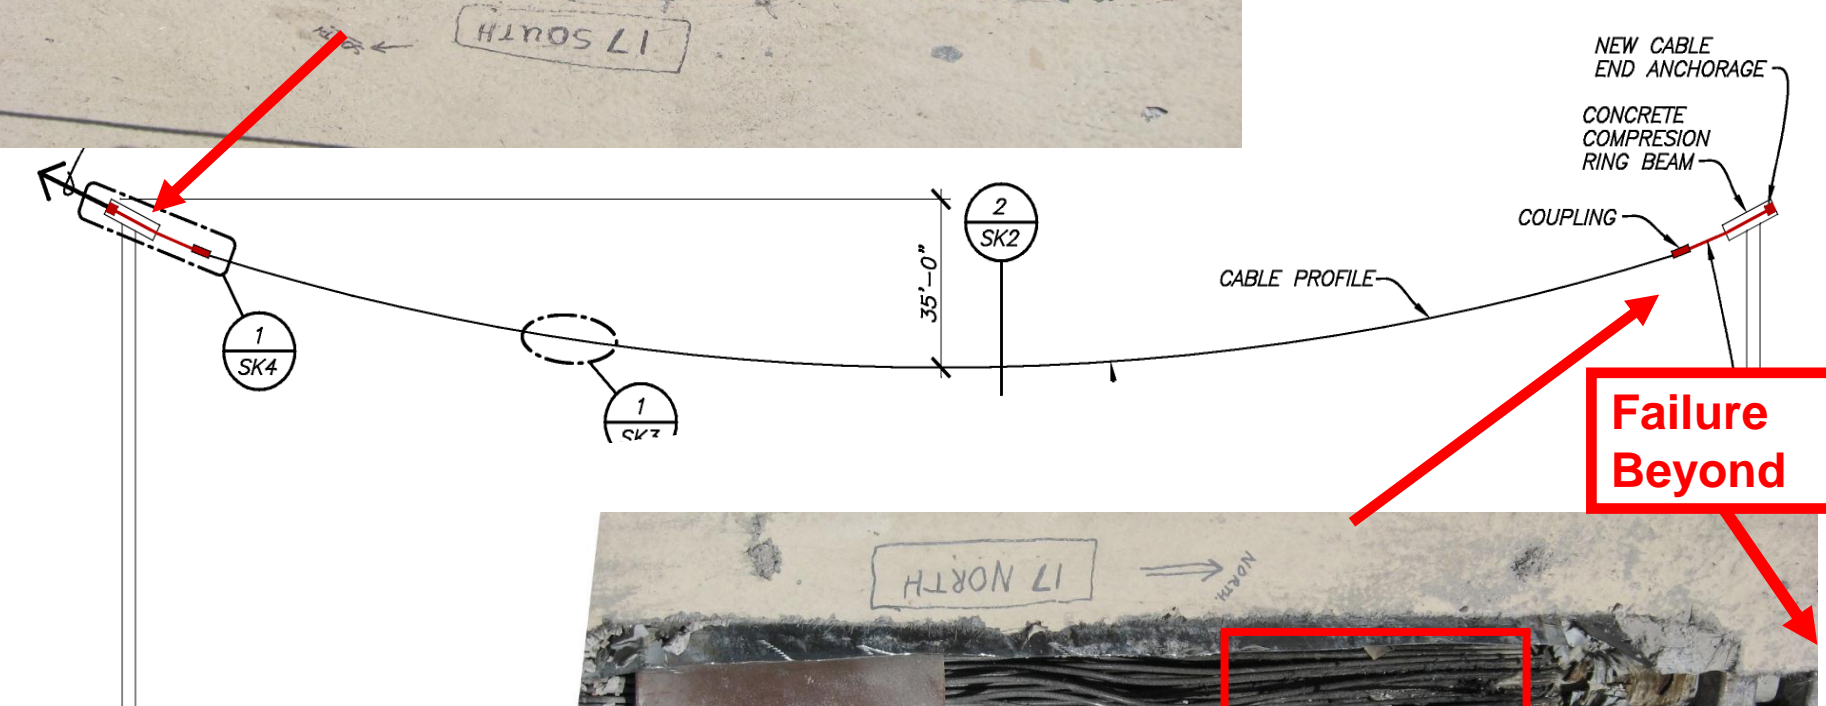
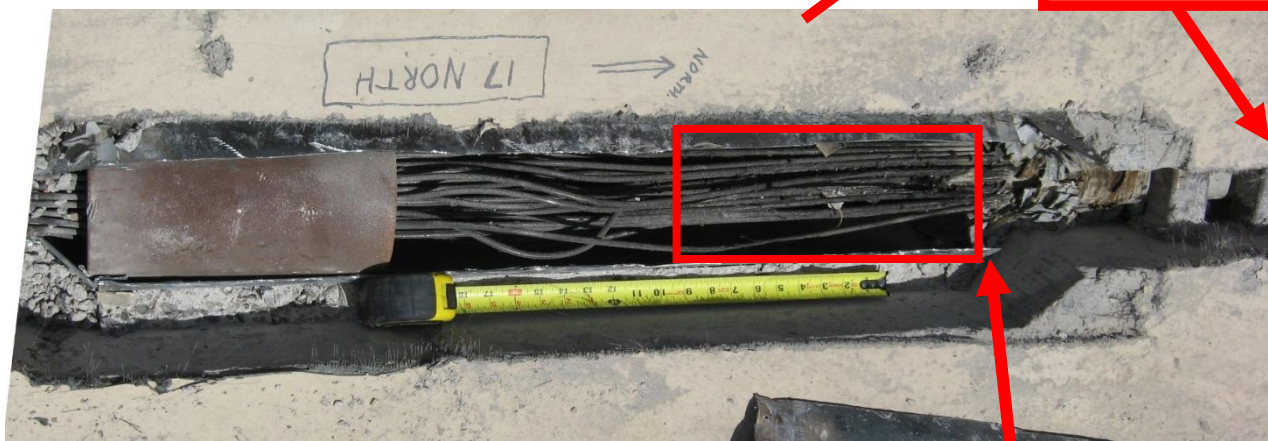
**Failure Beyond**

**Location of coupling before failure**

NEW CABLE  
END ANCHORAGE

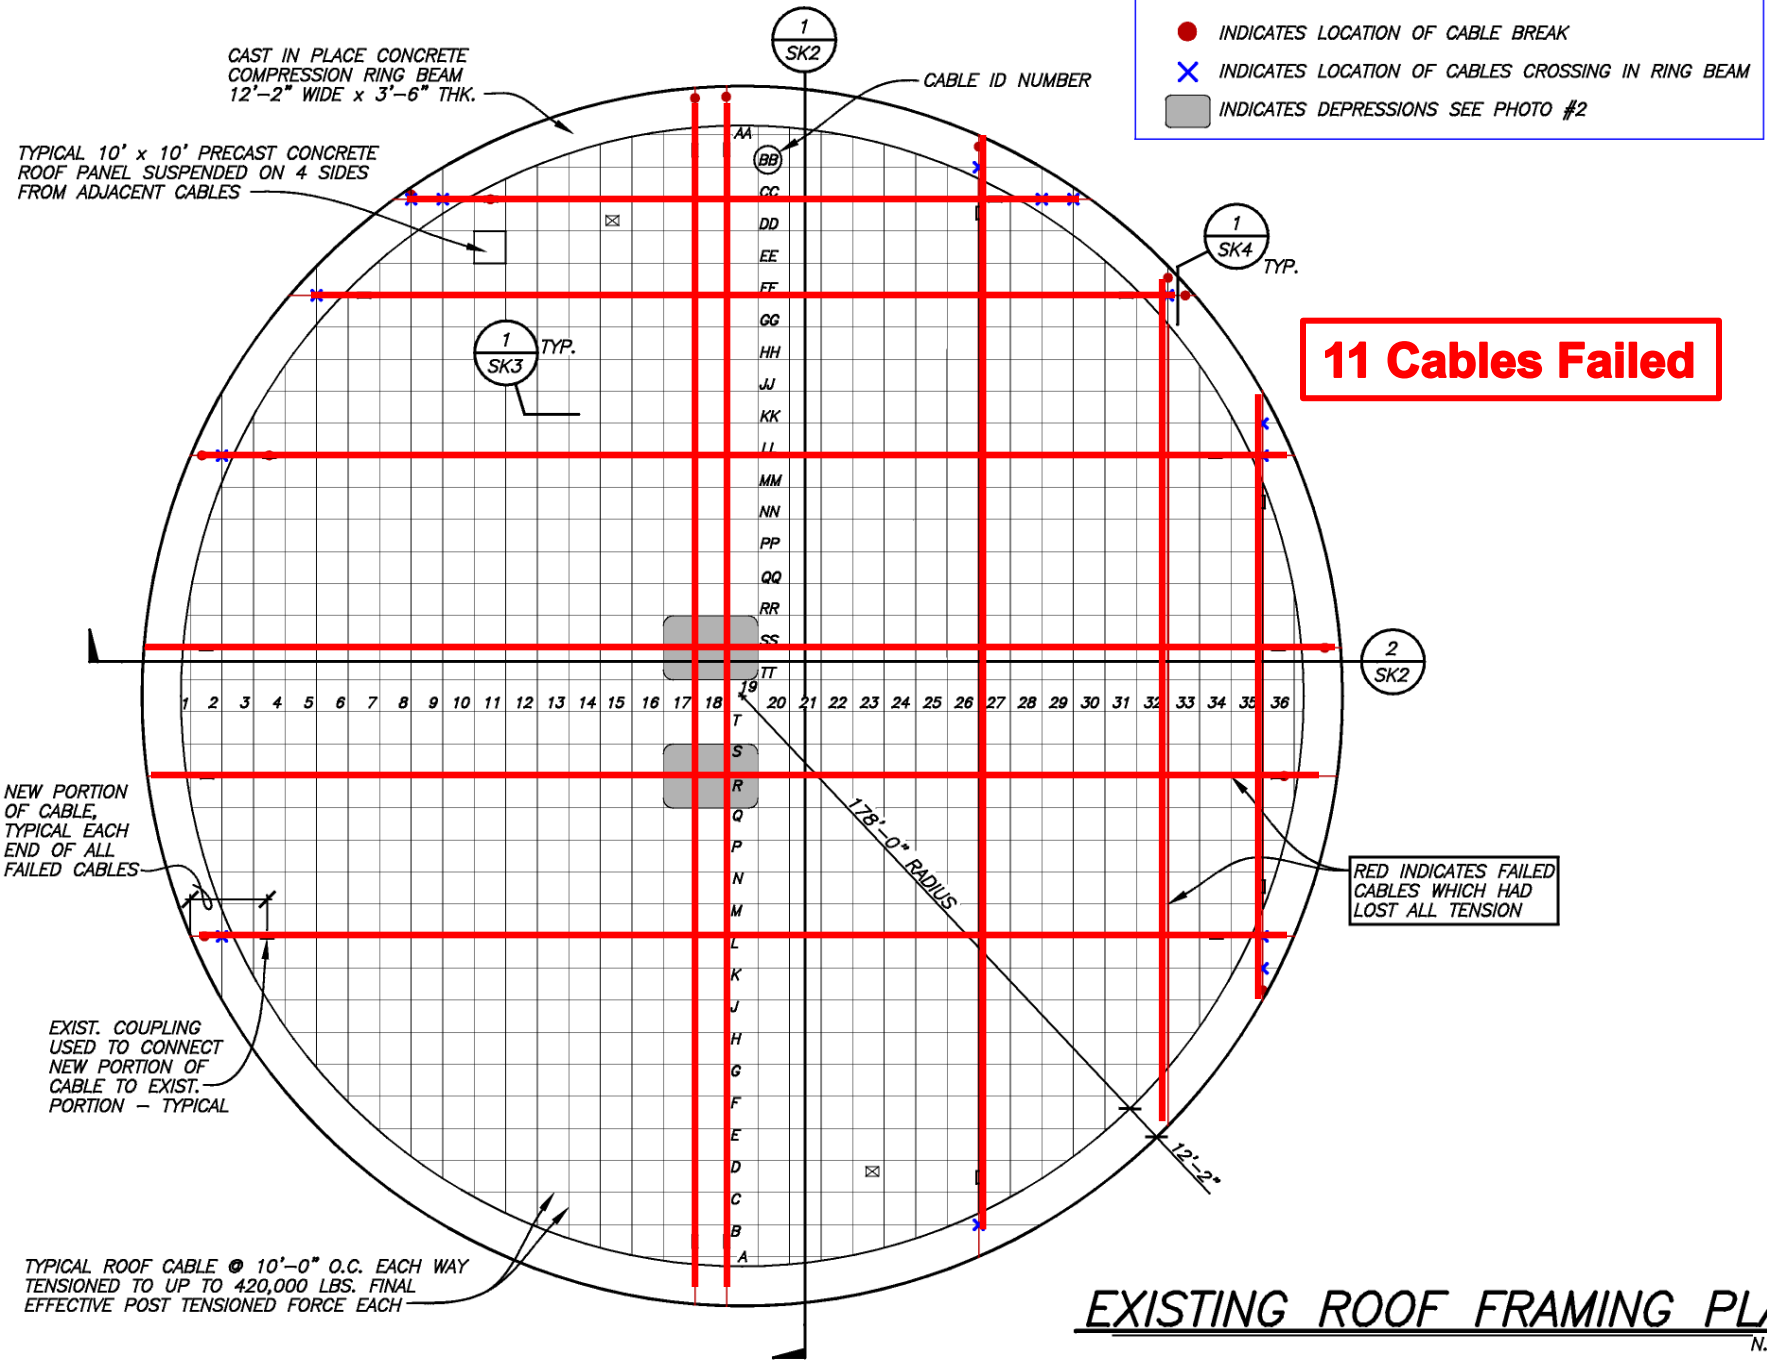
**EXISTING ROOF FRAMING PLAN**  
N.T.S.

- INDICATES LOCATION OF CABLE BREAK
- × INDICATES LOCATION OF CABLES CROSSING IN RING BEAM
- INDICATES DEPRESSIONS SEE PHOTO #2

**11 Cables Failed**

RED INDICATES FAILED  
CABLES WHICH HAD  
LOST ALL TENSION

NEW PORTION  
OF CABLE,  
TYPICAL EACH  
END OF ALL  
FAILED CABLES

EXIST. COUPLING  
USED TO CONNECT  
NEW PORTION OF  
CABLE TO EXIST.  
PORTION - TYPICAL

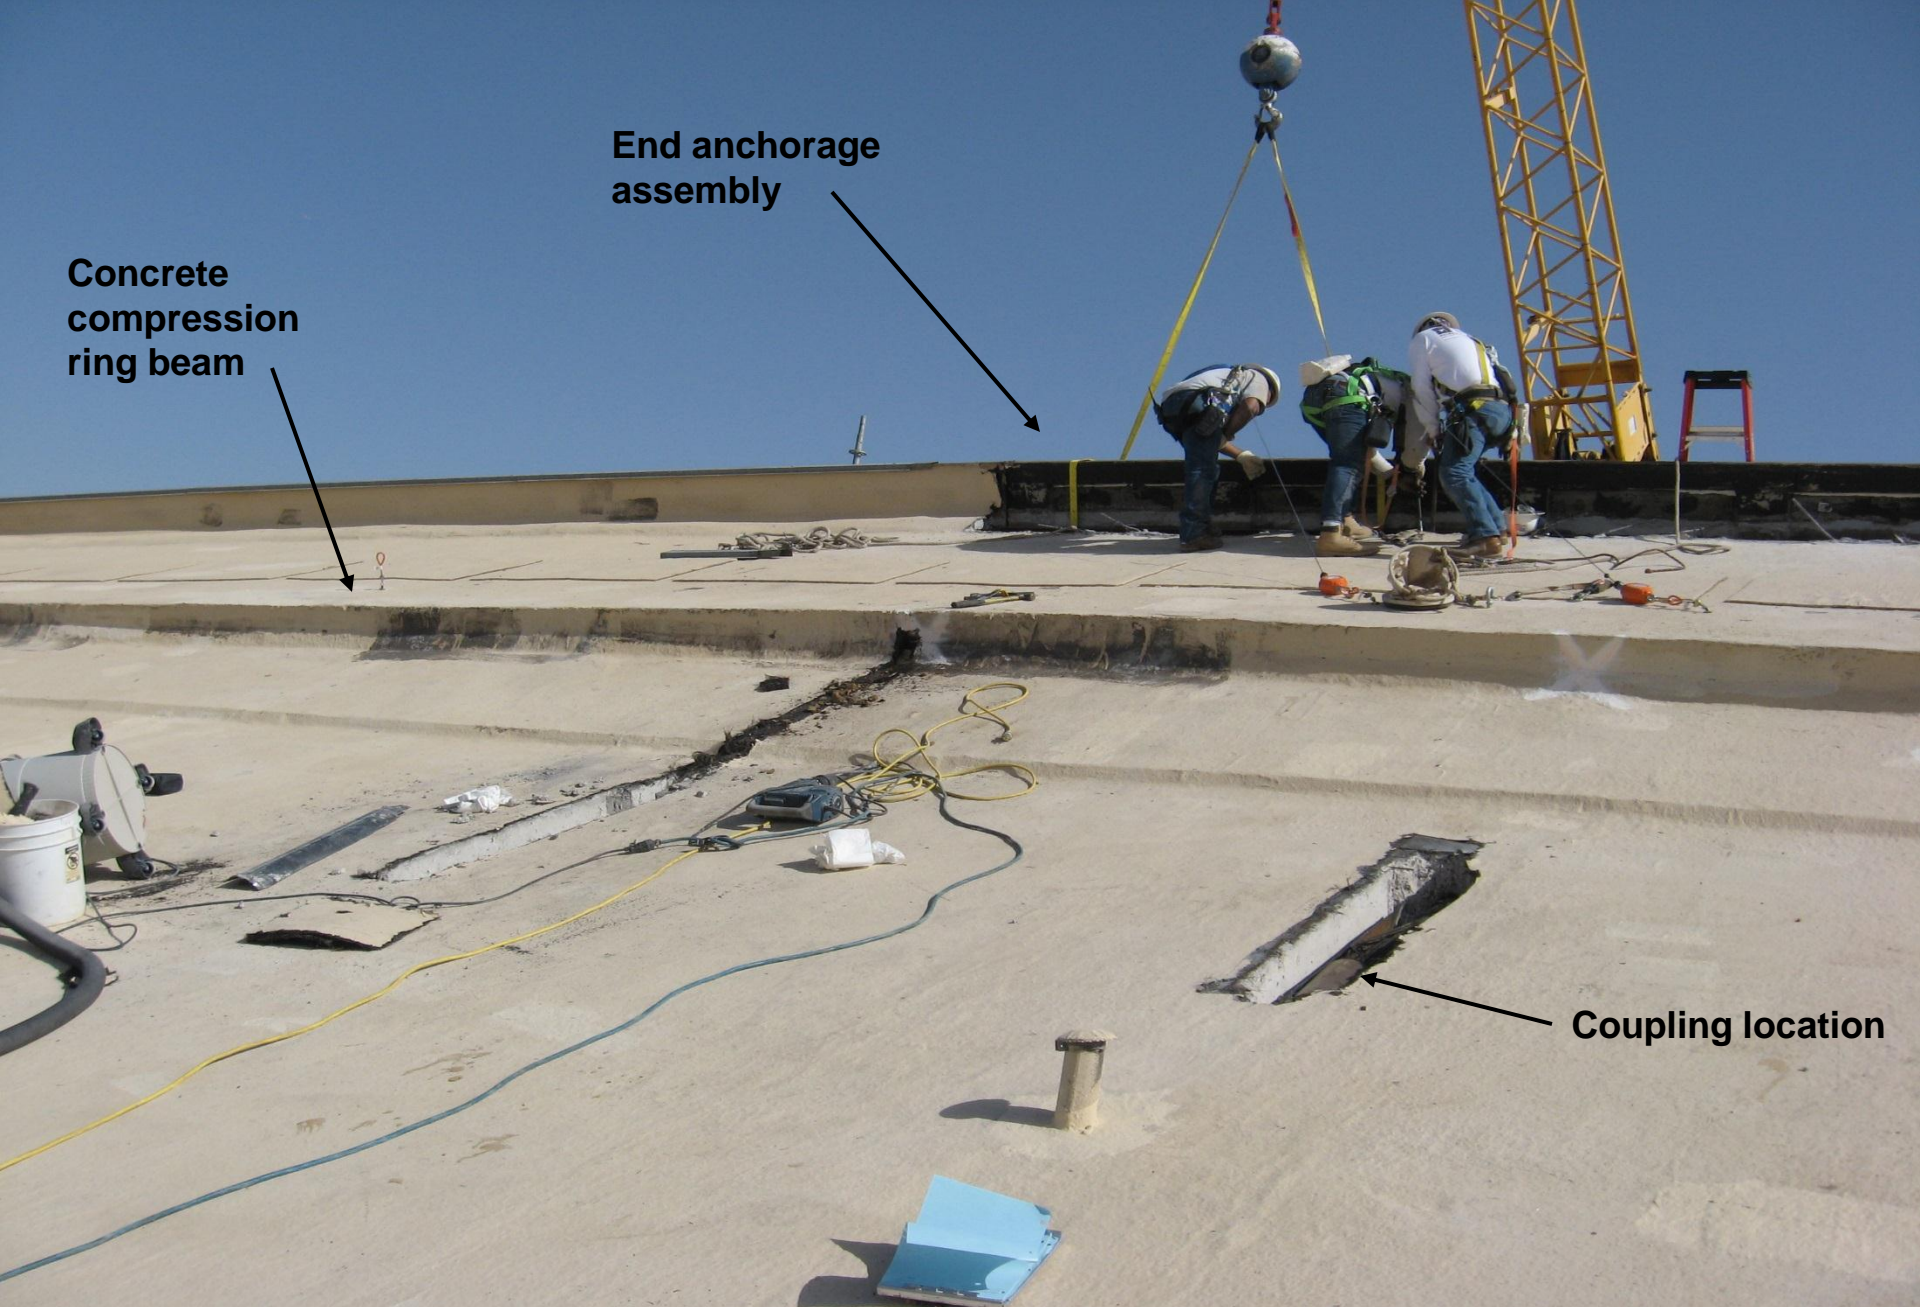
**Concrete  
compression  
ring beam**

**End anchorage  
assembly**

**Coupling location**

Coupling to end anchorage area. Coupling on left has slot chipped in roof to allow replacement of roof cable from the coupling to the end anchorage with new post tension strand. Contractor in process of removing fascia panels to expose end anchorage.

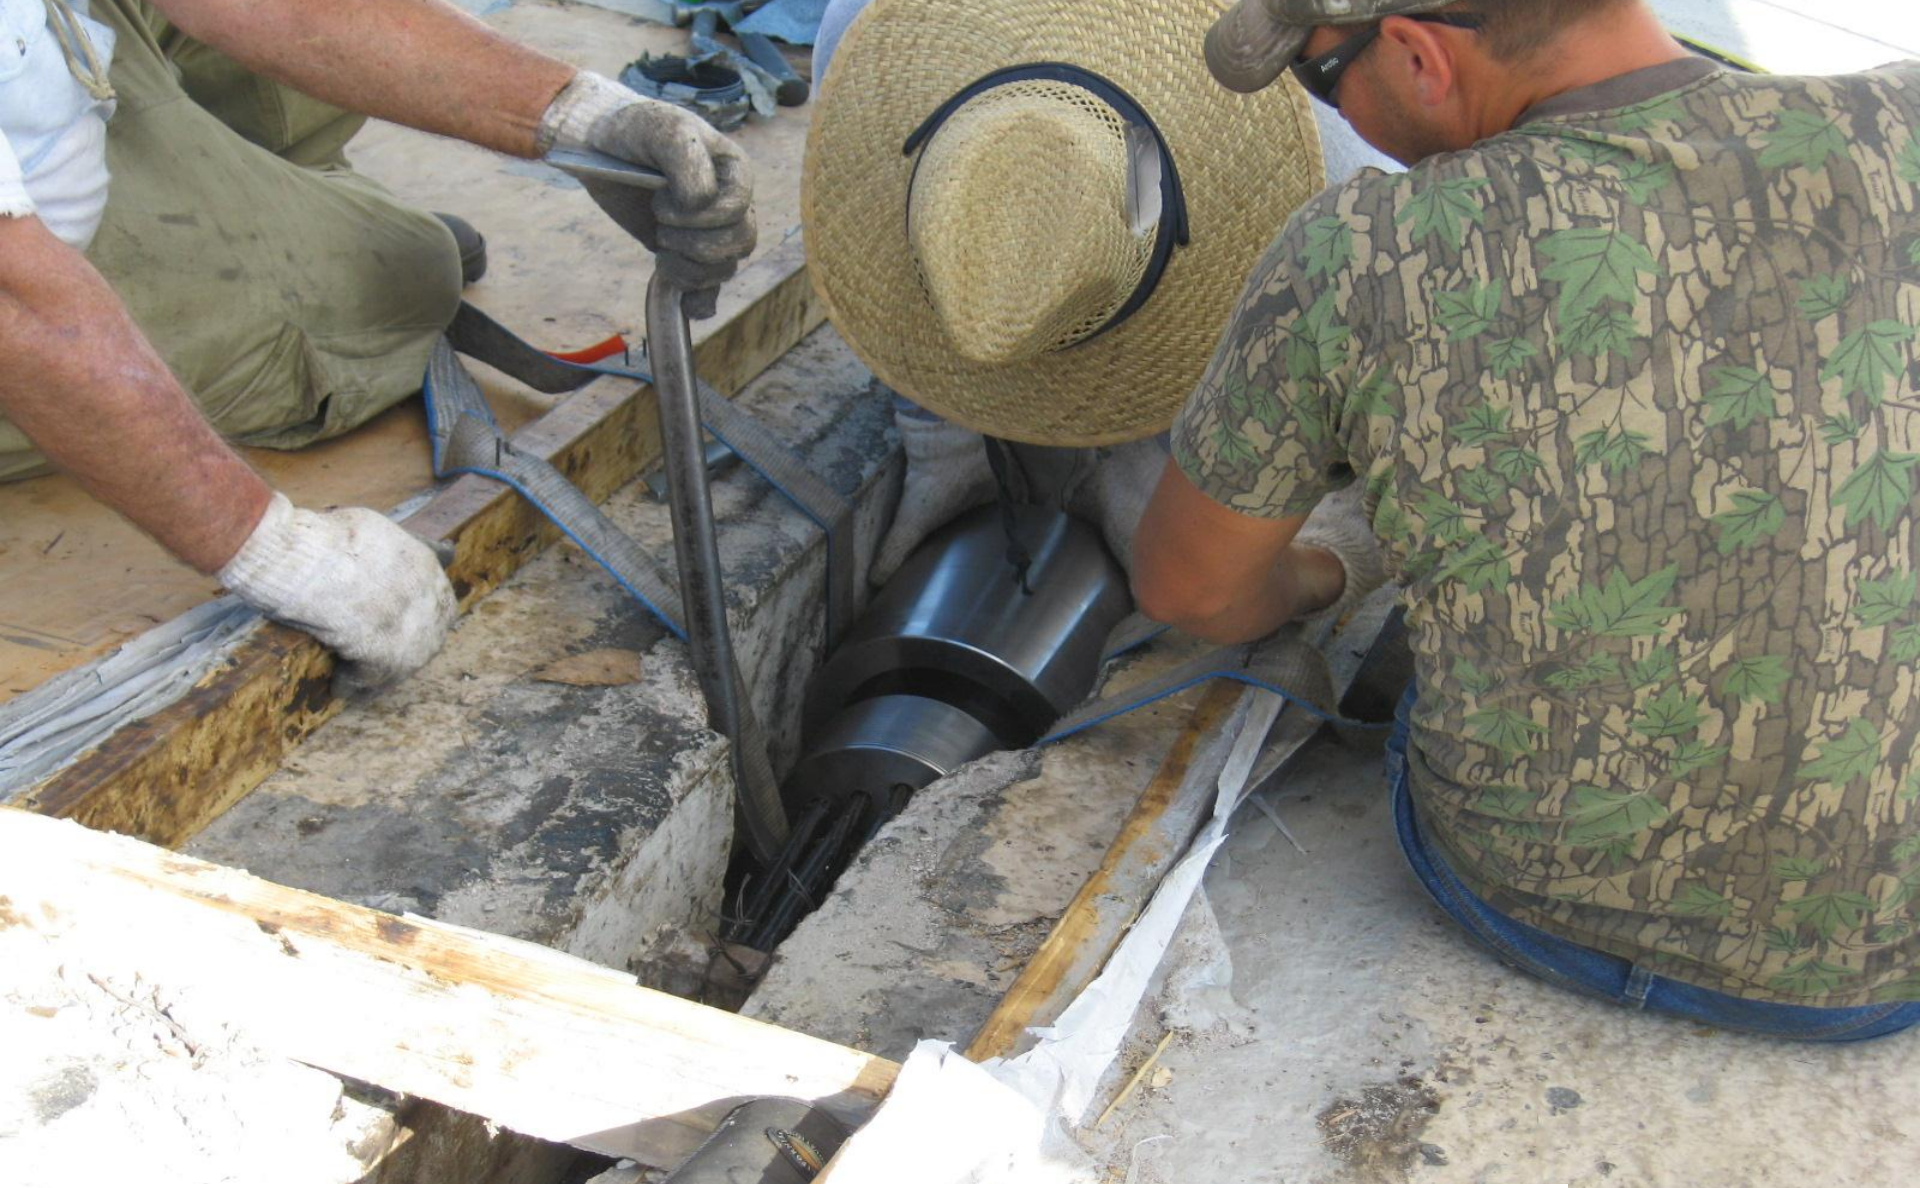
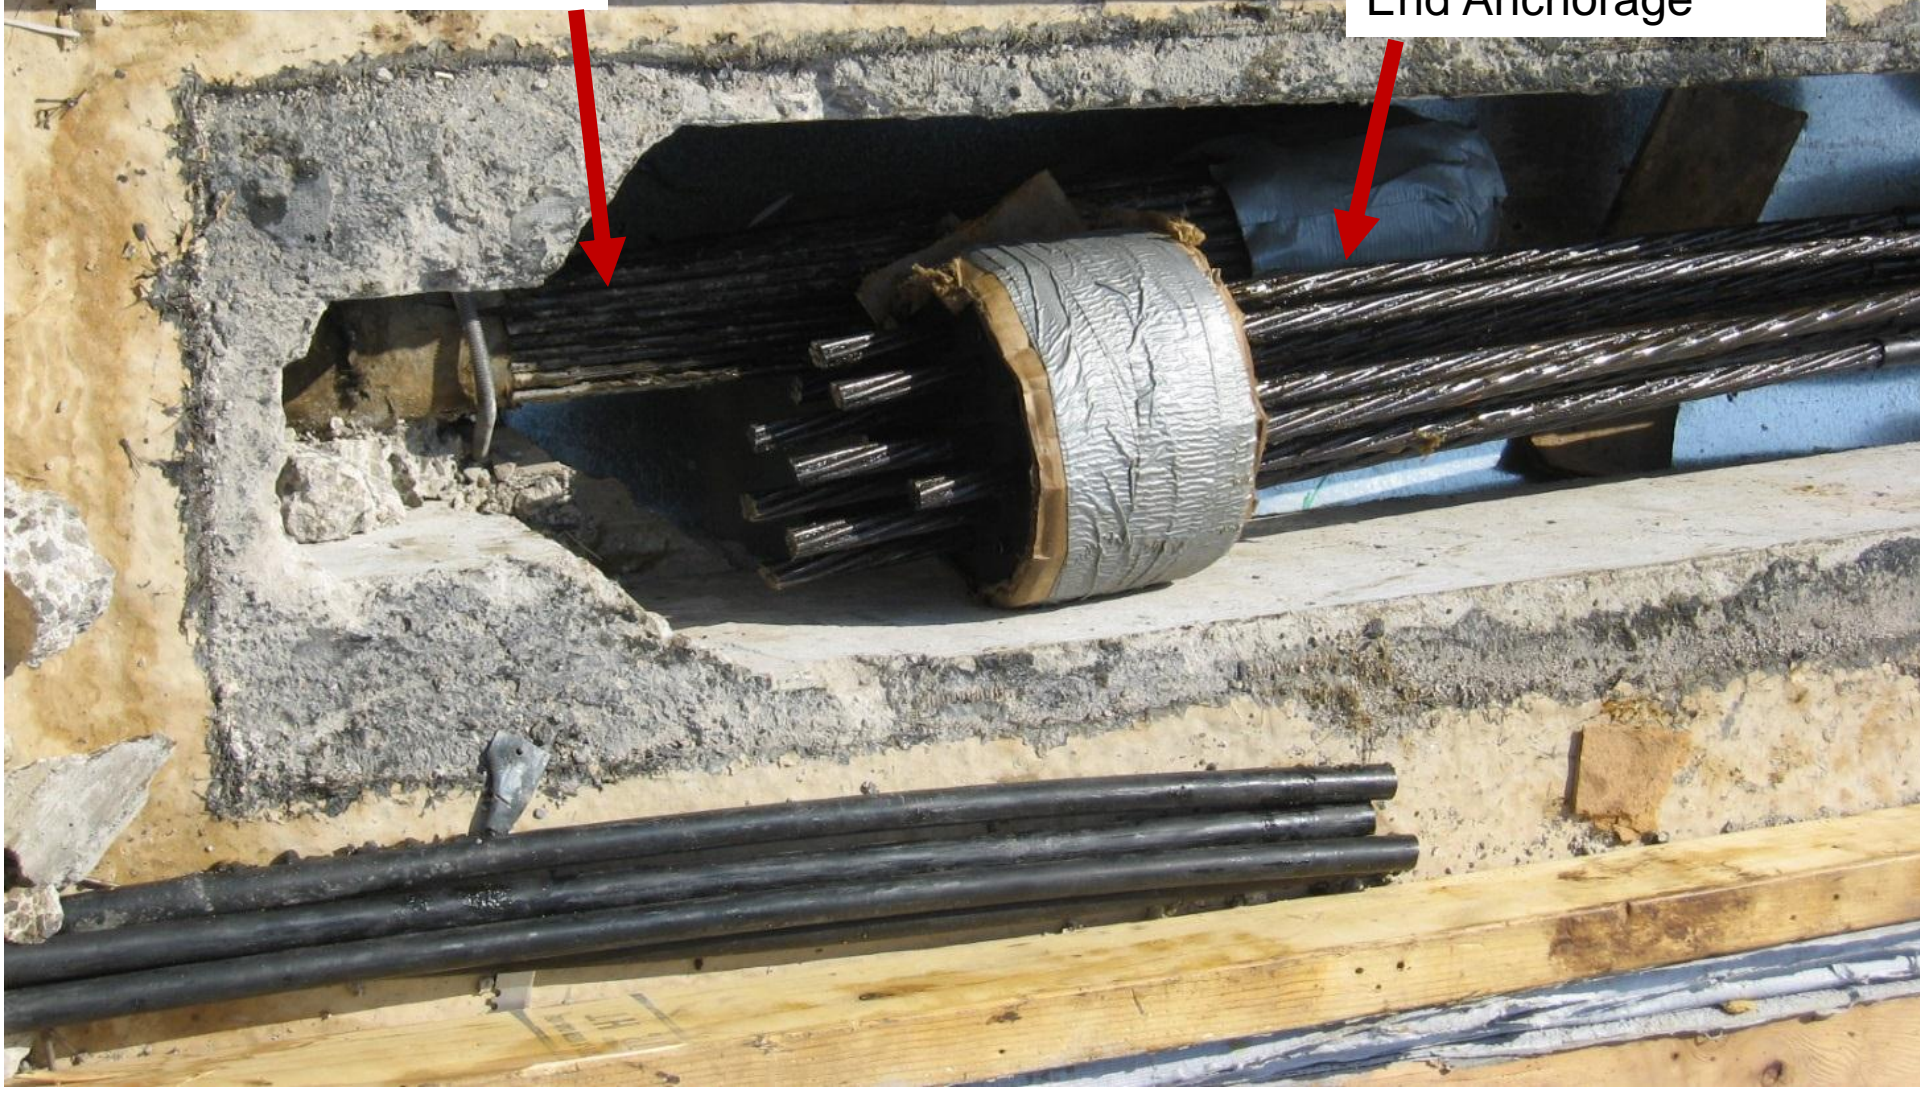
Installation of the New Coupling

Original Button Head  
Wire Tendons to Main  
Span

New 0.6" Dia. Post  
Tension Strands to  
End Anchorage

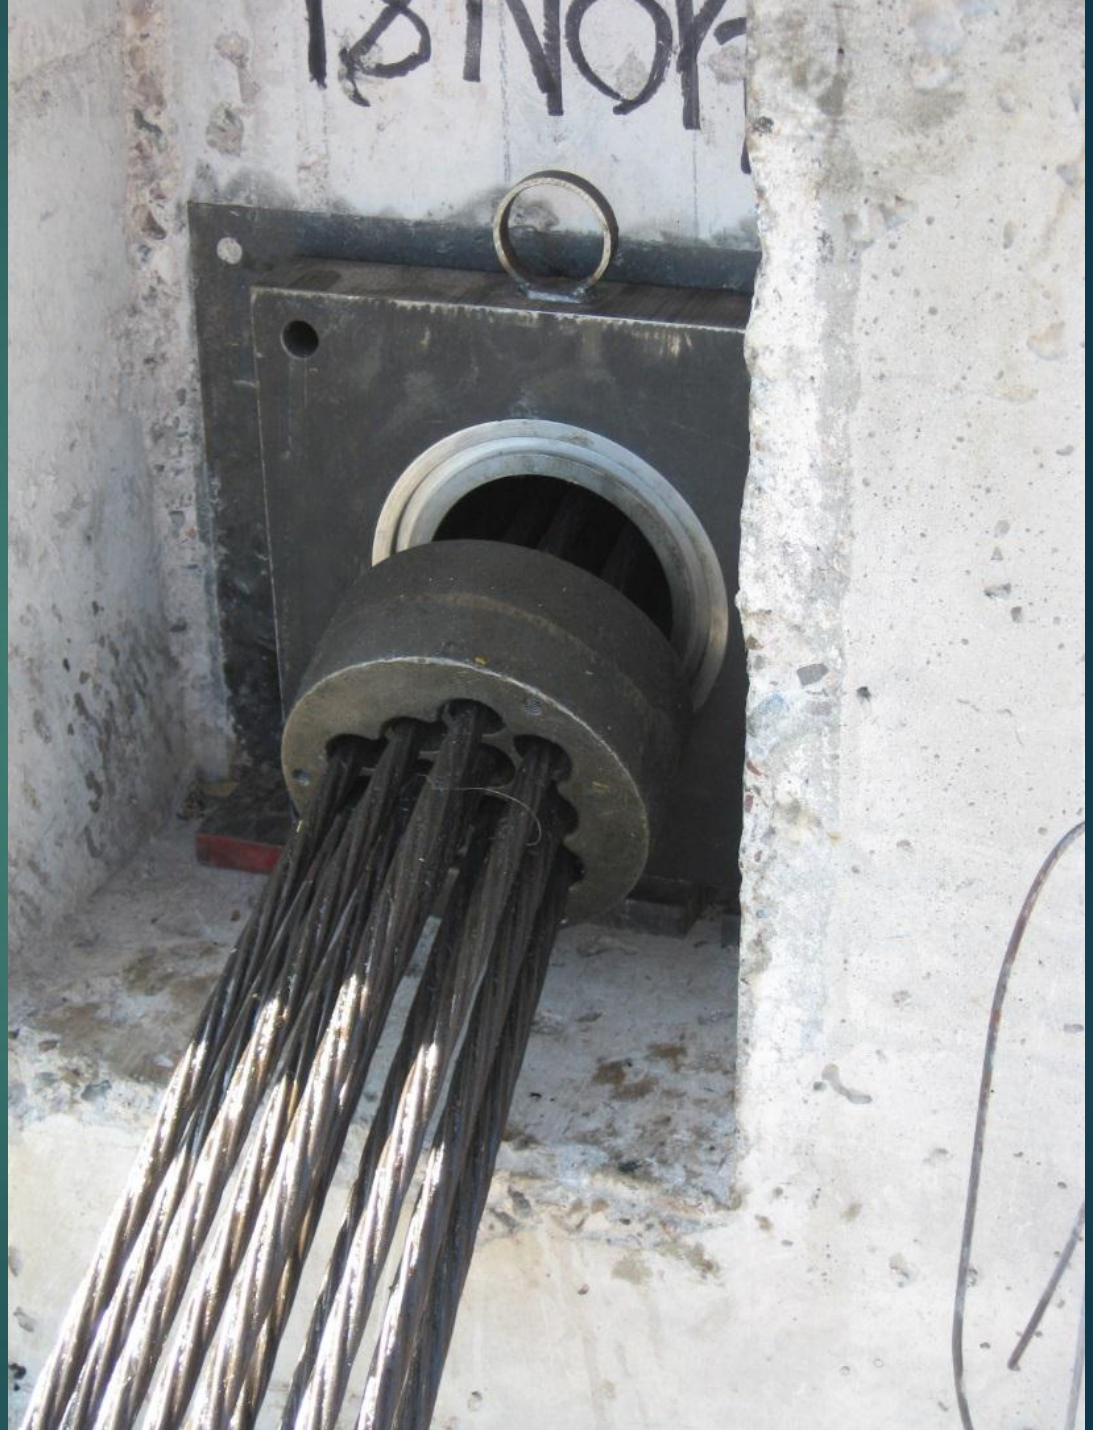
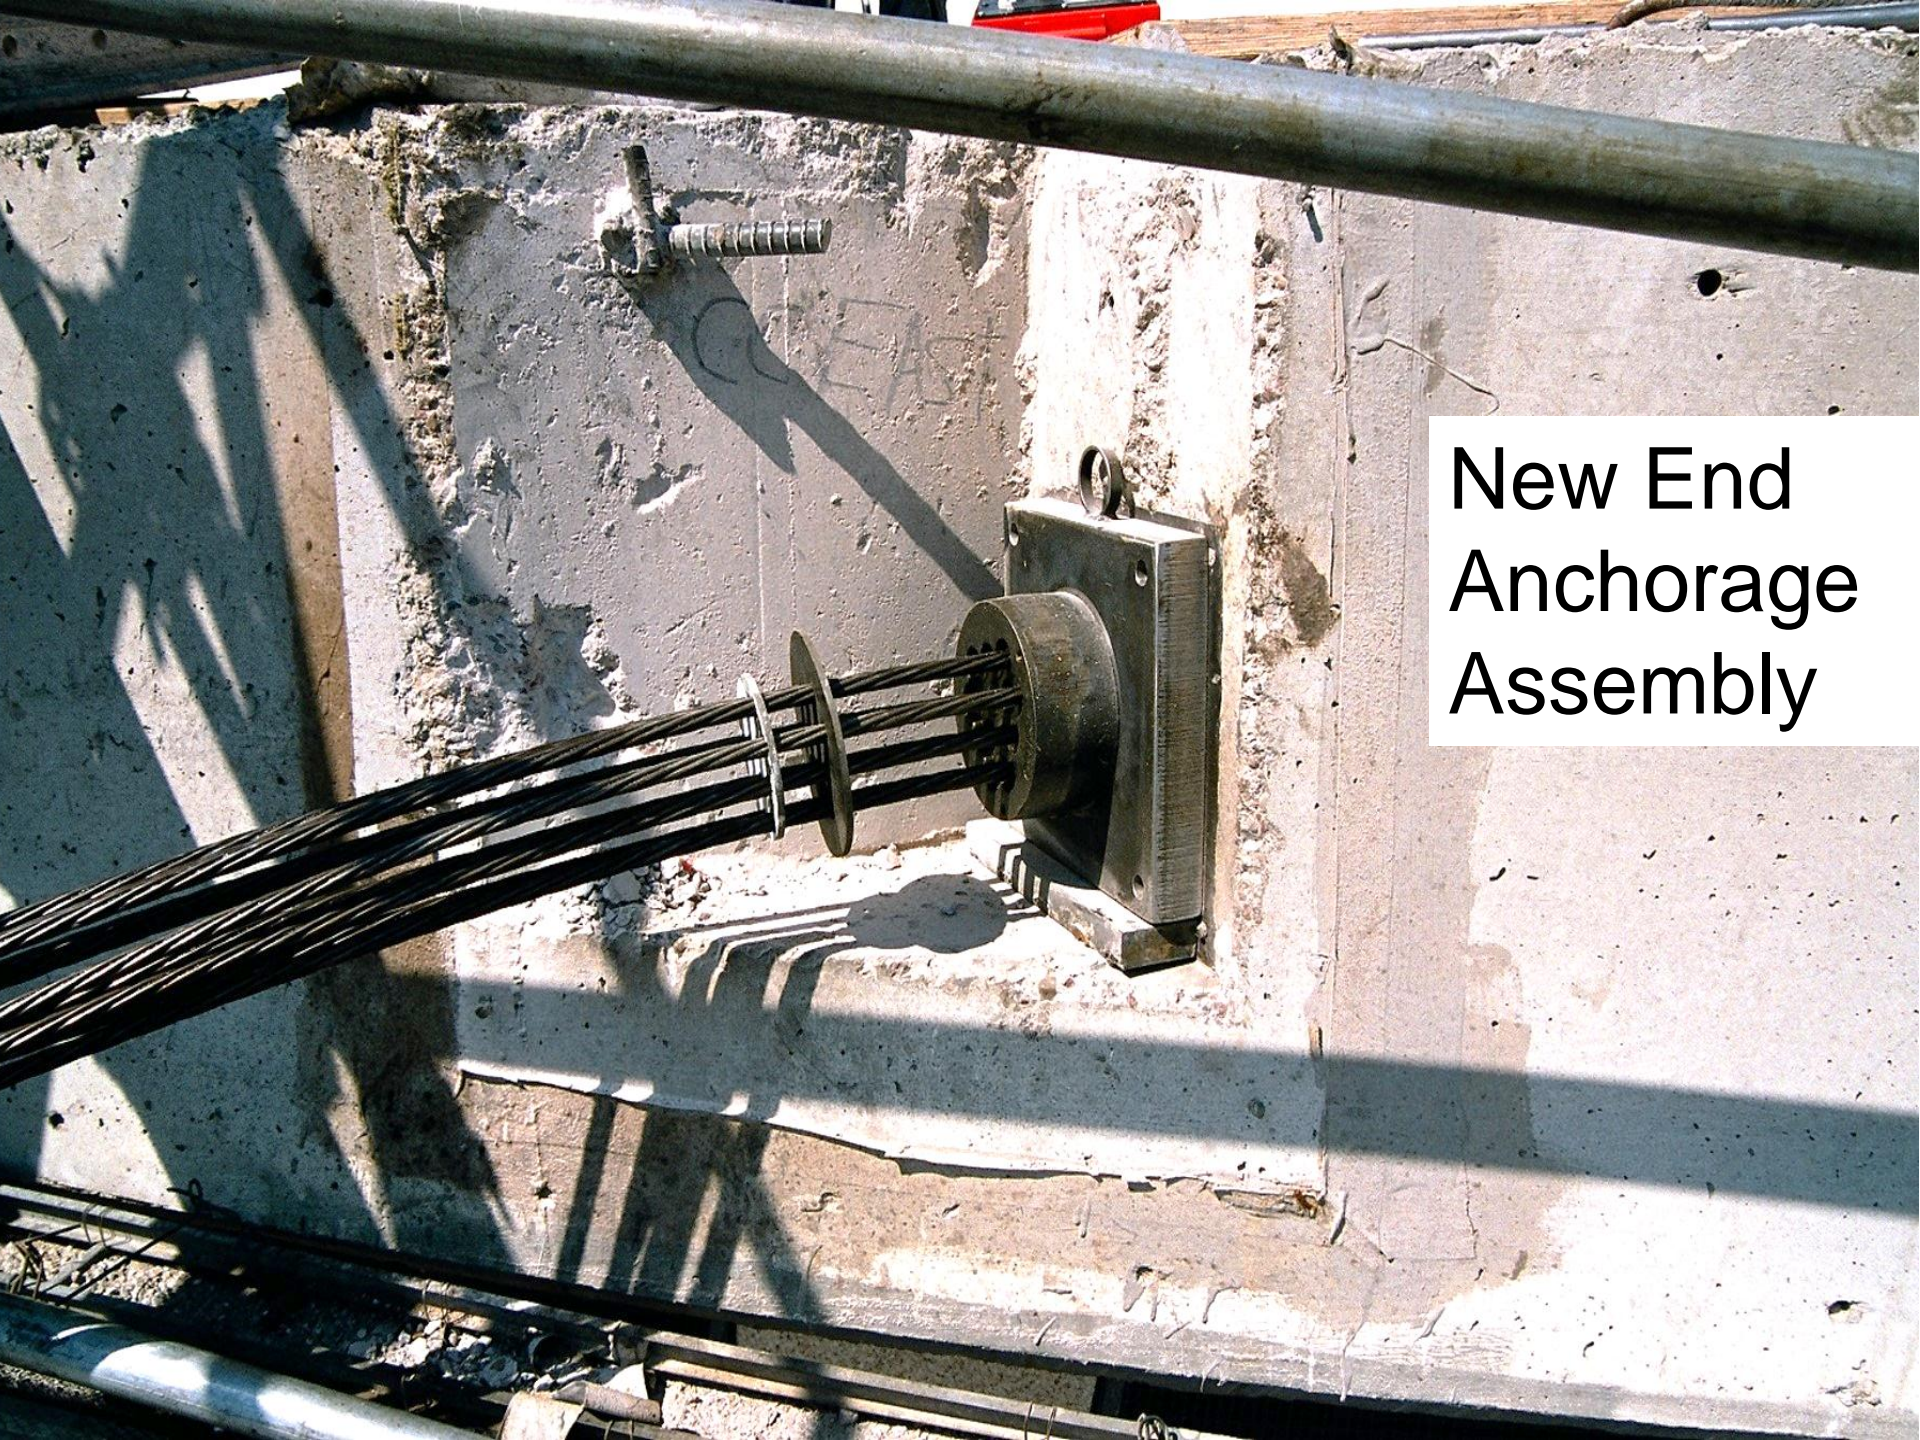
# New End Anchorage Assembly

New End  
Anchorage  
Assembly

Final tensioning of cable tendon, 420,000 pounds of force.
