# Structural Assessment Key to Returning Historic Union Depot to an Active Transportation Hub

ICRI 2012 Spring Convention  
Quebec City, QC, Canada

Kevin A. Michols, PE, SE

Wiss, Janney, Elstner Associates, Inc.

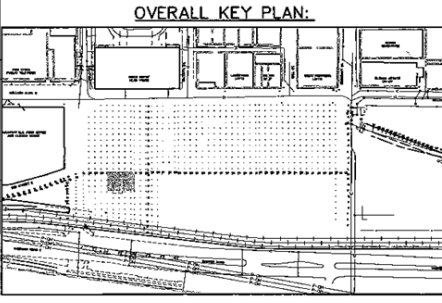
SHEET NO.  
 GL-47

COLUMN ID:	CONDITION NOTES:
M66	SJ
M65	SJ
M64	SJ
M63	SJ
N66	SJ
N65	SJ, PE - 1 SF @ DR
N64	SJ
N63	SJ
O66	SJ
O65	SJ, D - 2 SF
O64	SJ
O63	SJ

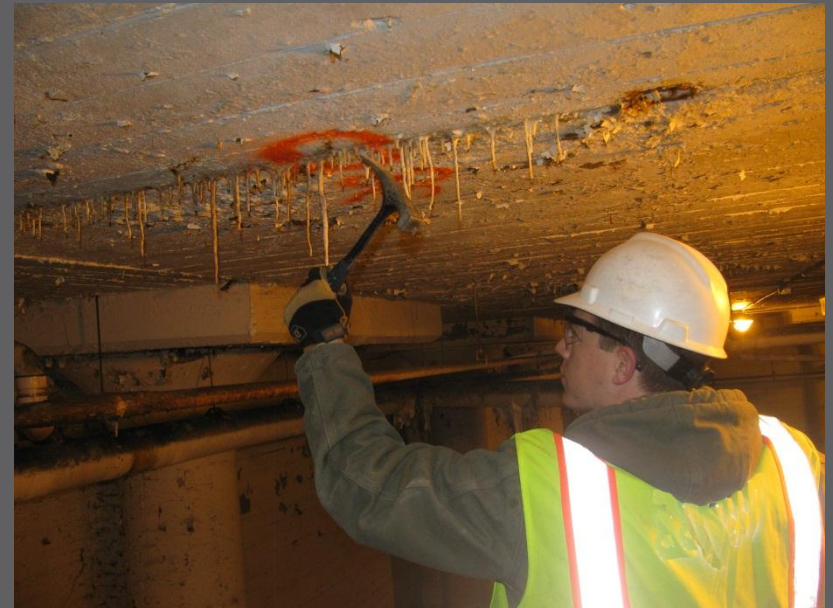
## 3. Additional Sounding of Representative Areas

- Include range of visual ratings
- Previous shotcrete repairs
- Expansion joints
- Construction joints
- Cracks

Proved beneficial in estimating extent of deterioration and repair quantities

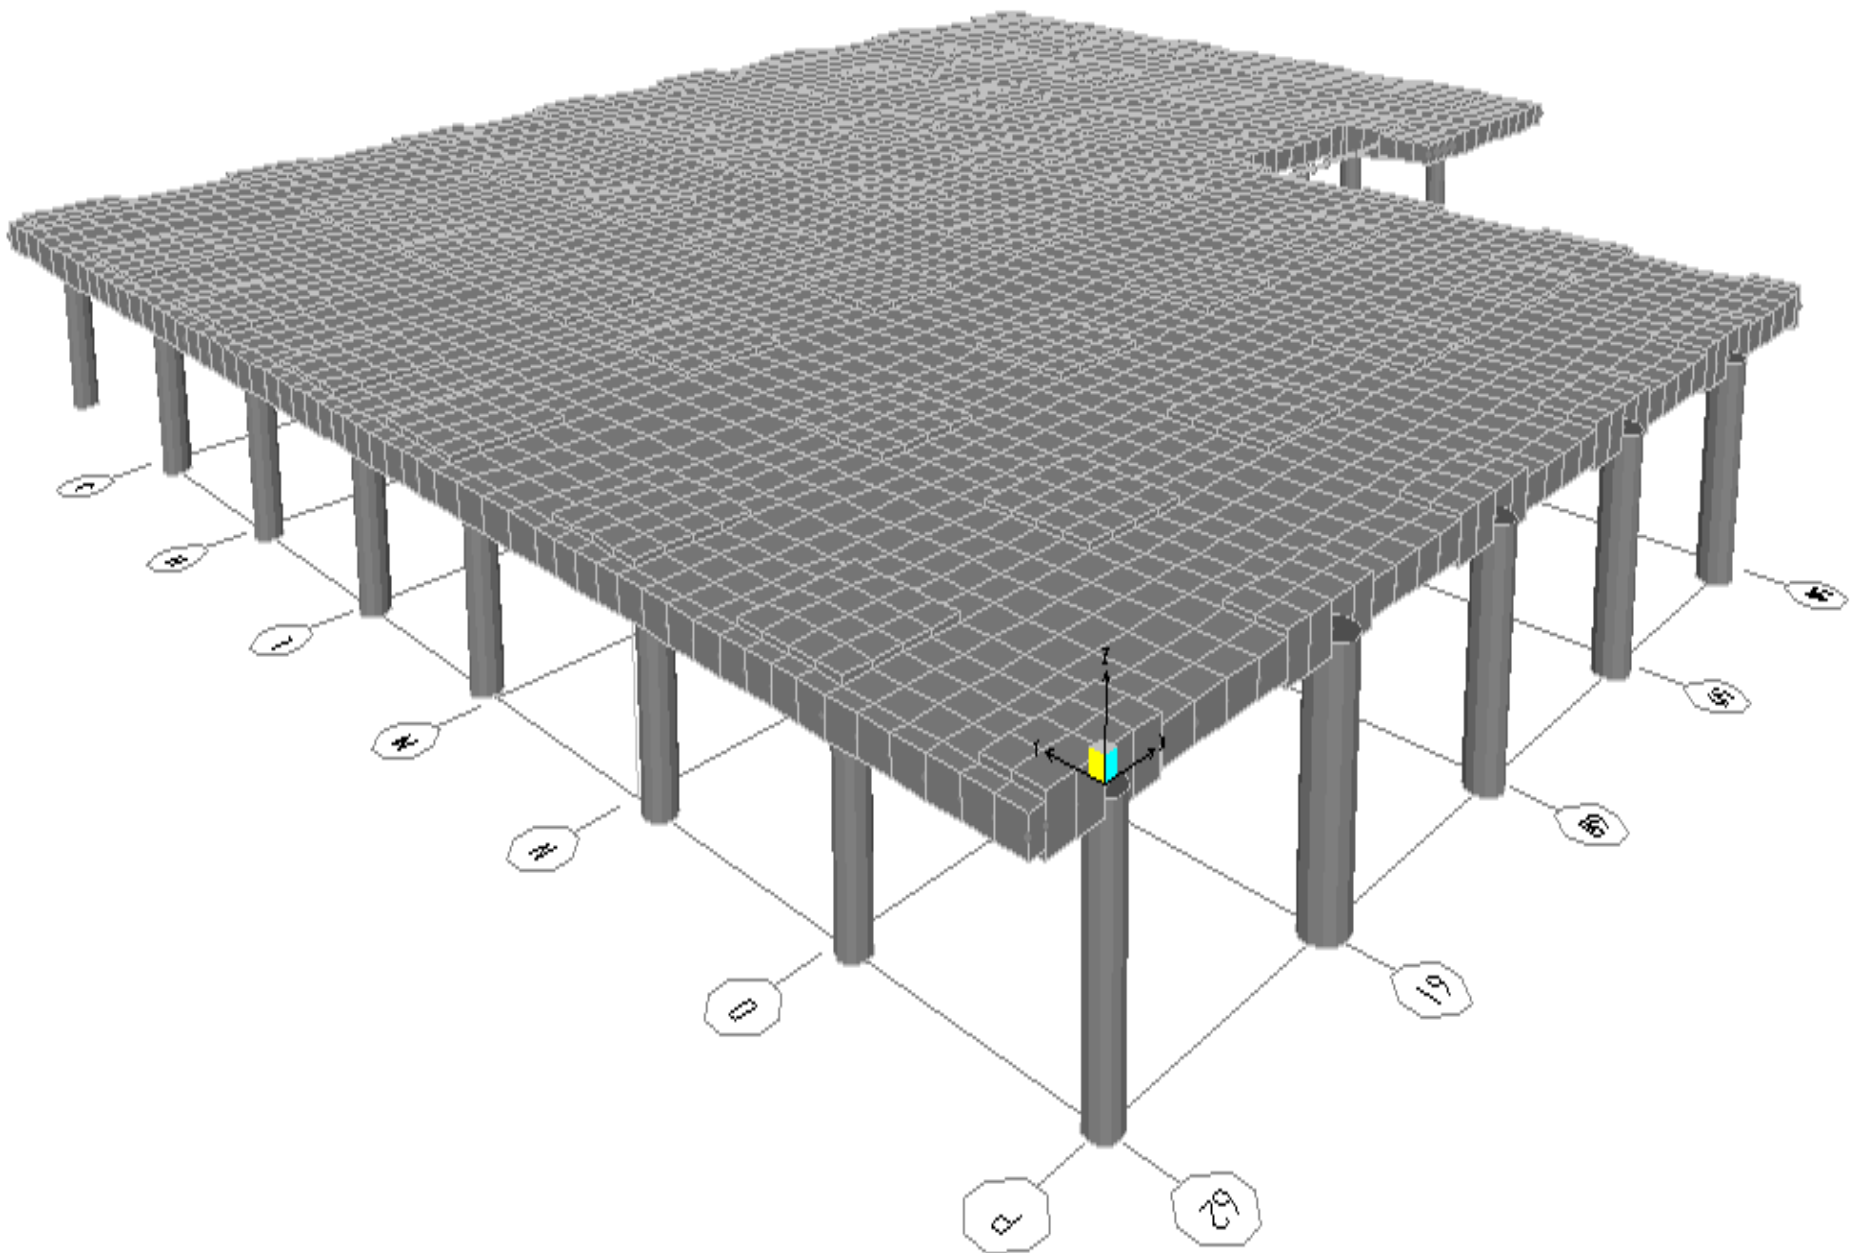
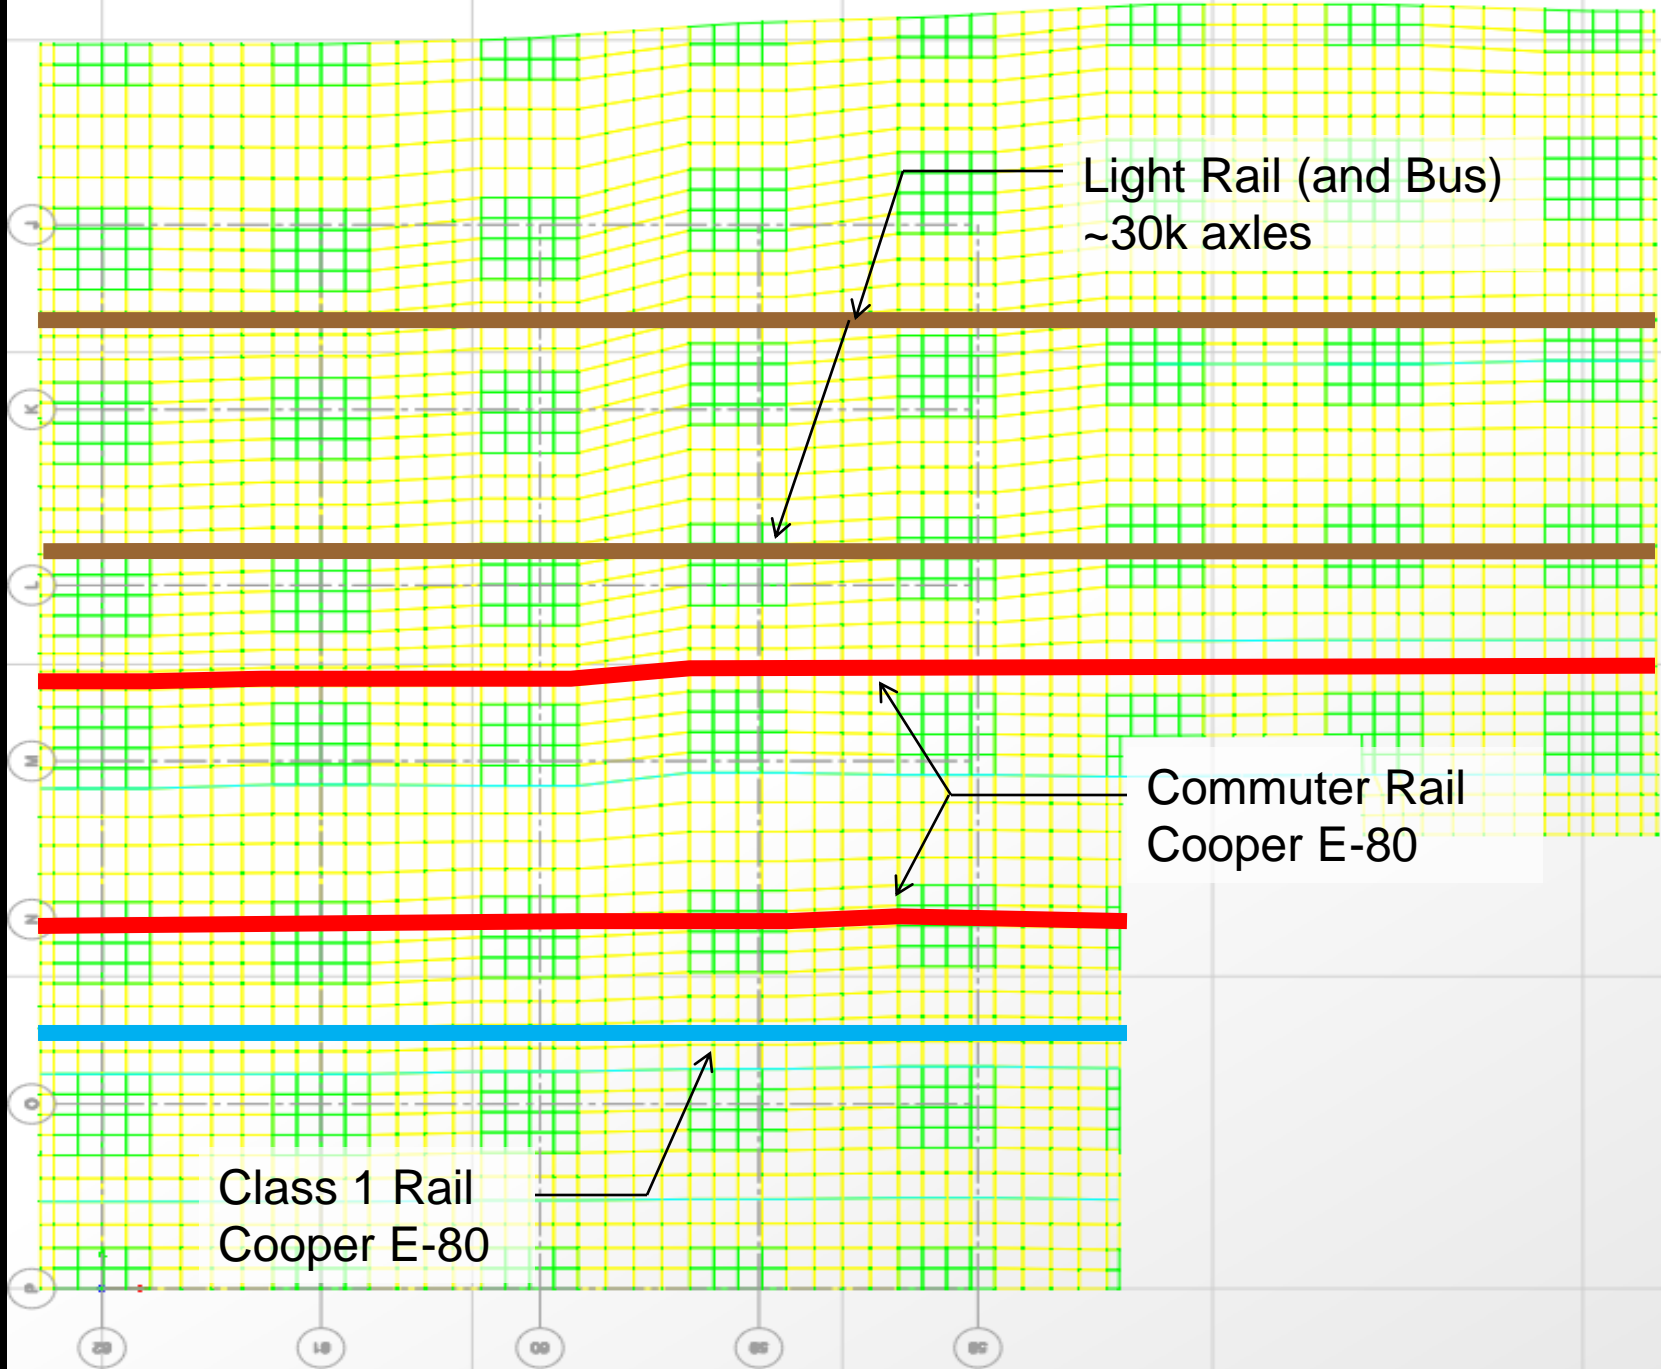
Light Rail (and Bus)  
~30k axles

Commuter Rail  
Cooper E-80

- Deck:
  - Not Cooper E-80, more like E-60
  - Adequate for Amtrak and Commuter Rail
- Columns:
  - Adequate strength
  - Reserve capacity
- No strengthening required
