Restorative Waterproofing for Below Grade Parking Structures

Walt Hanford – Euclid Chemical Company
William Nimis – Karins Engineering Group, Florida

Case Study, La Rive Condominium, Underground Parking Garage

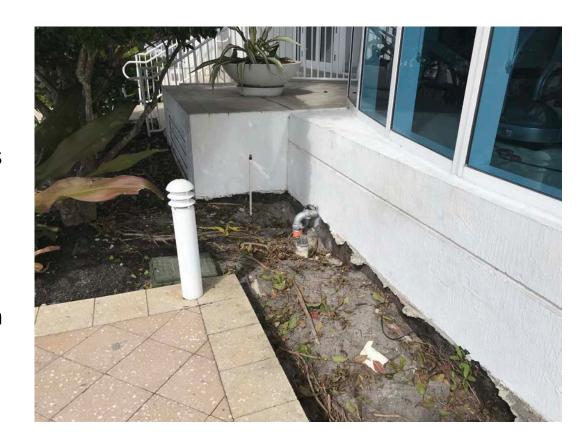
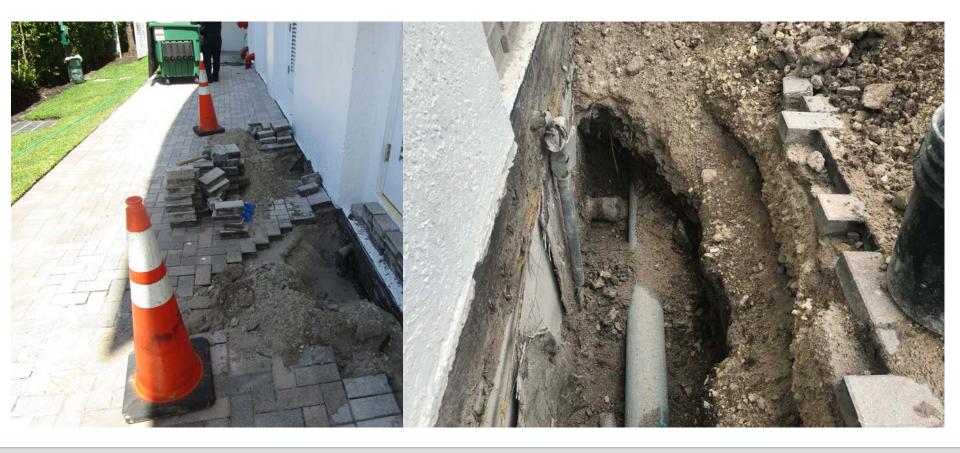
The Below grade exterior waterproofing – bentonite type sheets - no longer servicing the building. Landscaping roots had penetrated and dislodged.

A consultant recommended excavating outside foundation. Installing new waterproofing on the positive side.

Estimated cost: \$3,000,000.

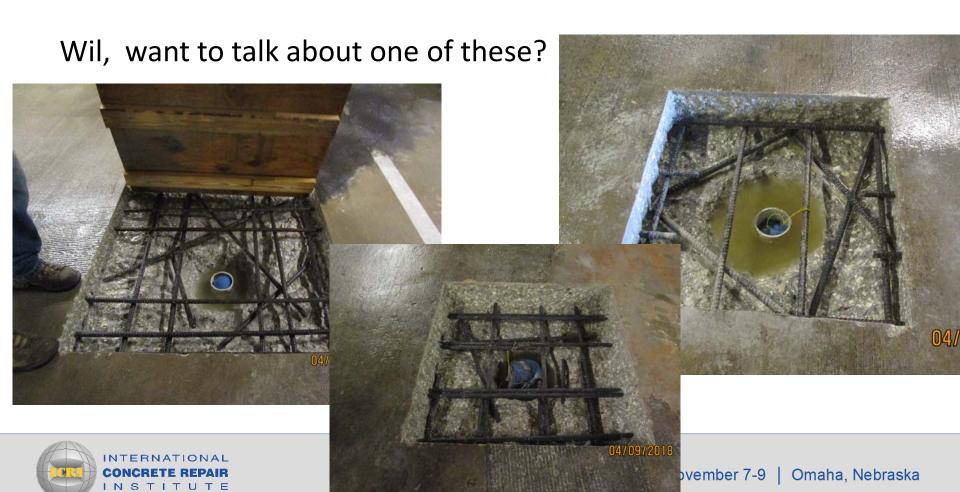
When the water table was high they allowed water to weep into the structure.

At the Floor Wall Interface **Belt & Suspenders solution**

- 1. Urethane injection grouting
- 2. A new channel of mortar that reacts to water and grows crystals to close off pores
- 3. A coating of crystalline waterproofing finished with a protective wear resistant decorative coating

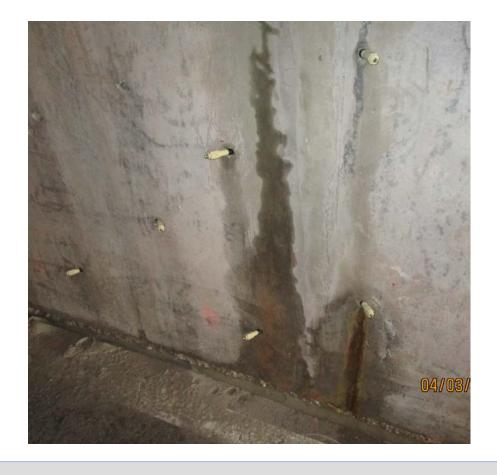
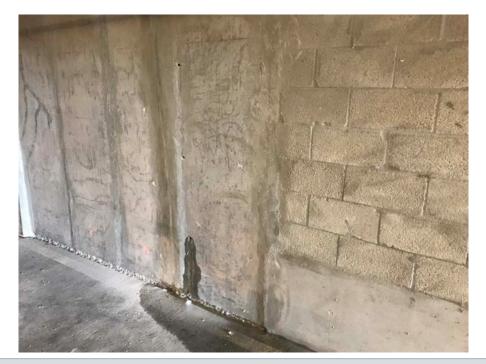
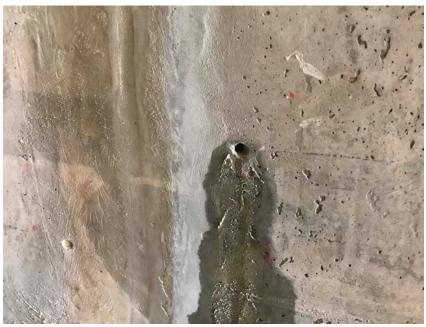
The below grade garage had two distinctly different types of cracks 2. Leaking water wall cracks along <u>form lines</u>

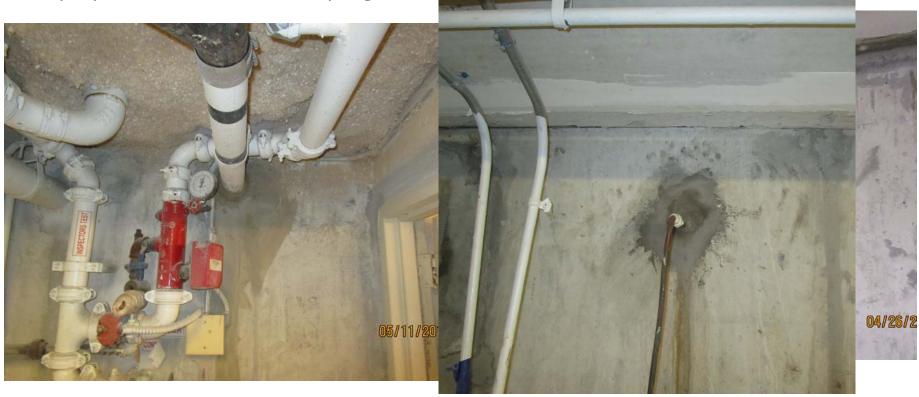
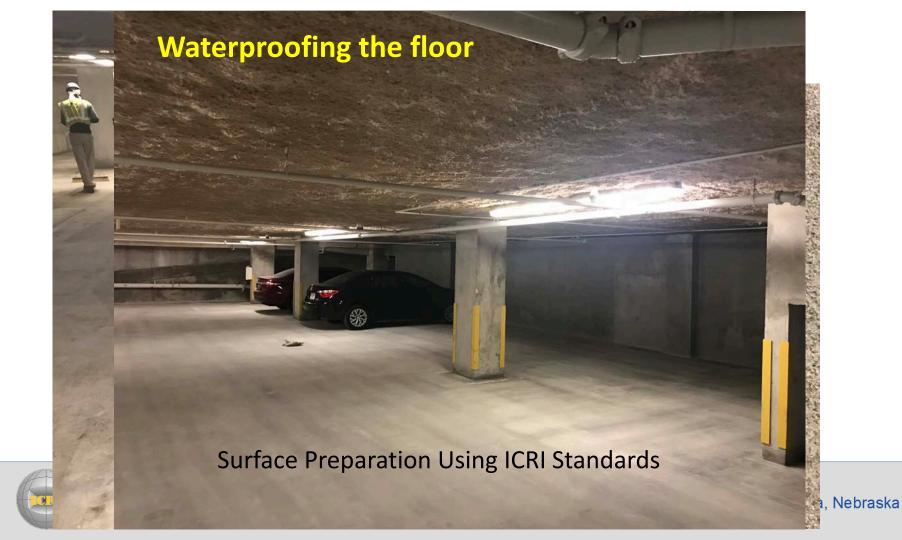
Pipe penetrations sealed up tight.

A breathable cement based waterproofing – applied over the floor to be followed by a durable epoxy and urethane traffic system.

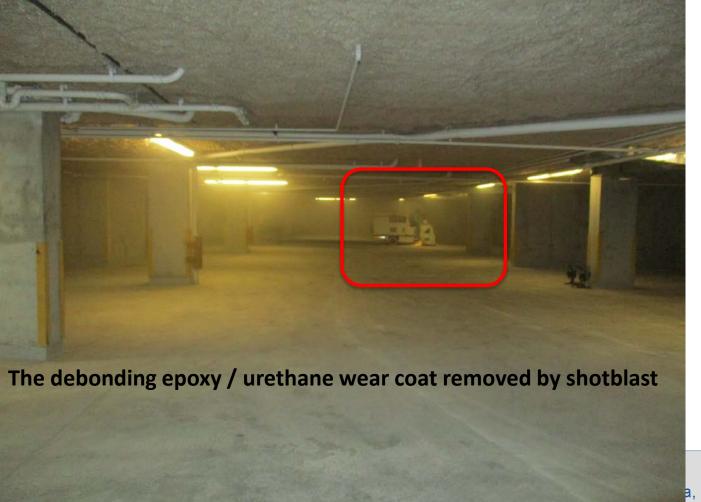
The numbers were very high. MVT Rate of 10 to 20 lbs per 1000 sq. ft. That's huge.

Plan 'B'. Work with the floor's vapor drive Install a breathable system. Ship in new materials.
