Sodium Hypochlorite Storage Area Rehabilitation

Kevin Krawiec, P.E.
Senior Structural Engineer
Corrosion Probe, Inc.
Scituate, Massachusetts

East Shore Water Pollution Abatement Facility

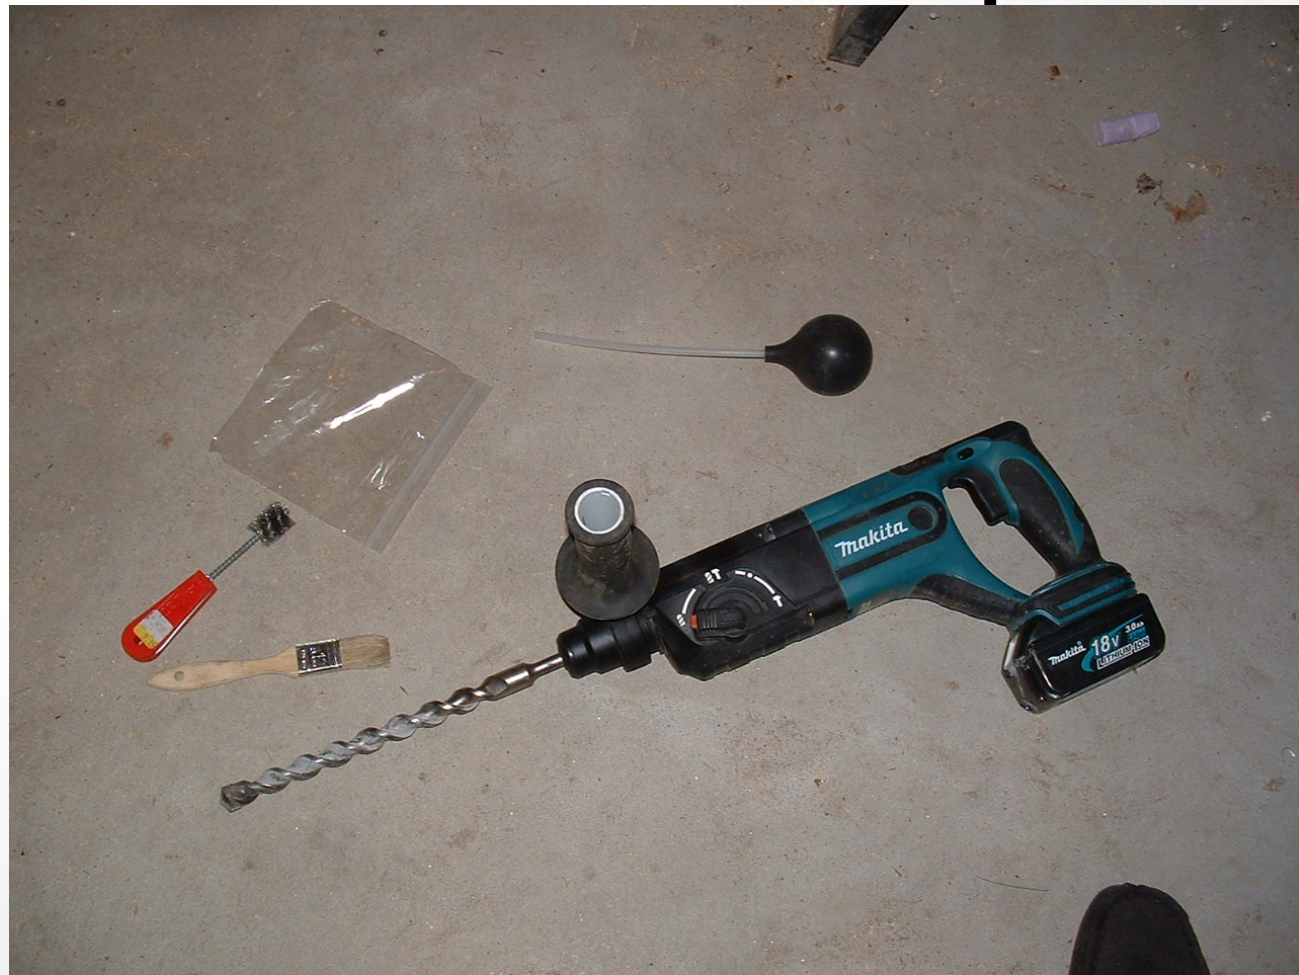
Drilled Powder Samples

- Slab chloride content (% weight of cement):
 - 0.06% minimum
 - 0.90% maximum
- Limit for corrosion prevention (ACI)
 - 0.08% to 0.15%
