Evaluation, Restoration
and Protection of
Sandstone Façade on
a Historic Building –
The Boston Building
Denver, CO

Presenter: Leo Whiteley

ICRI 2016 Spring Convention / March 17, 2016
San Juan, Puerto Rico

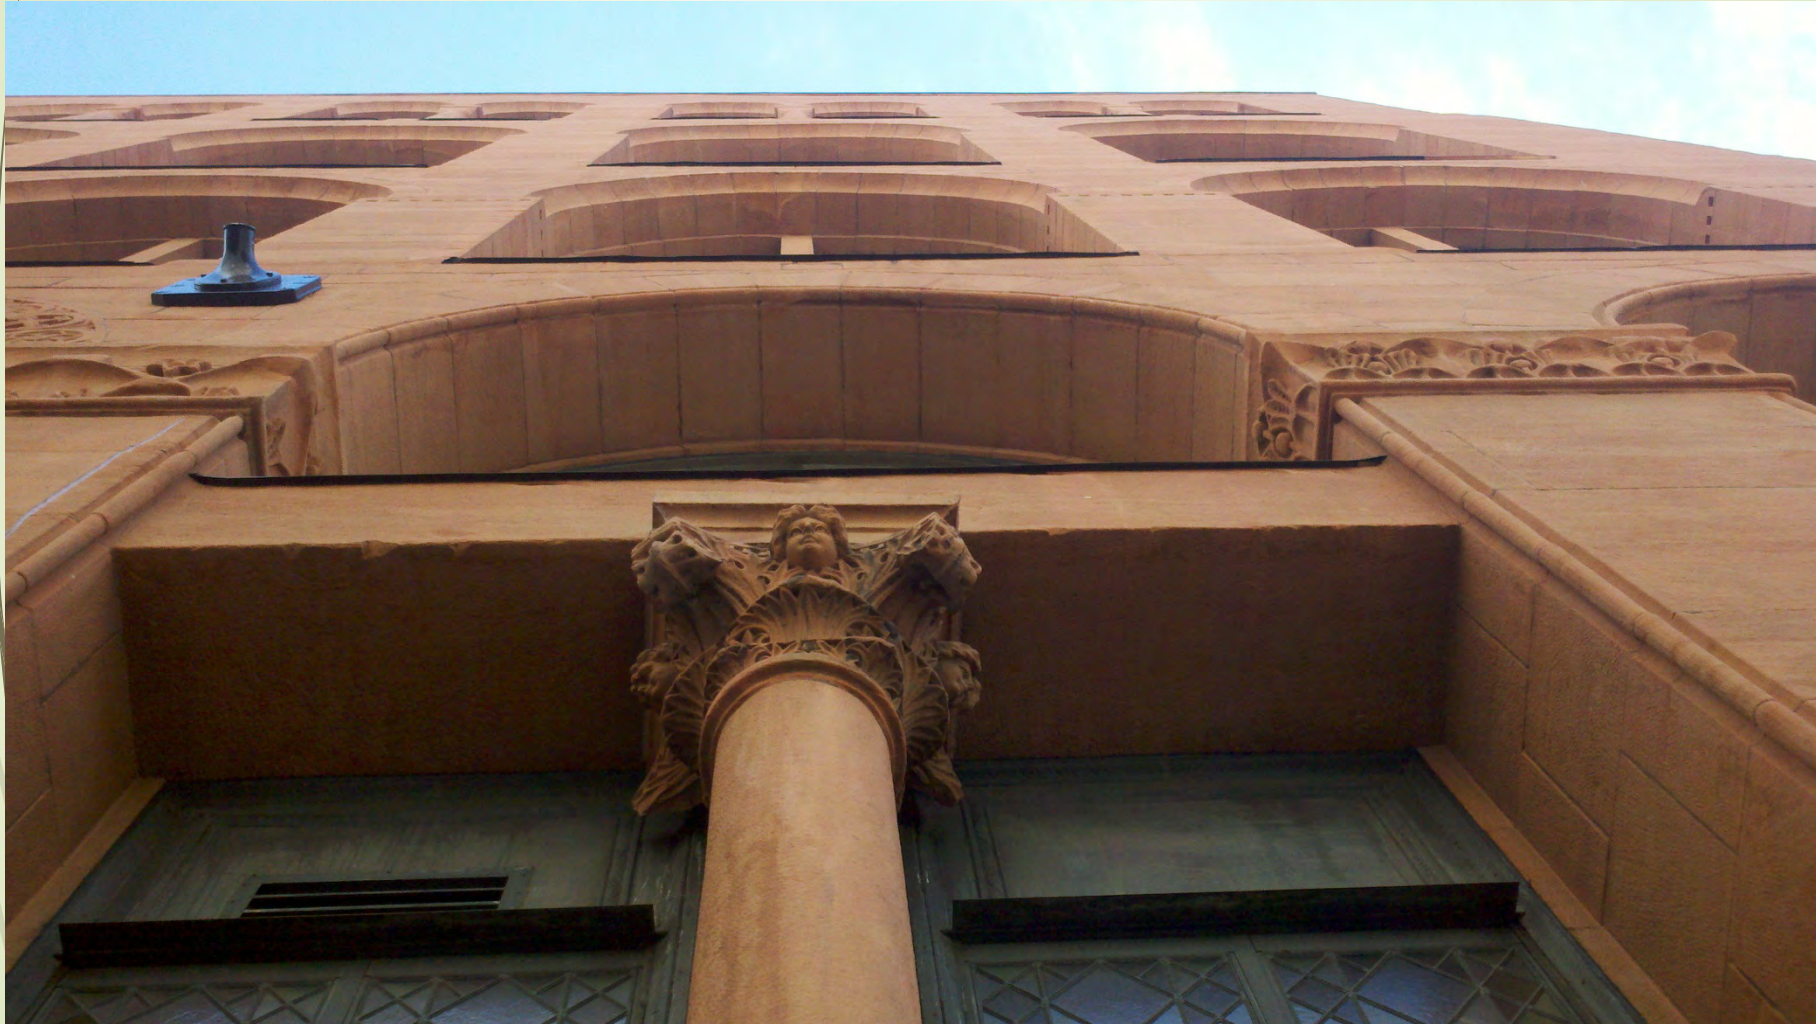
Sandstone Lintels and Arches

- Structure is wood floor joists, supported by wood and steel beams at the interior and supported by masonry bearing walls on the exterior.
- Exterior walls are solid sandstone blocks stacked up to 4'-0" thick, with individual blocks ranging from 2'-0" thick at the base to 5" thick at the parapet
- Solid sandstone lintels or sandstone block arches are spanning all exterior window/door openings

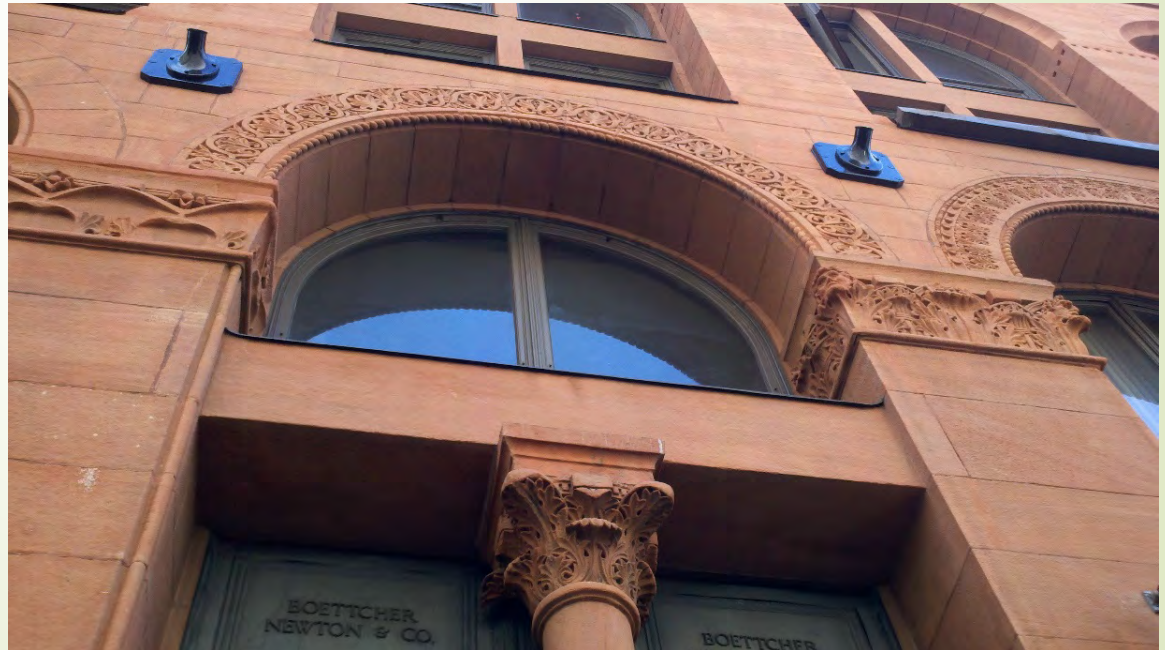
- Greenlee Sandstone was quarried near Manitou Springs, Colorado
- Stone: Soft, medium grained red sandstone with iron oxide material properties

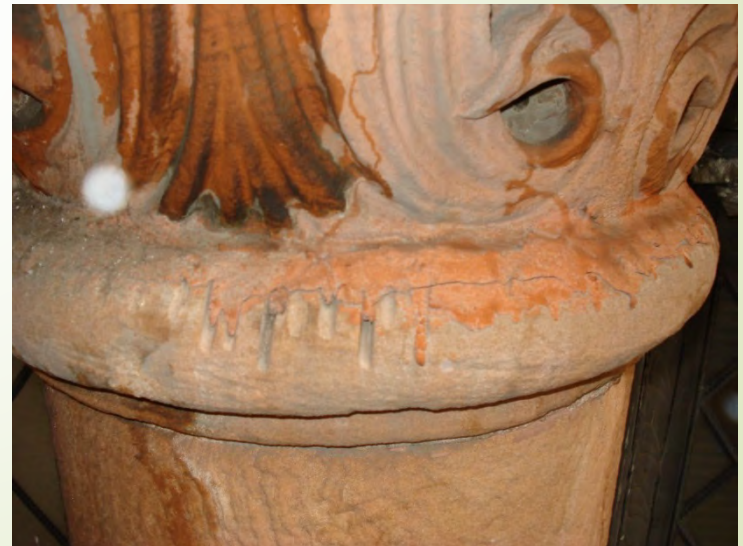
- Iron oxide is the prominent binding material in this type of sandstone which creates the warm red color
- Oxidation (rusting) of the iron in the stone has caused disintegration, and a loss of the cohesive binder.
- Material testing revealed that this stone is very absorbent, making it susceptible to saturation and freeze thaw damage.

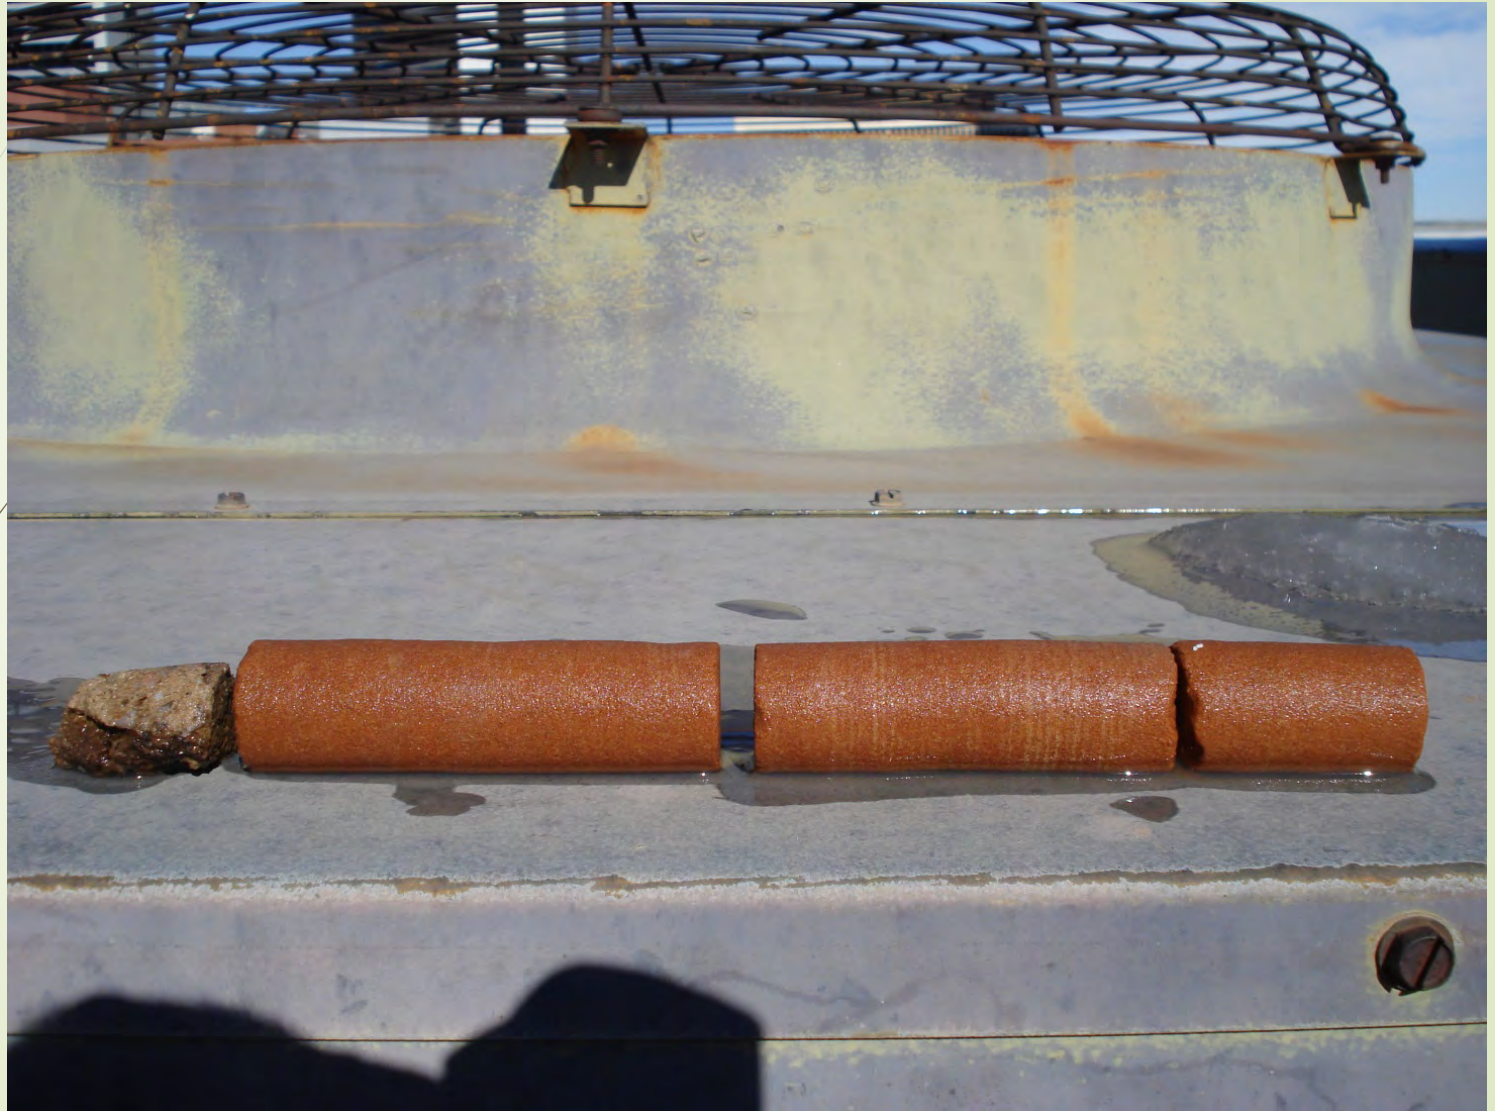
Cored Sandstone Samples

- Freeze/Thaw action
- 6.3% absorption characteristic holds water
- Ledges and detailed pieces suffer most damage due to collection of water
