Thomas L. Rewerts, SE  
THOS. REWERTS & CO., LLC  
Kansas City, MO  
[t.rewerts@rewerts.com](mailto:t.rewerts@rewerts.com)

**Complex and Innovative Structural Repair  
of Severely Damaged, 1917 era School Structures**

**Structural Repairs**  
 Phase II: Concrete Floor System Repairs  
 Allison Traditional Magnet Middle School  
 221 S. Street - White, Kansas

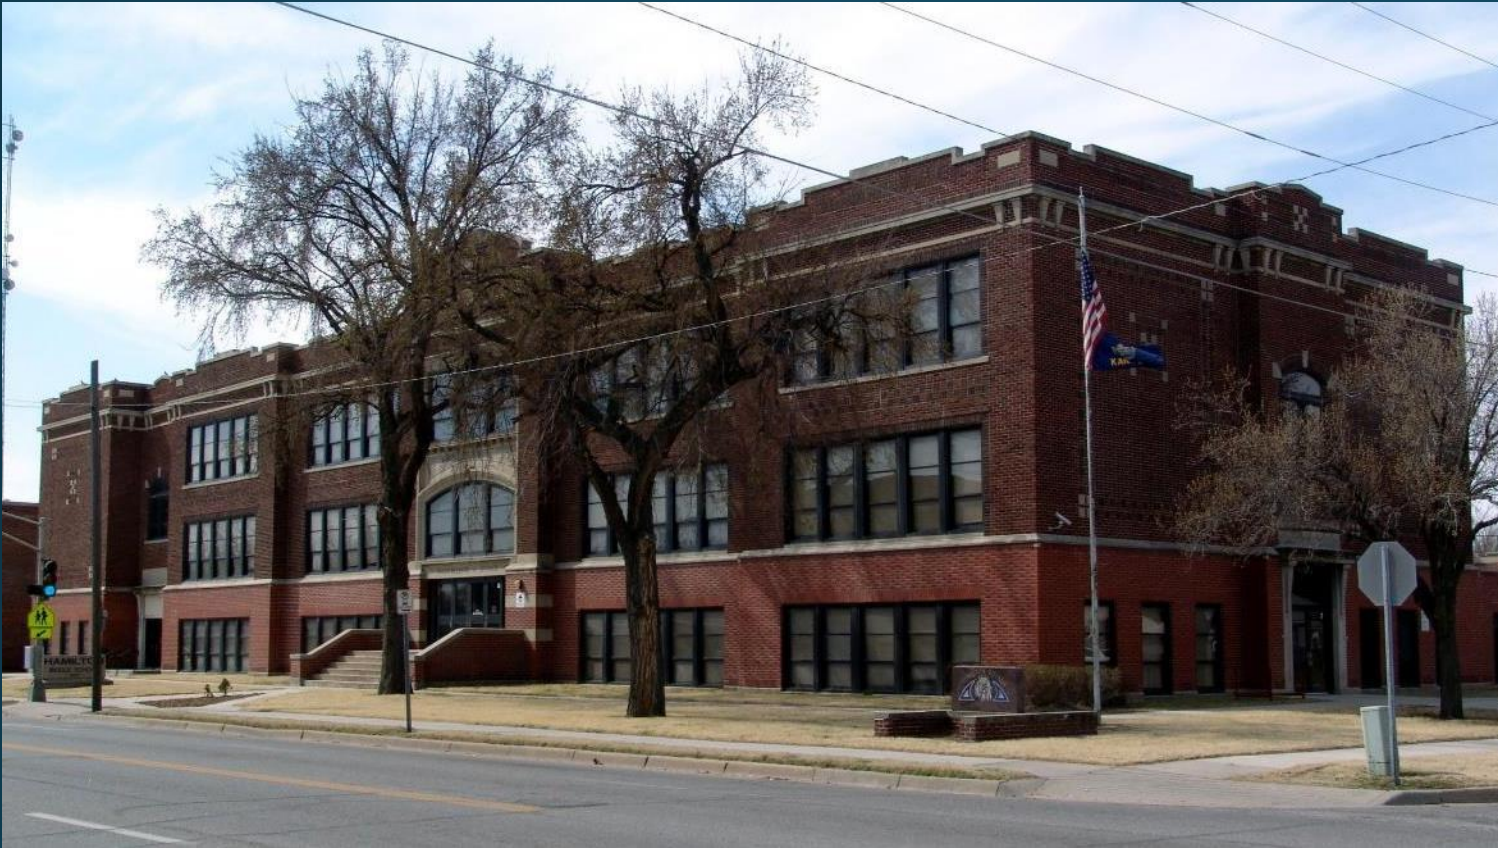
A comprehensive renovation of two existing, 1917-era concrete-framed, historic school buildings in a Midwestern city resulted in serious structural problems.

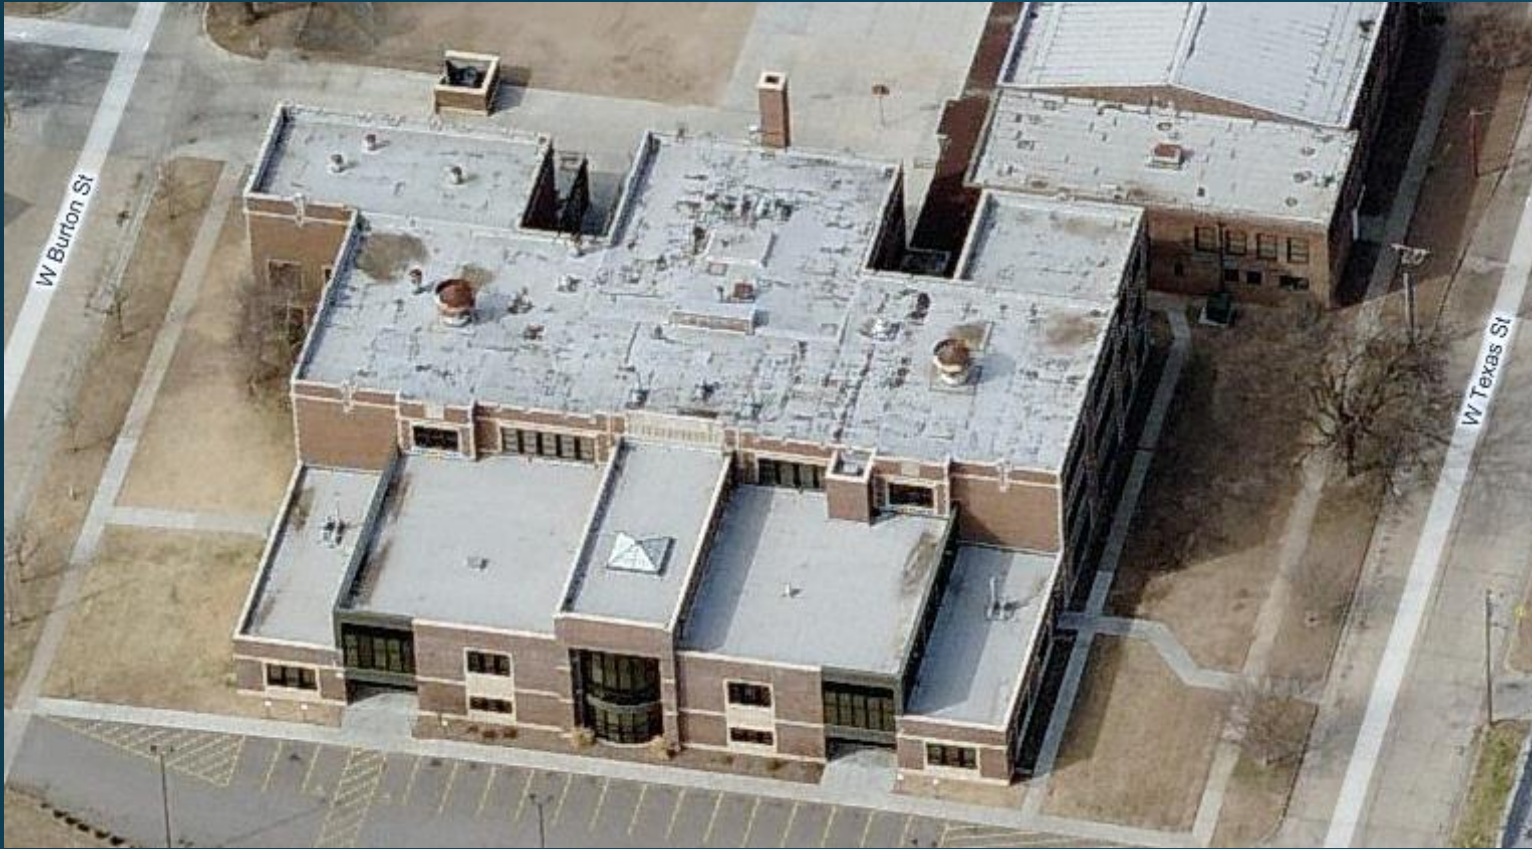
The structural problems were severe enough to require evacuation and complete closure of one of the buildings, and portions of the other, until comprehensive structural repairs could be made.

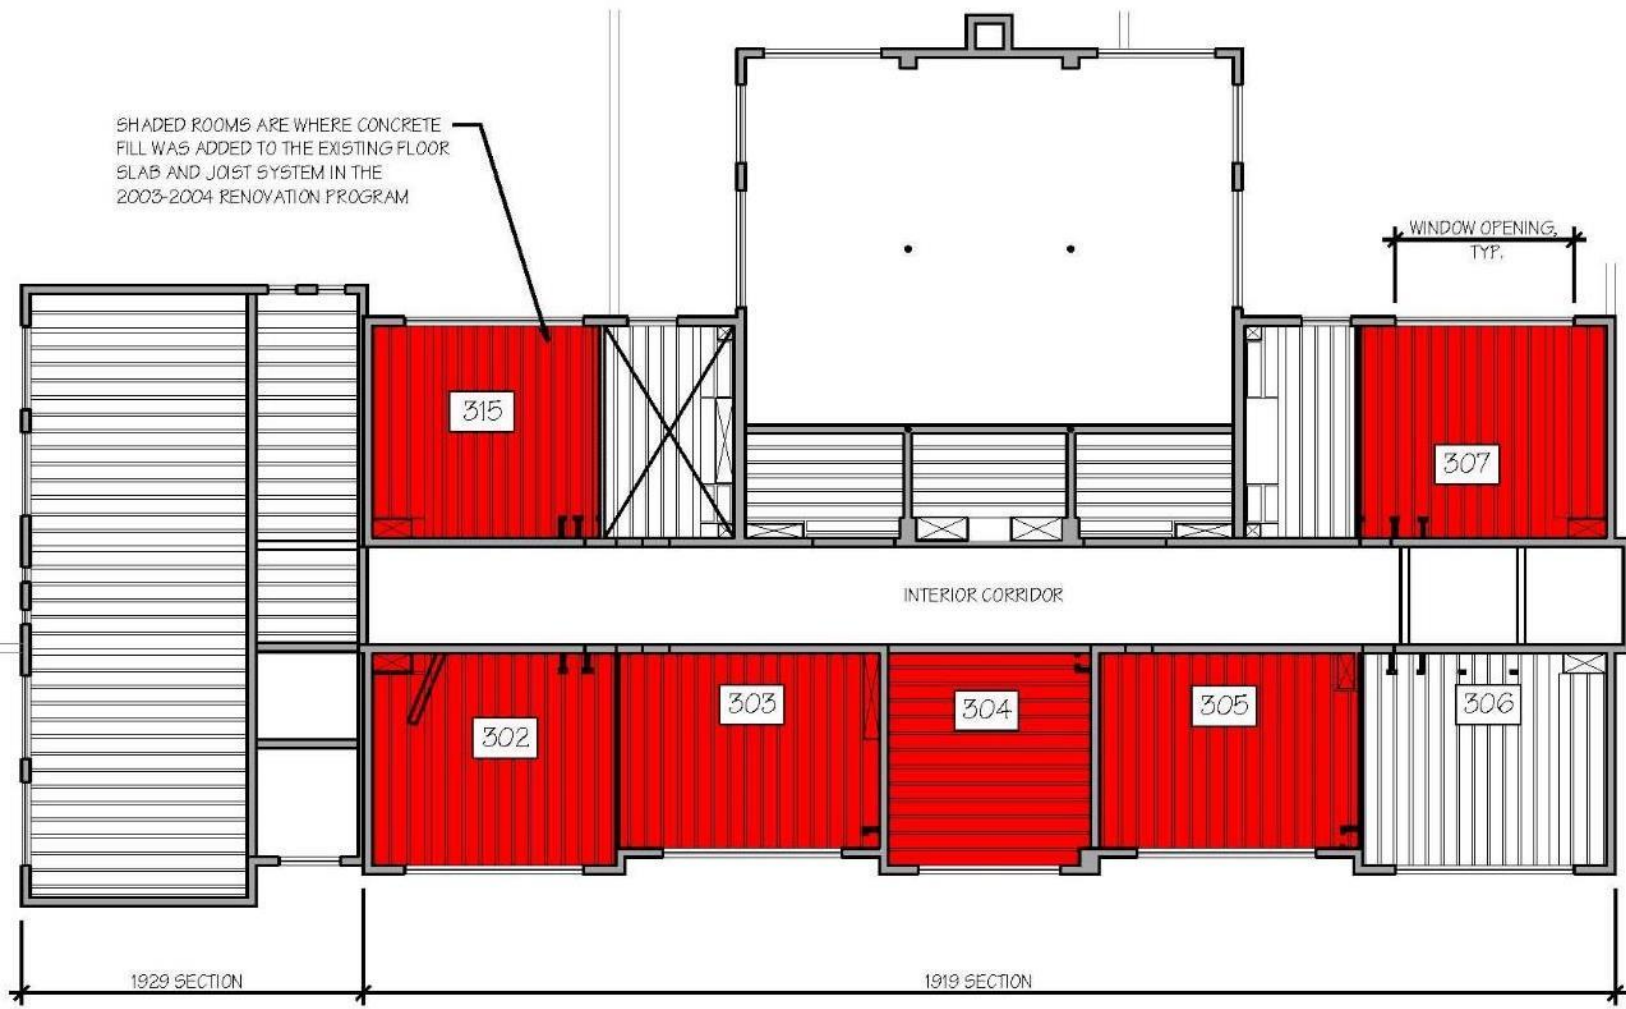
Third Floor Plan  
Not To Scale

SHADED ROOMS ARE WHERE CONCRETE FILL WAS ADDED TO THE EXISTING FLOOR SLAB AND JOIST SYSTEM IN THE 2003-2004 RENOVATION PROGRAM

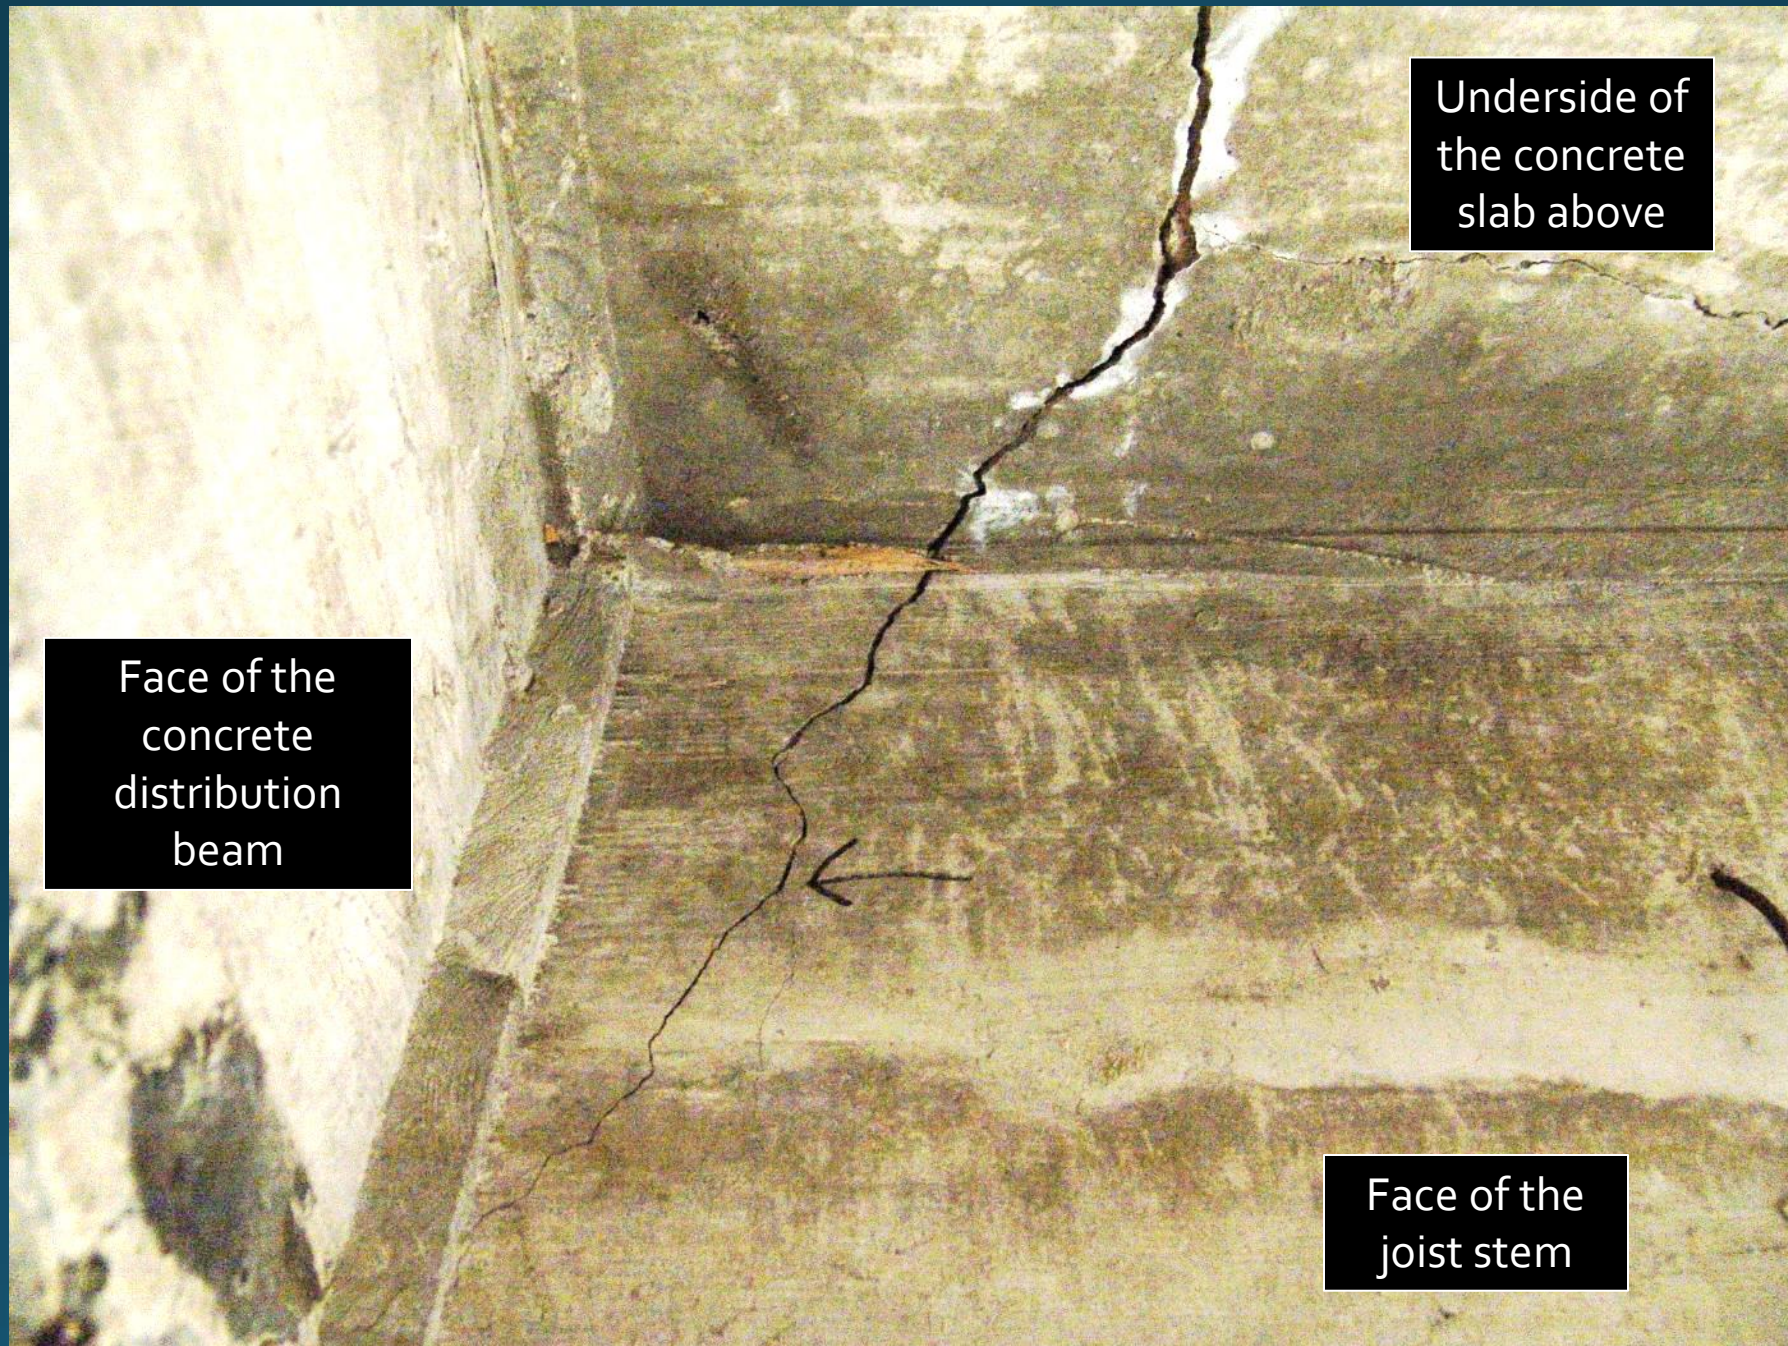
Underside of  
the concrete  
slab above

Face of the  
concrete  
distribution  
beam

Face of the  
joist stem

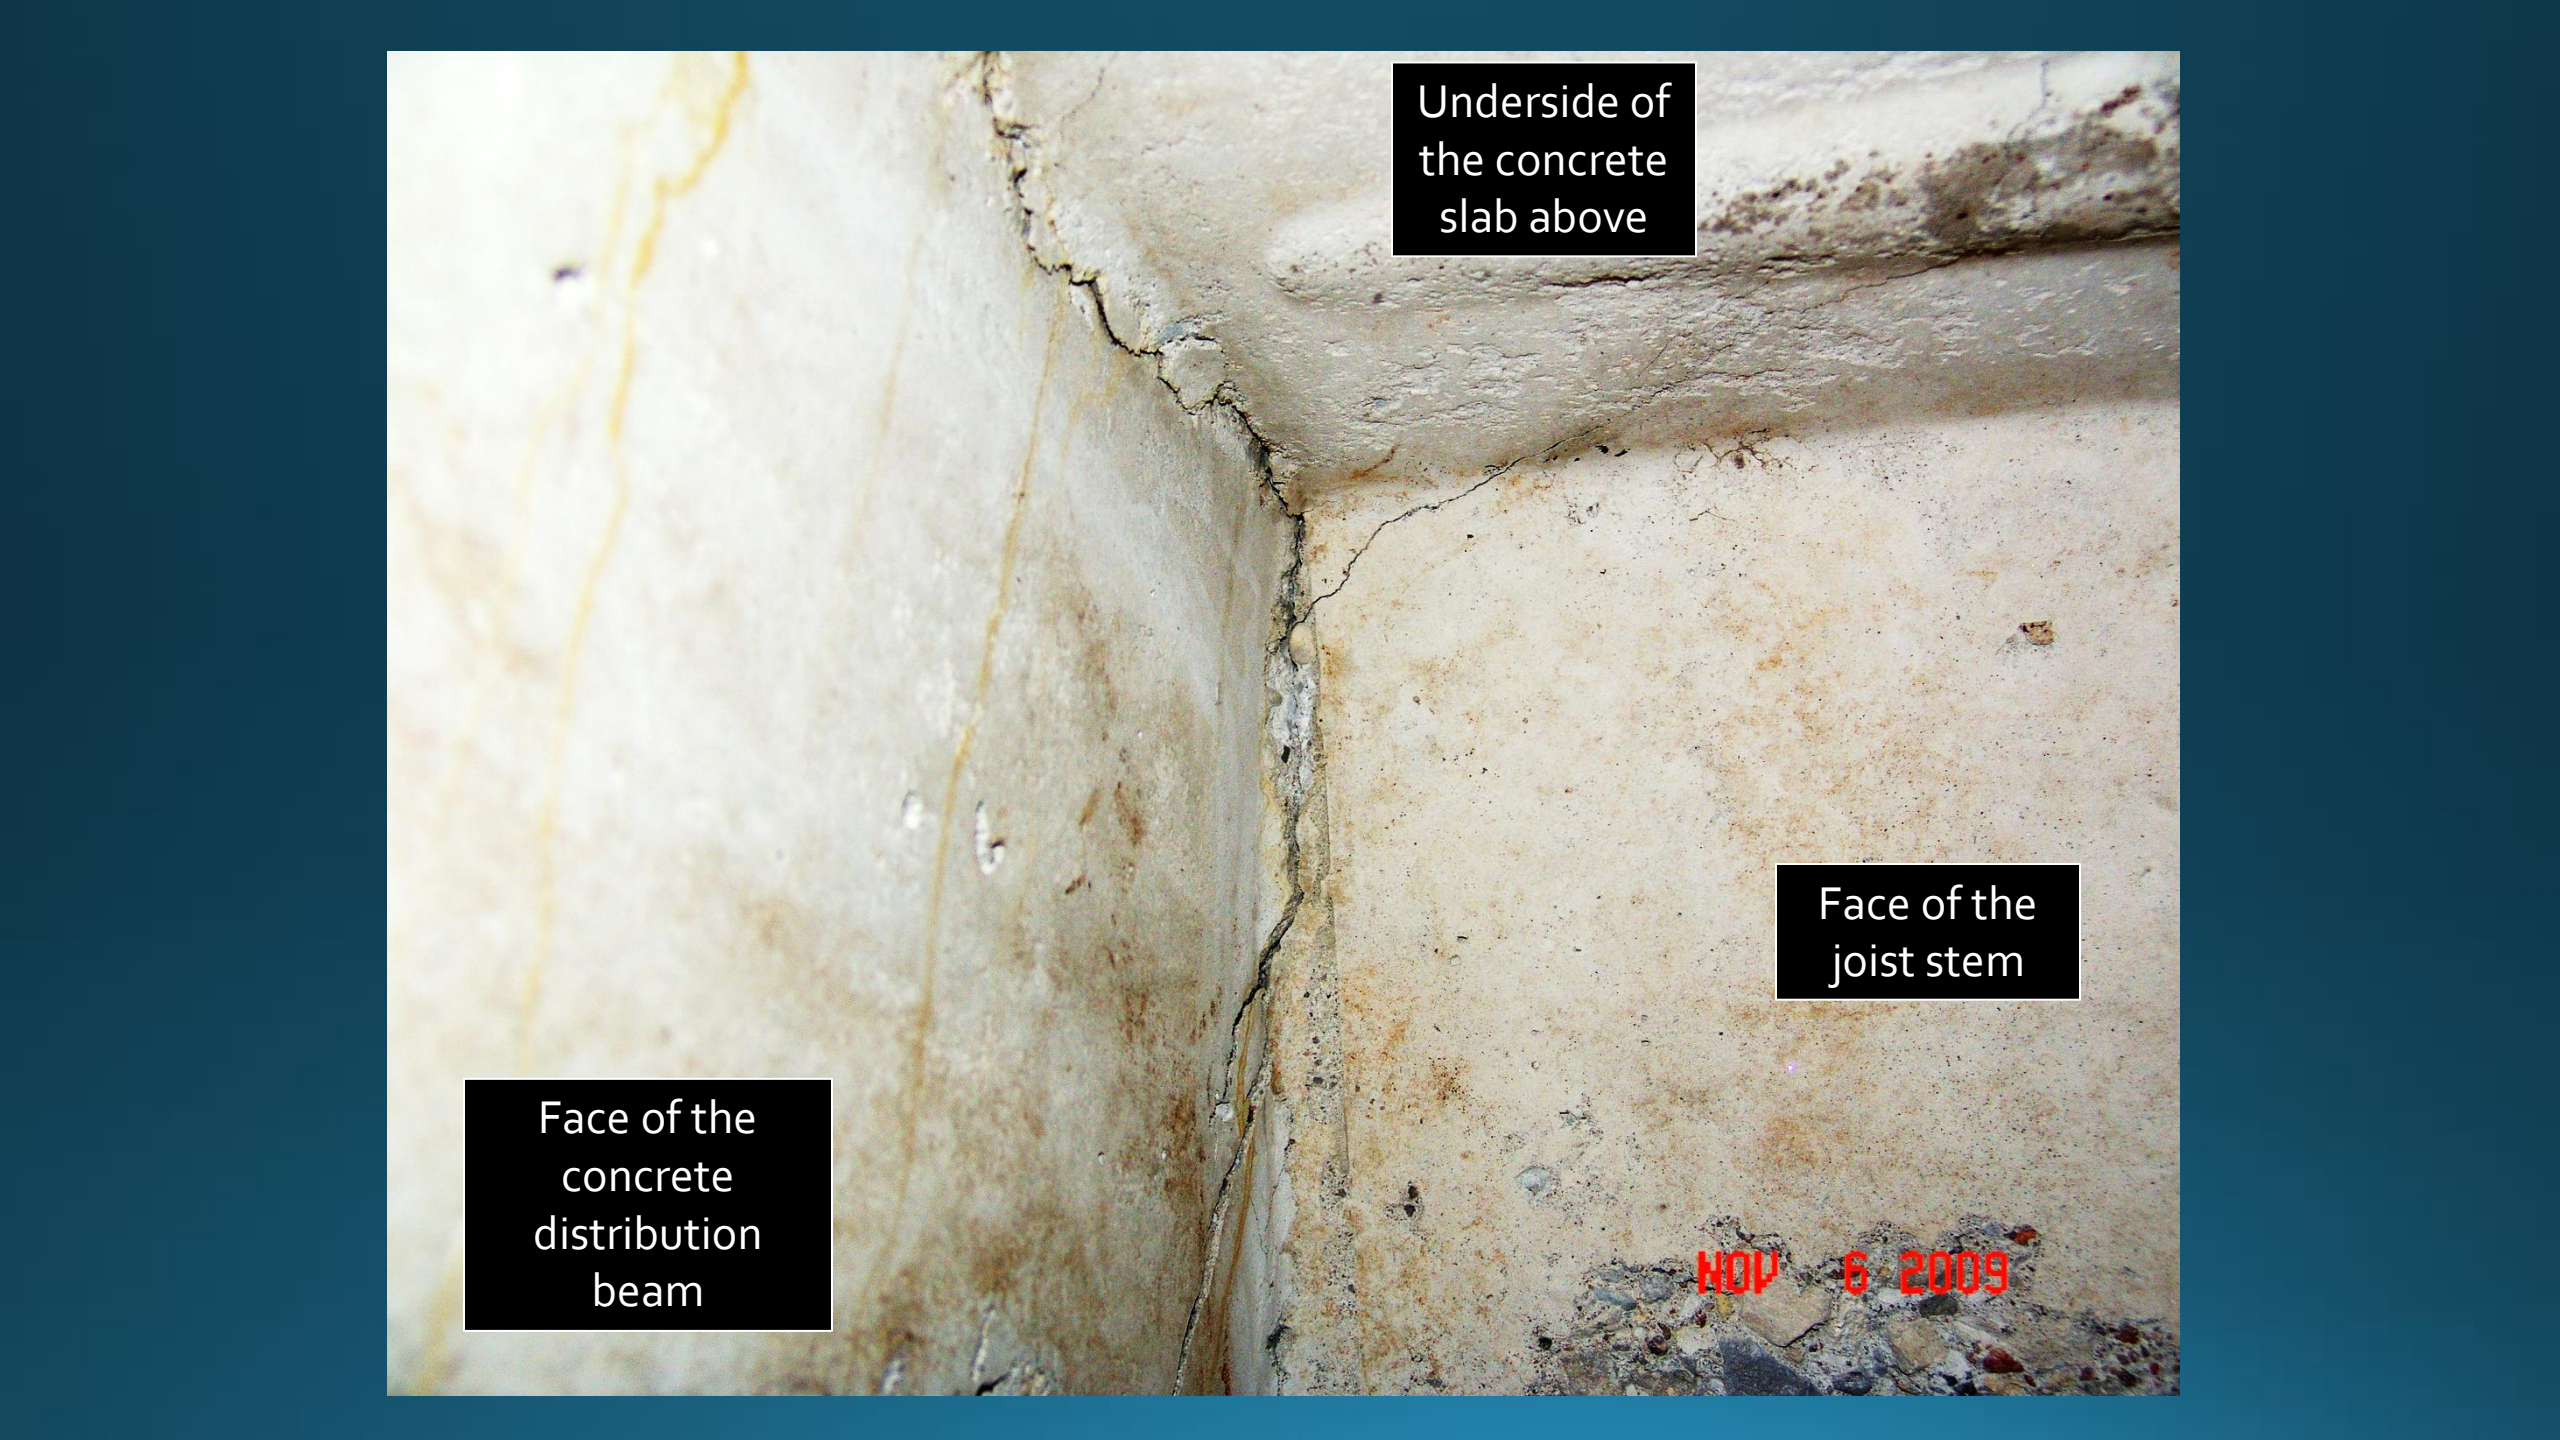
Underside of  
the concrete  
slab above

Face of the  
joist stem

Face of the  
concrete  
distribution  
beam

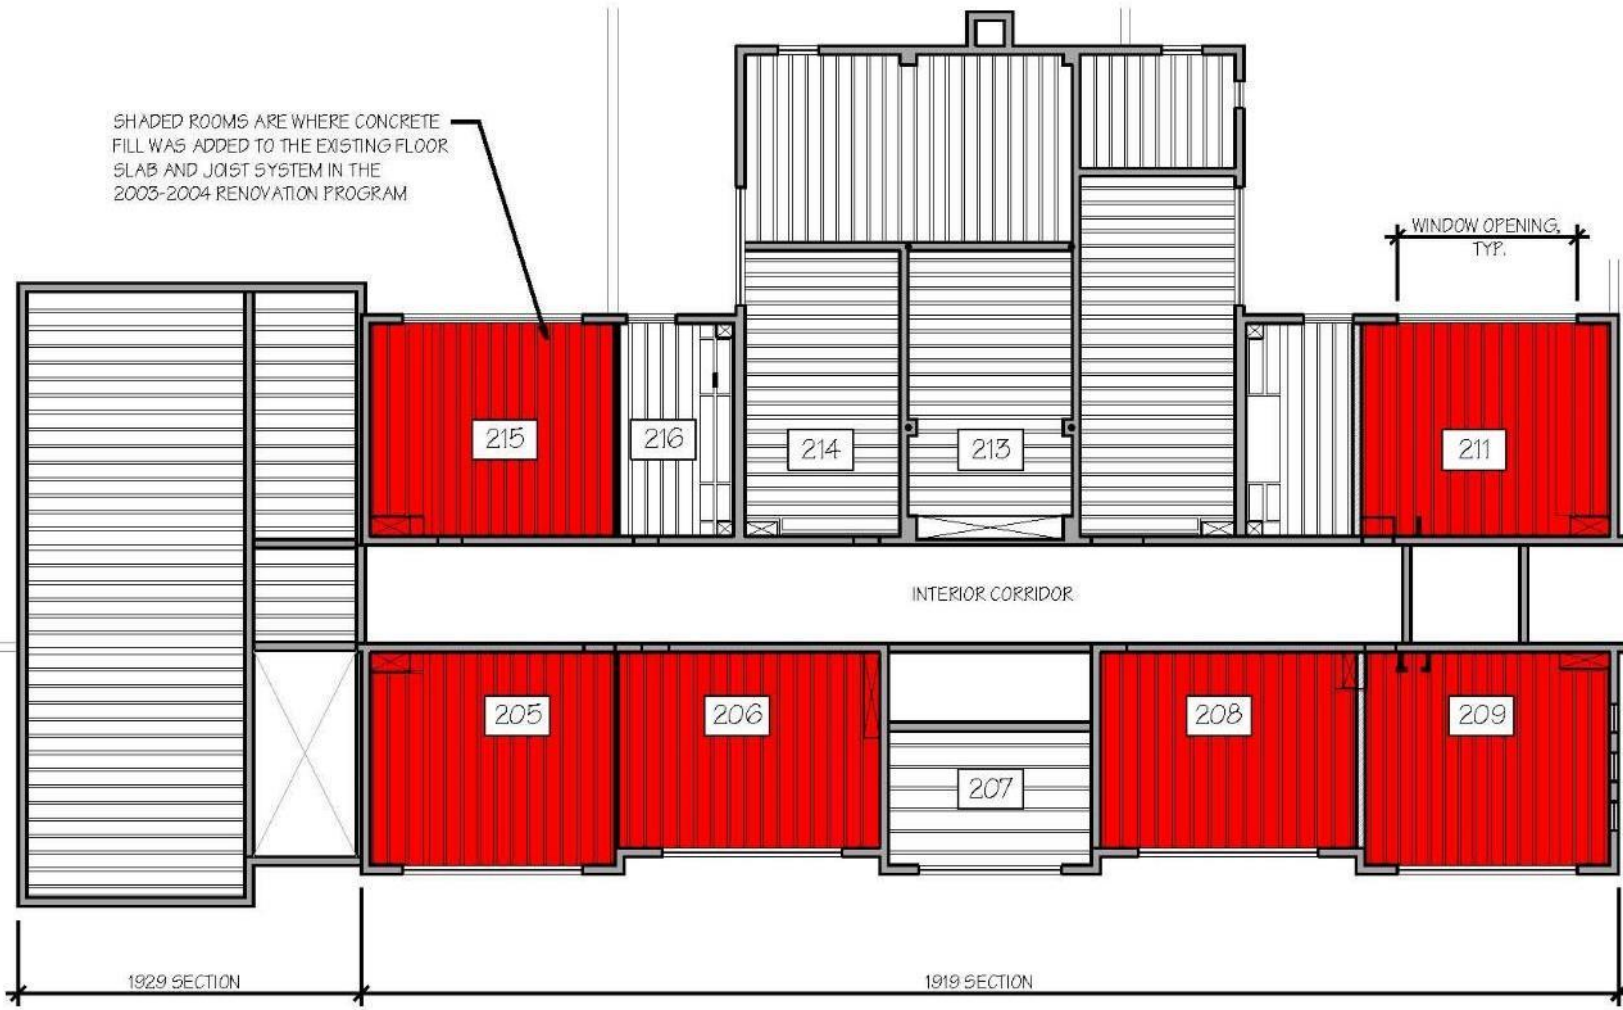
**Second Floor Structural Framing Plan**

SHADED ROOMS ARE WHERE CONCRETE FILL WAS ADDED TO THE EXISTING FLOOR SLAB AND JOIST SYSTEM IN THE 2003-2004 RENOVATION PROGRAM

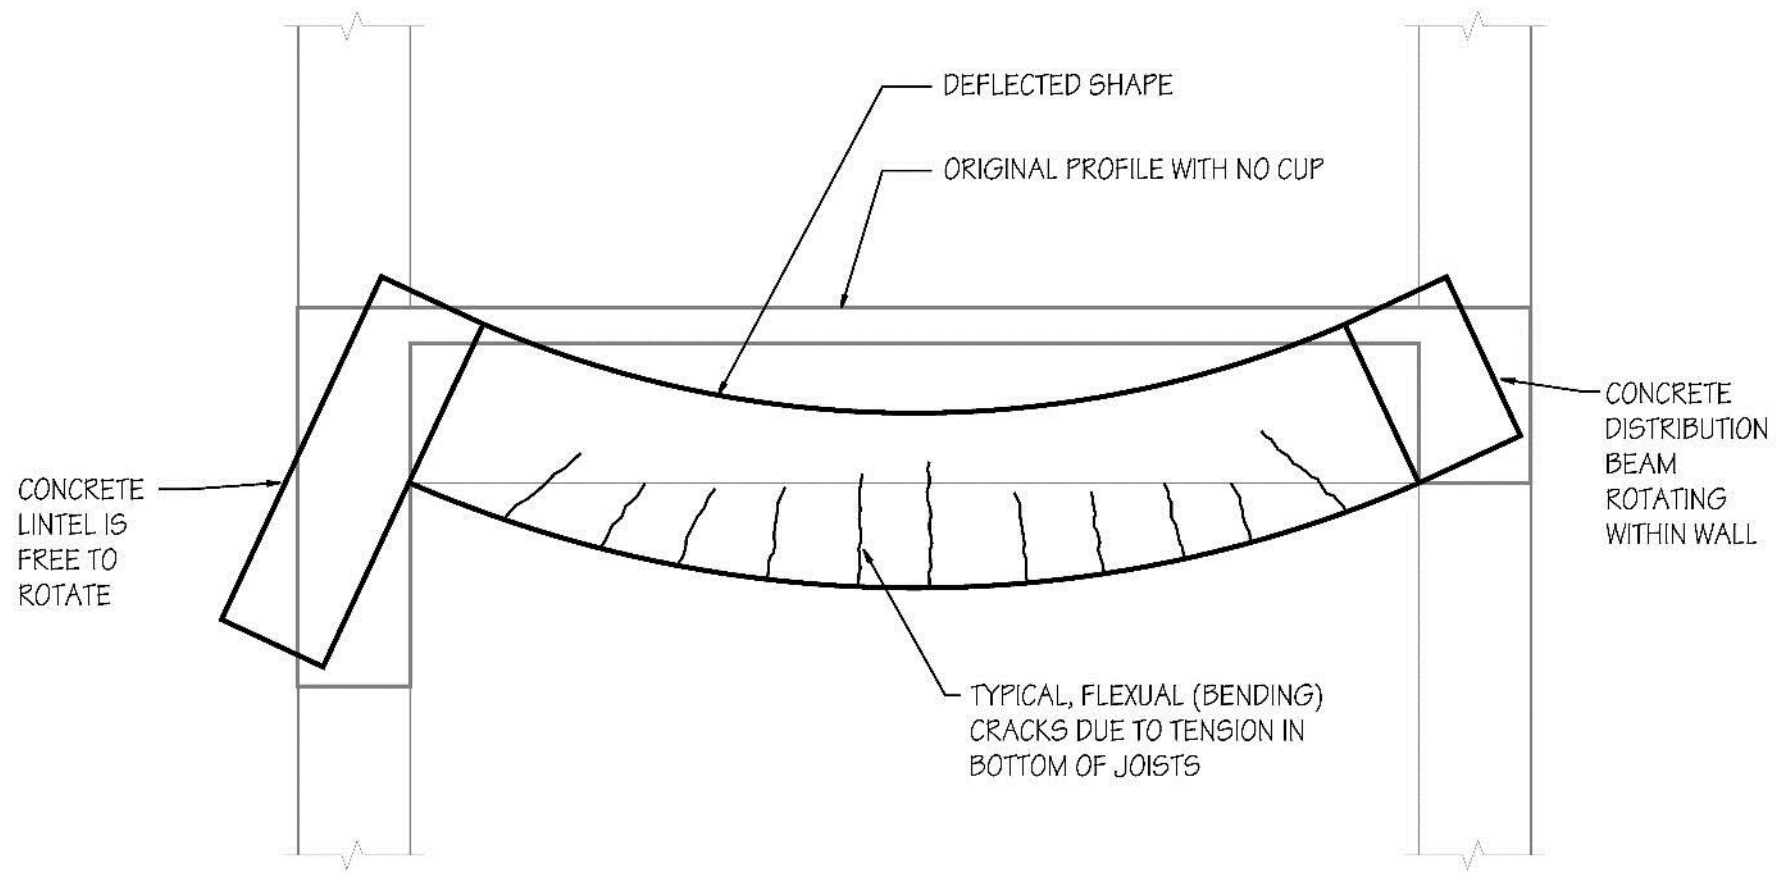
**Cross Section Thru The Typical Concrete Floor Slab & Joist System Illustration Simple Span Behavior**

Load bearing,  
structural clay tile  
interior corridor wall

*Typical interior joist  
framing into window lintel*

Concrete lintel over  
windows, with  
masonry above

Load bearing, brick  
masonry and structural  
clay tile exterior wall

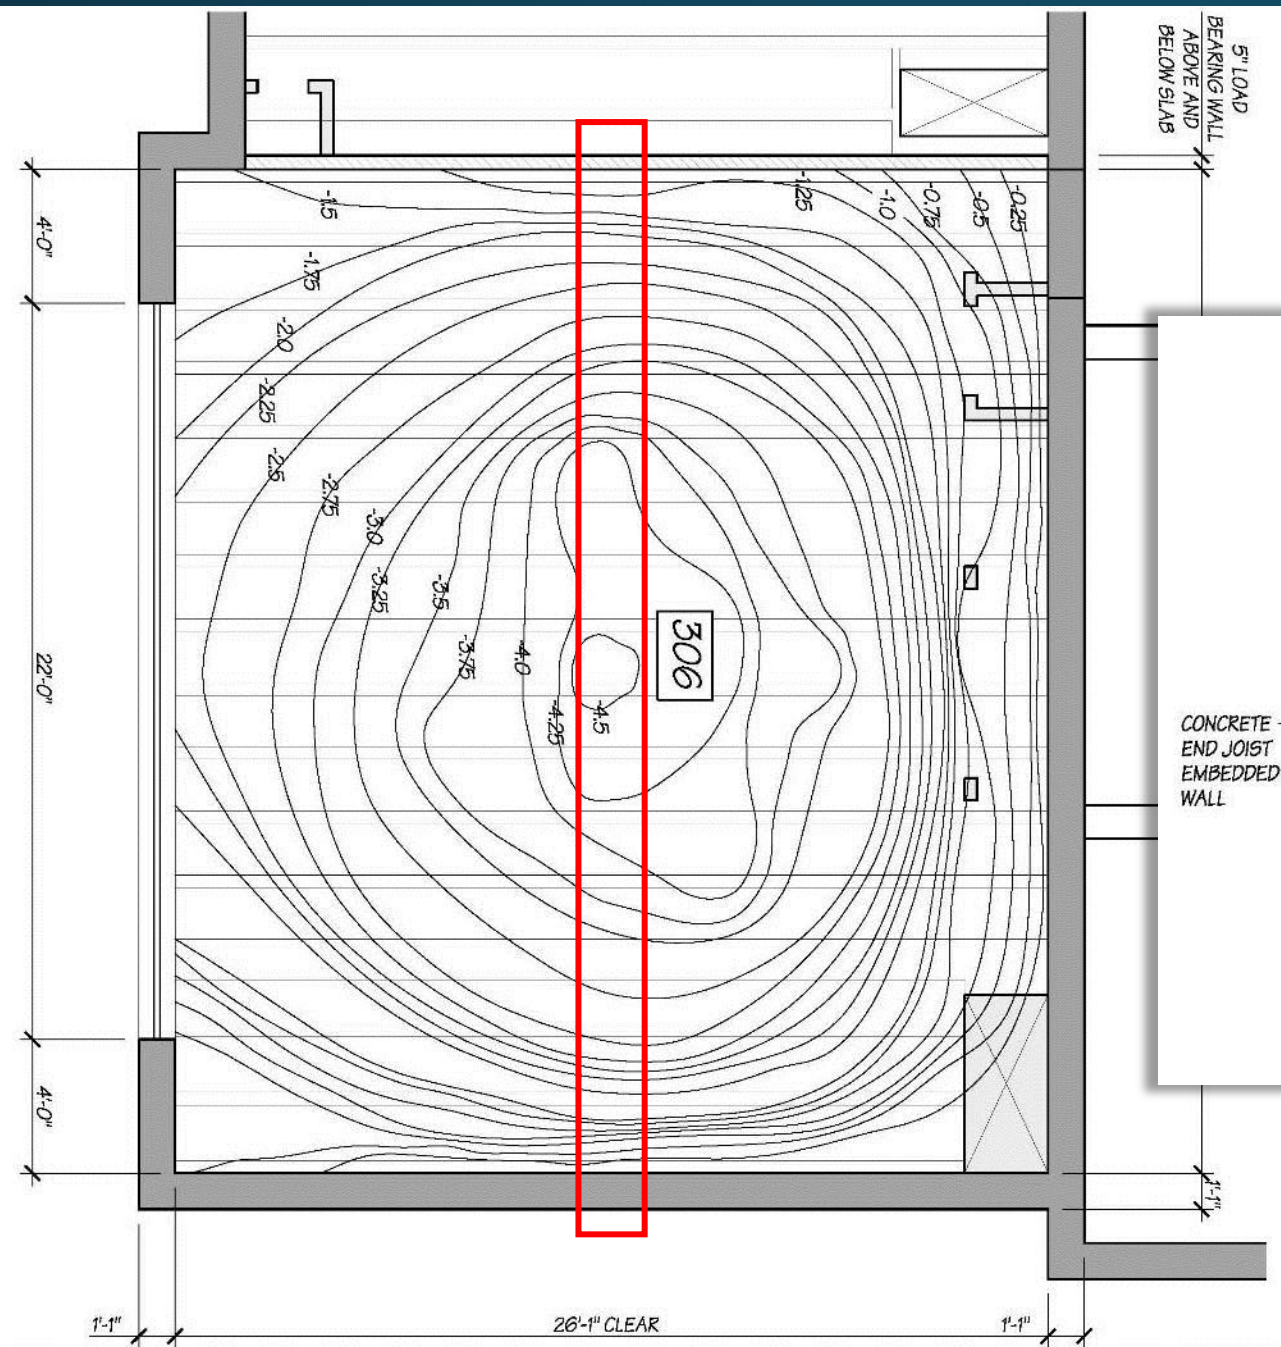
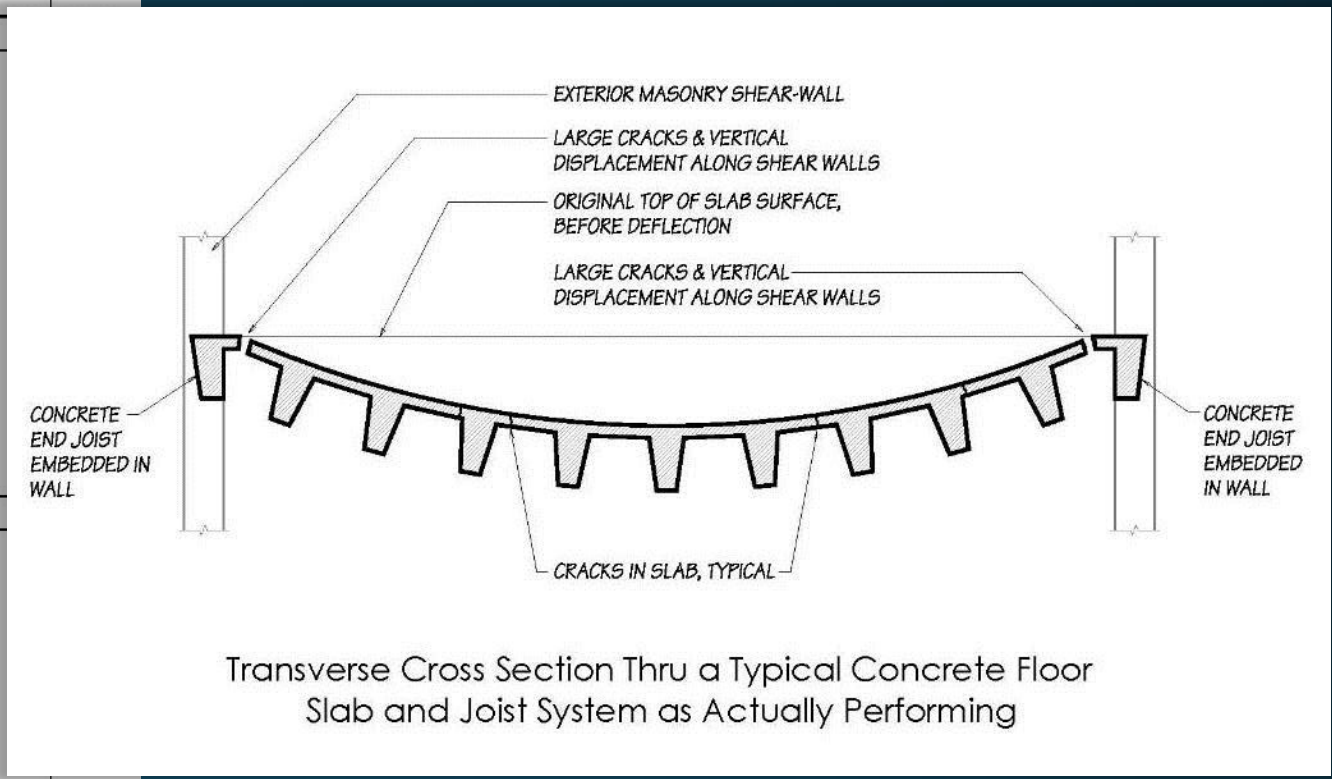
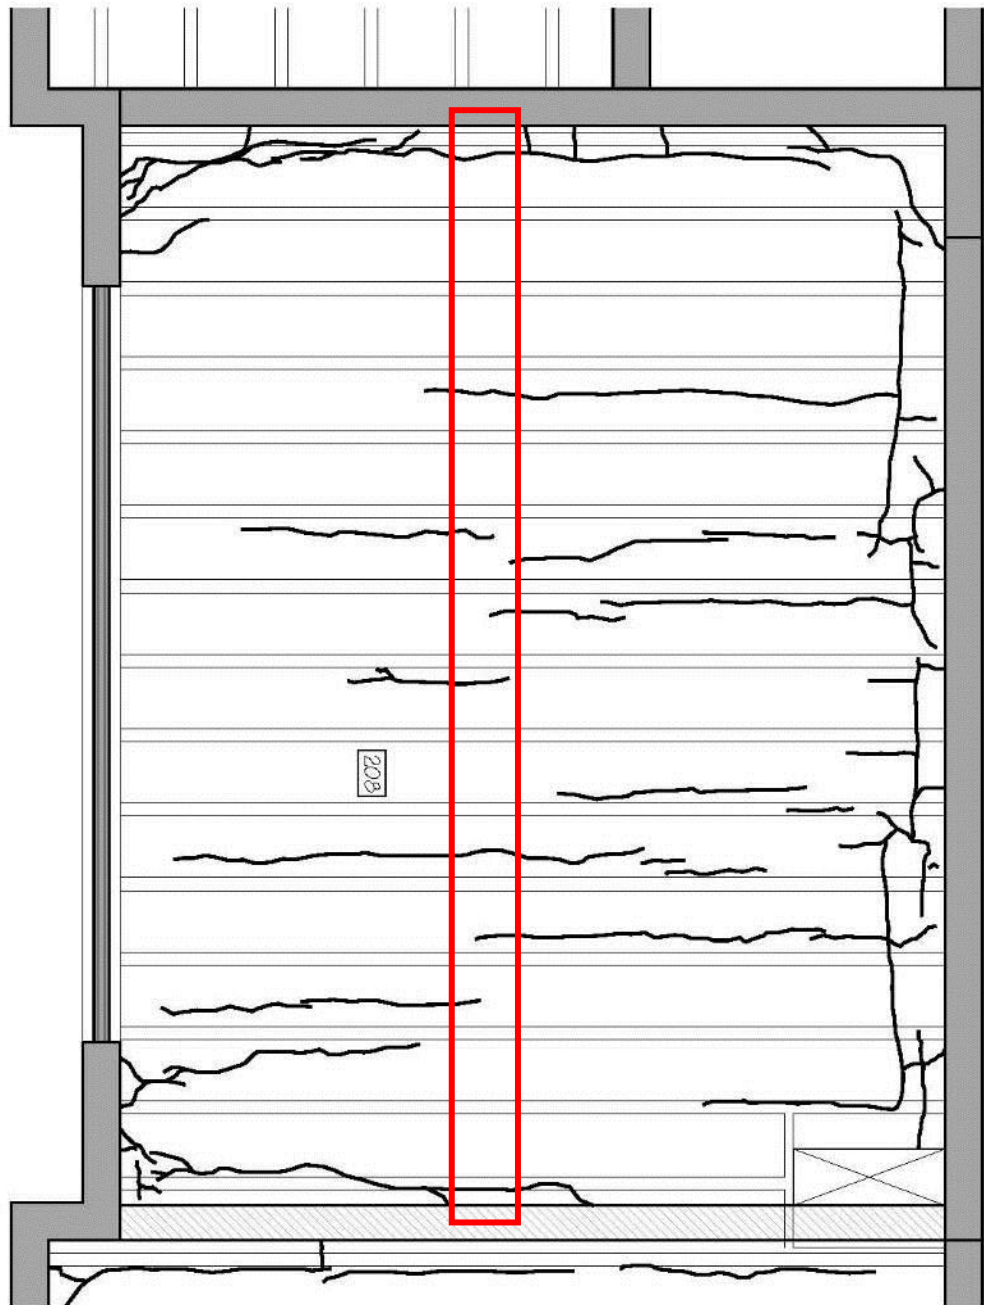
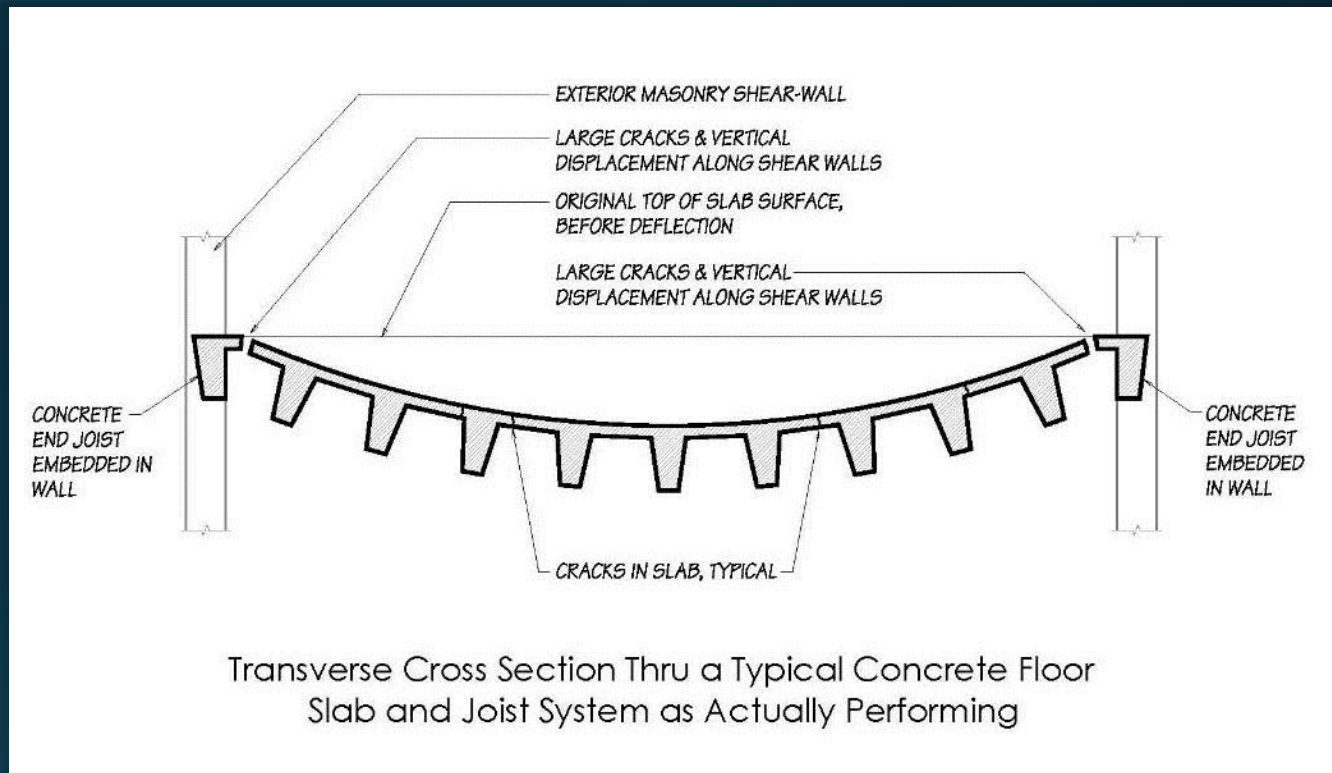
Cross Section Thru Concrete Floor Slab & Joist System Illustrating the Actual Behavior in This Building (Away From Window Locations)
