Thomas L. Rewerts, SE  
THOS. REWERTS & CO., LLC  
Kansas City, MO  
[t.rewerts@rewerts.com](mailto:t.rewerts@rewerts.com)

**Complex and Innovative Structural Repair  
of Severely Damaged, 1917 era School Structures**

**Structural Repairs**  
 Phase II: Concrete Floor System Repairs  
 Allison Traditional Magnet Middle School  
 221 S. Street - White, Kansas

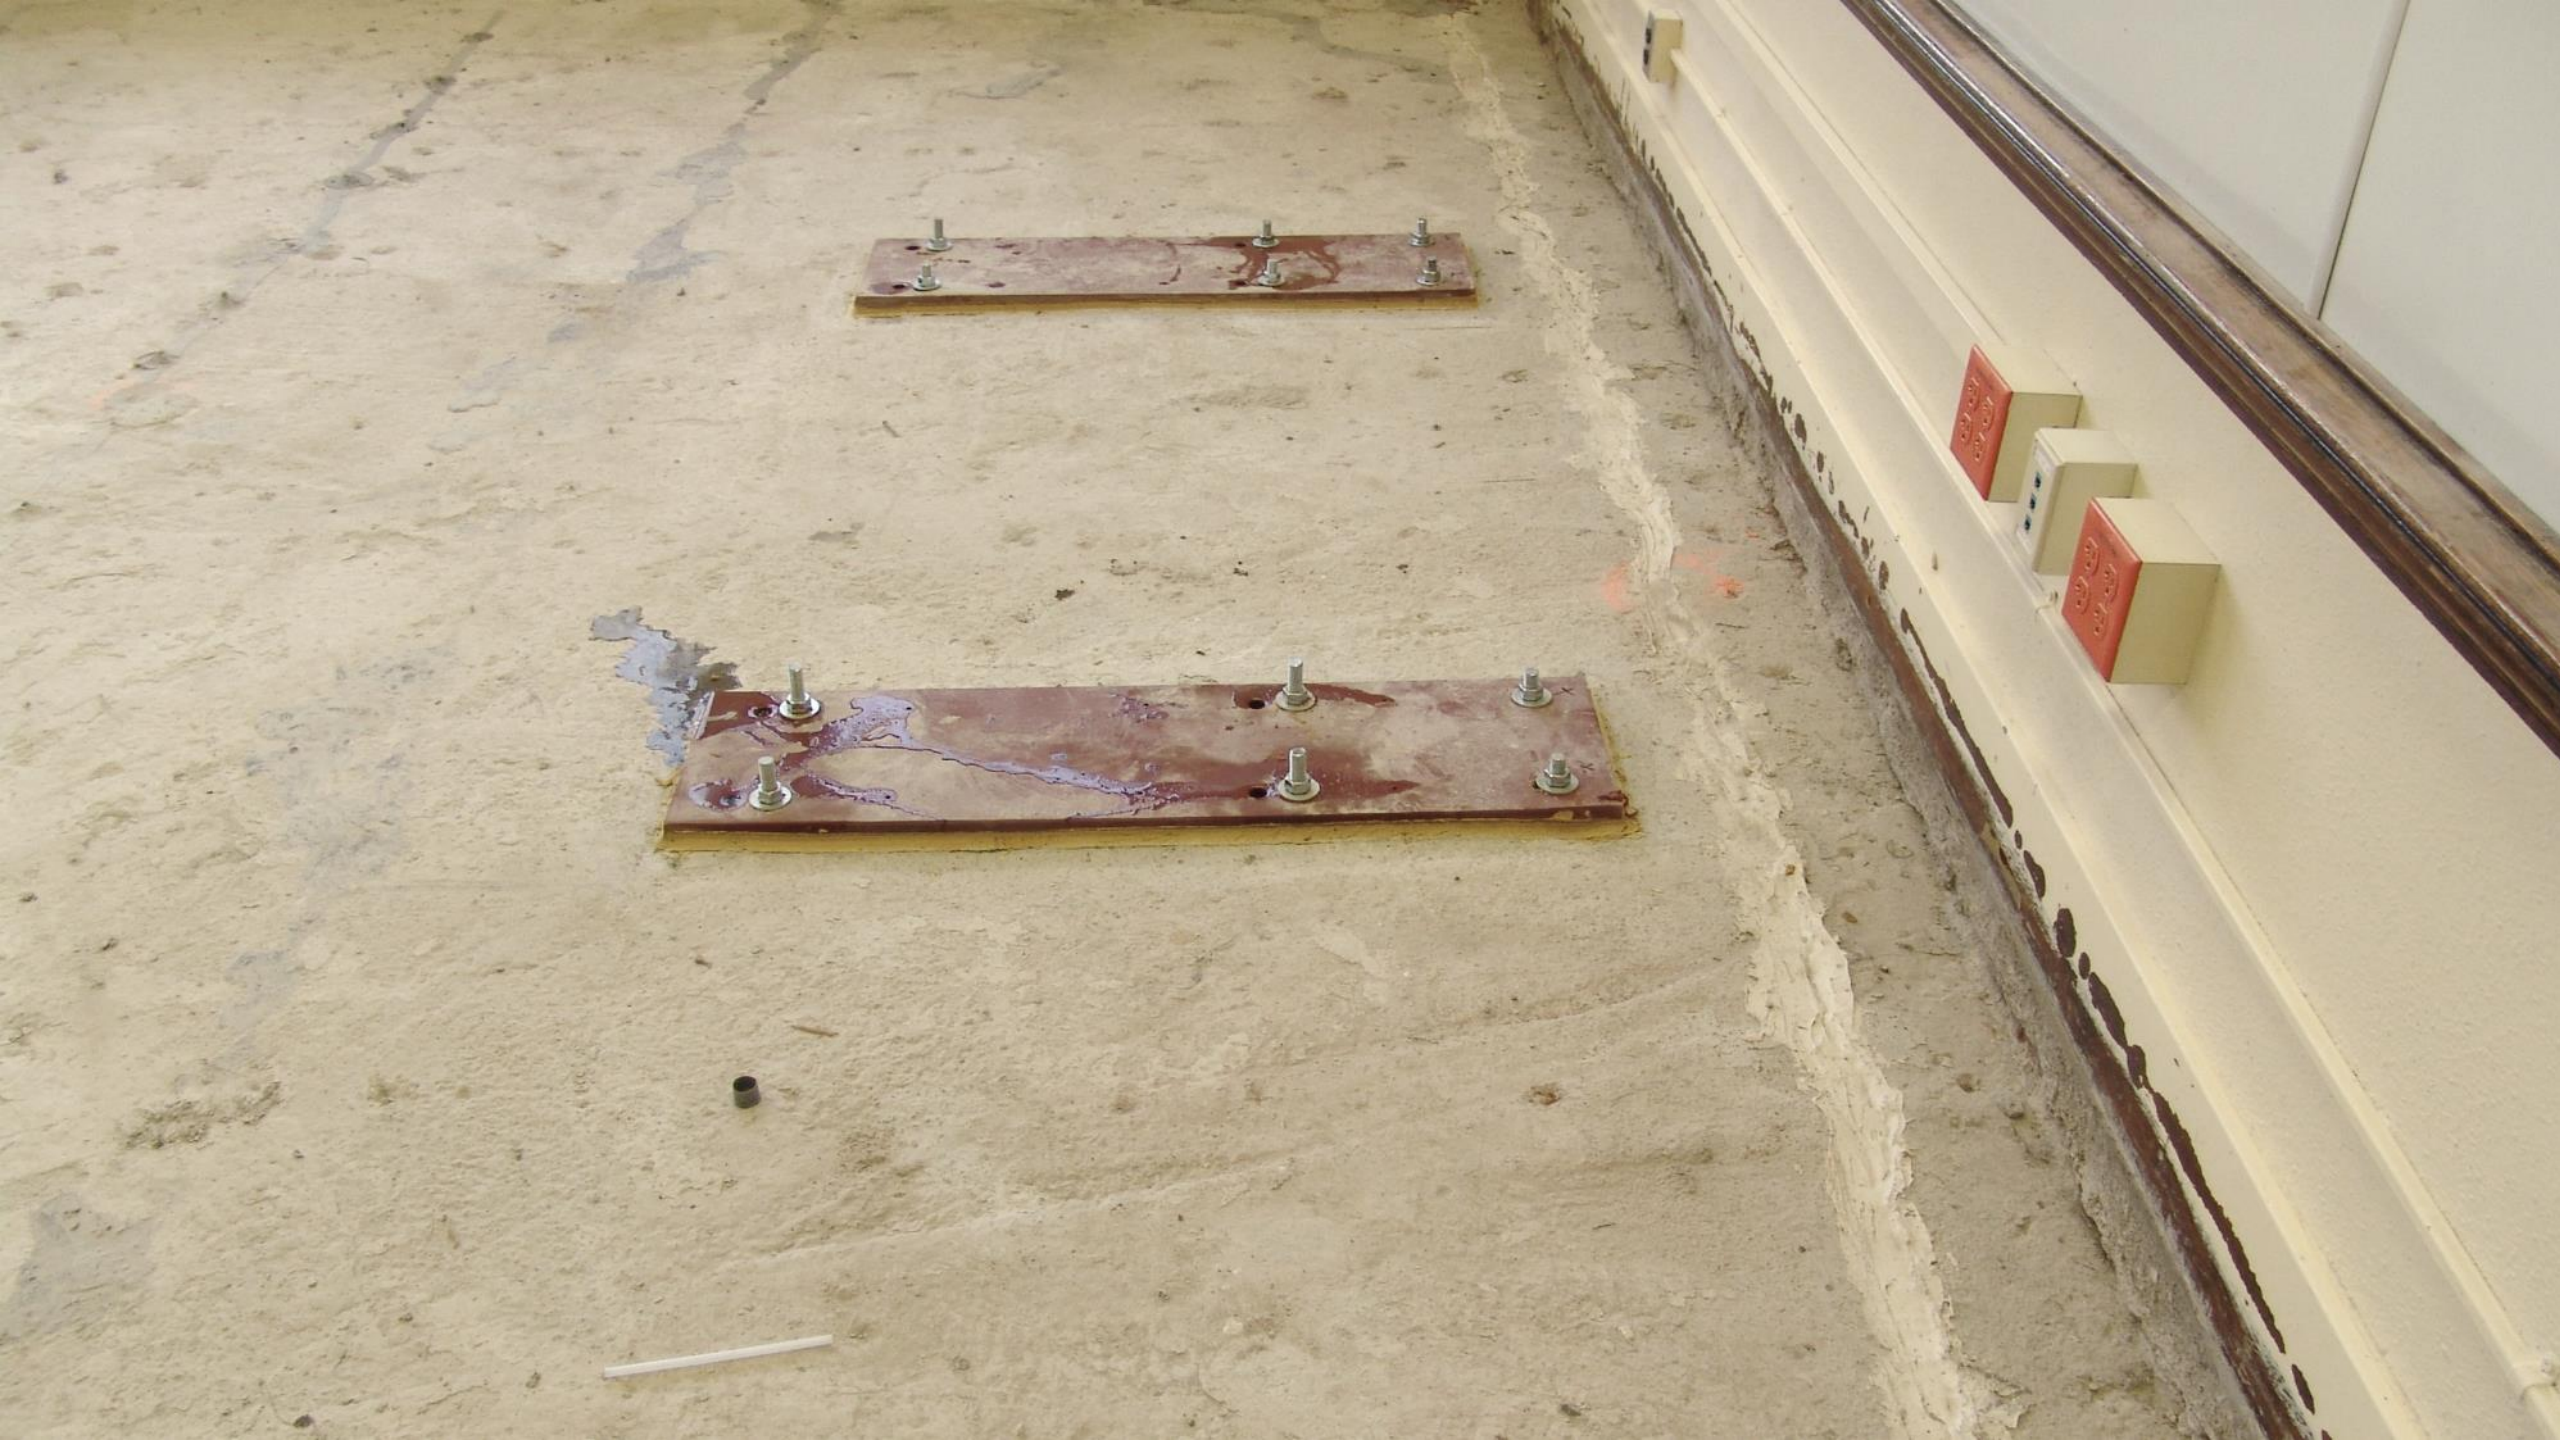
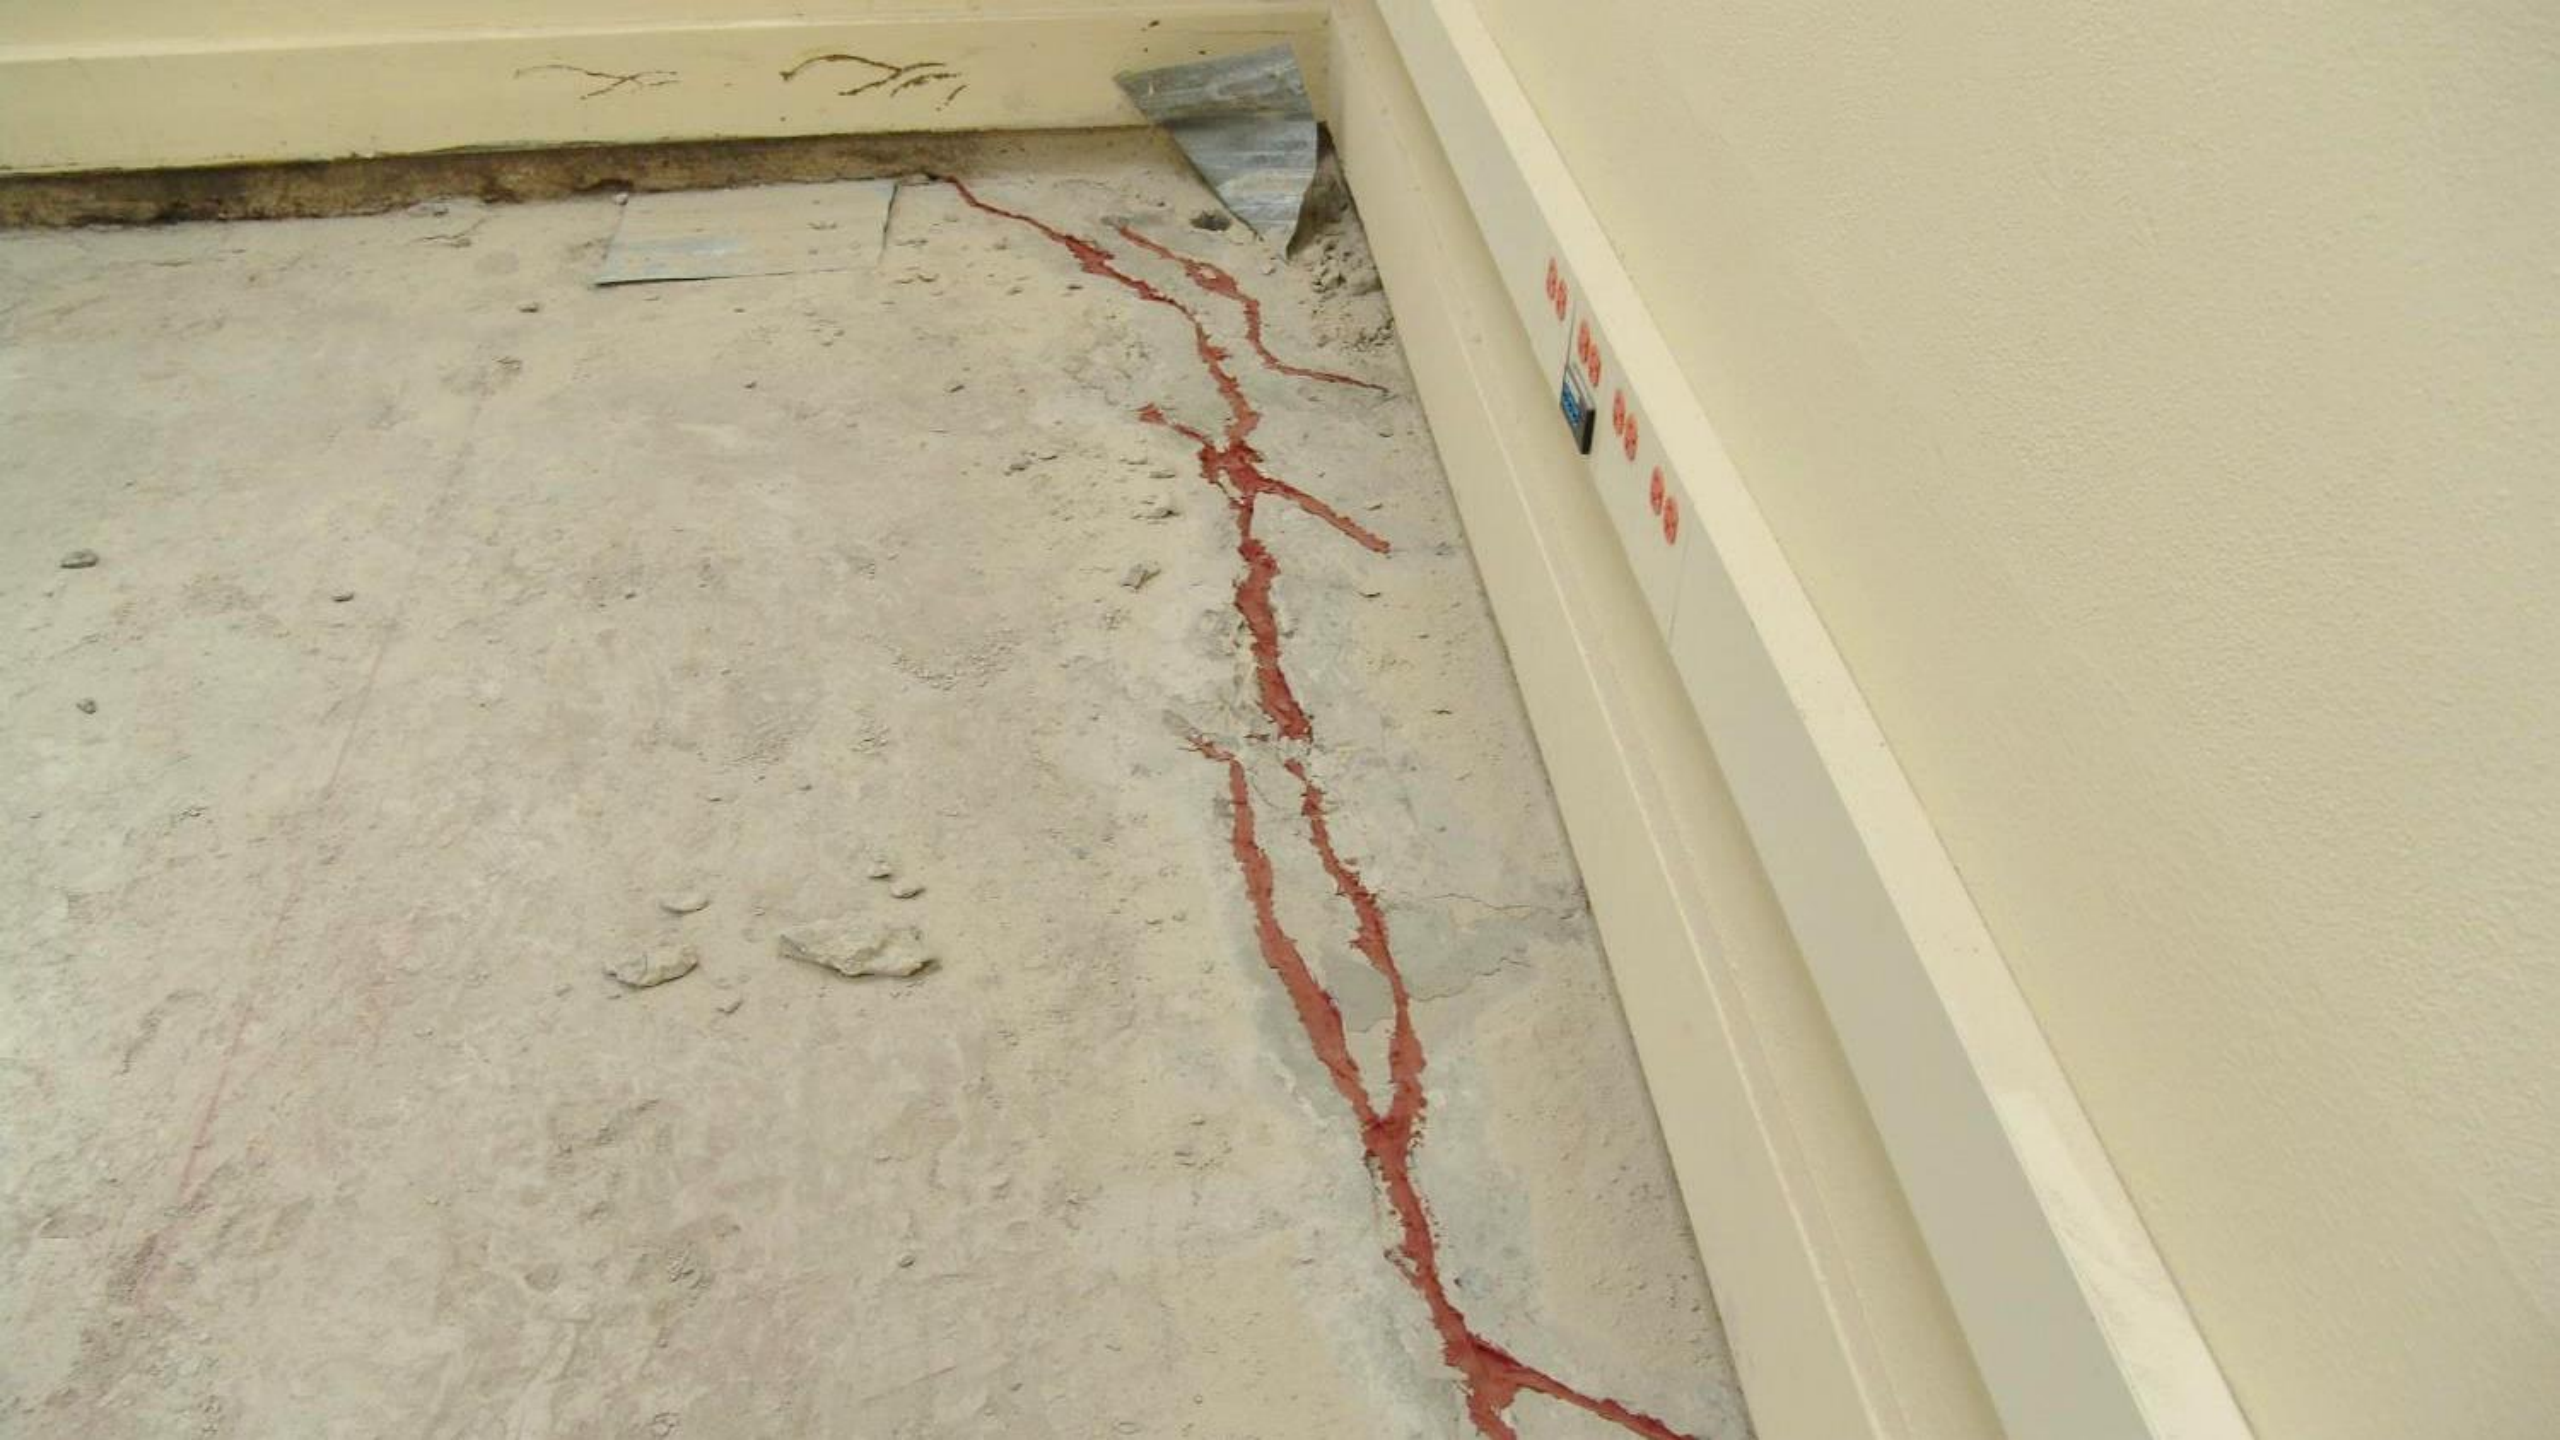
Selected areas of the existing concrete floor slab were in such bad condition, steel plates had to be installed to bridge between the joists below to prevent punching shear failures through the slab.
