Thomas L. Rewerts, SE  
THOS. REWERTS & CO., LLC  
Kansas City, MO  
[t.rewerts@rewerts.com](mailto:t.rewerts@rewerts.com)

**Complex and Innovative Structural Repair  
of Severely Damaged, 1917 era School Structures**

**Structural Repairs**  
 Phase II: Concrete Floor System Repairs  
 Allison Traditional Magnet Middle School  
 221 S. Street - White, Kansas

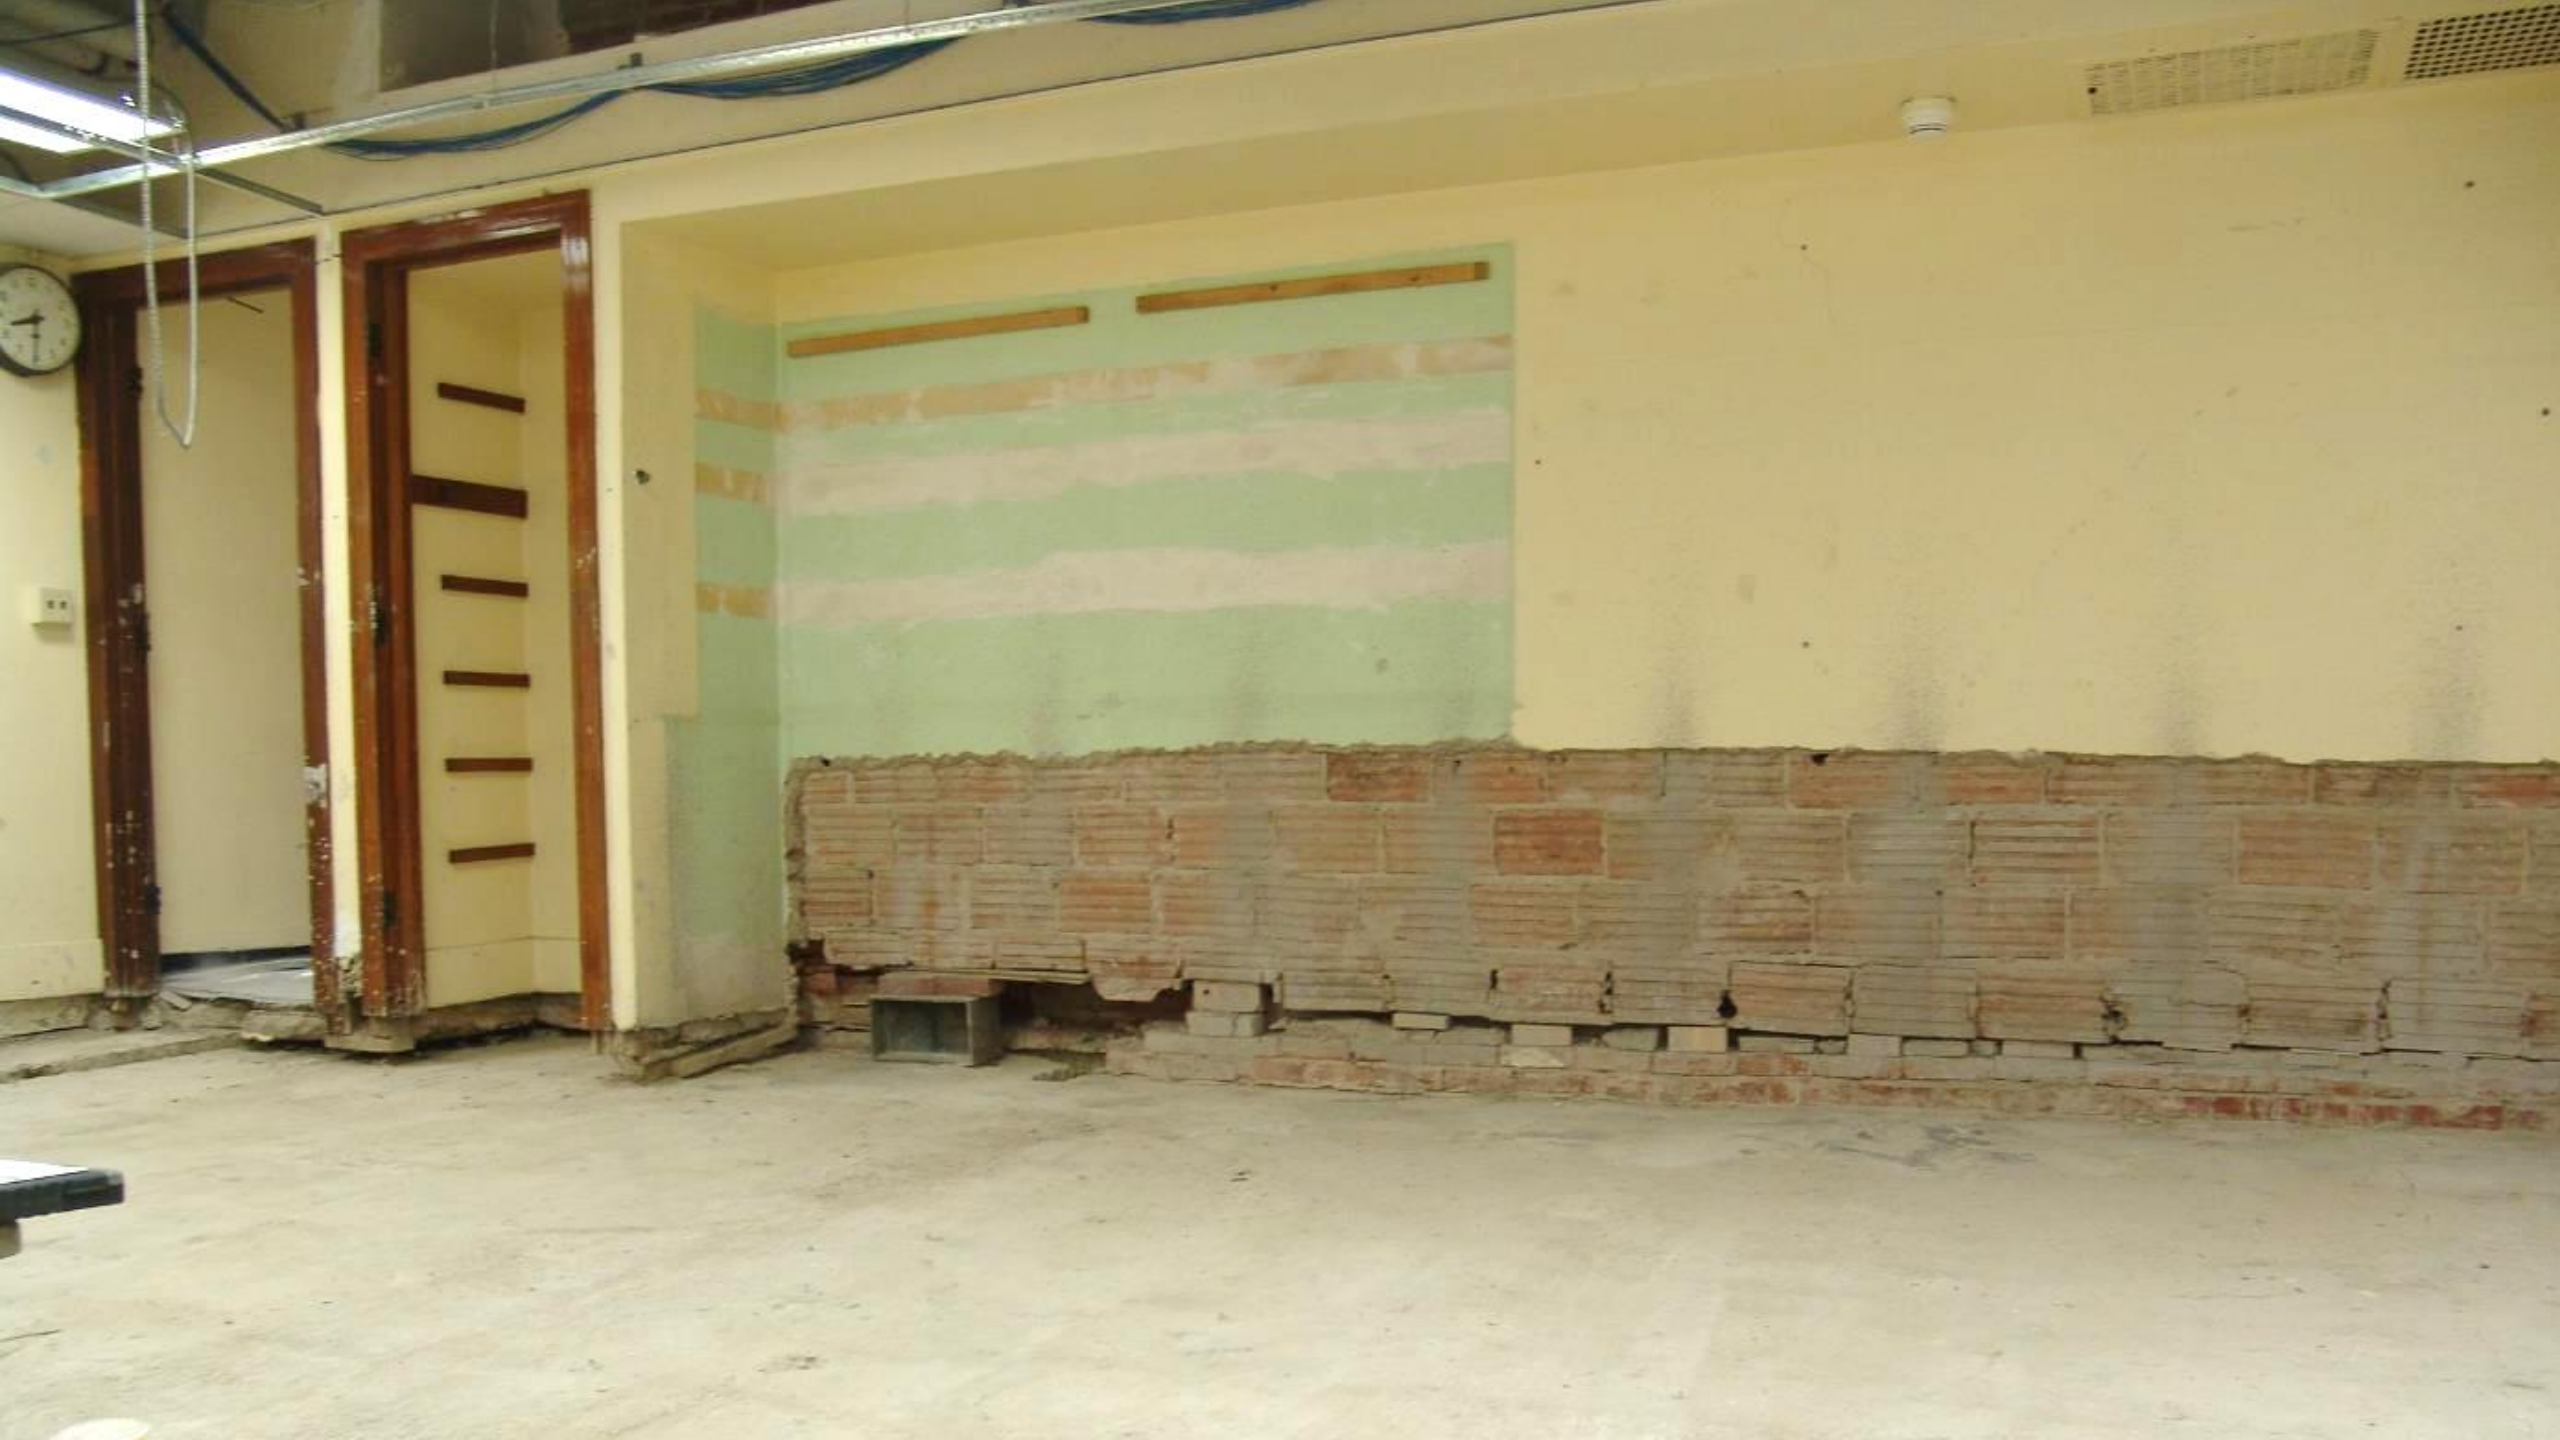
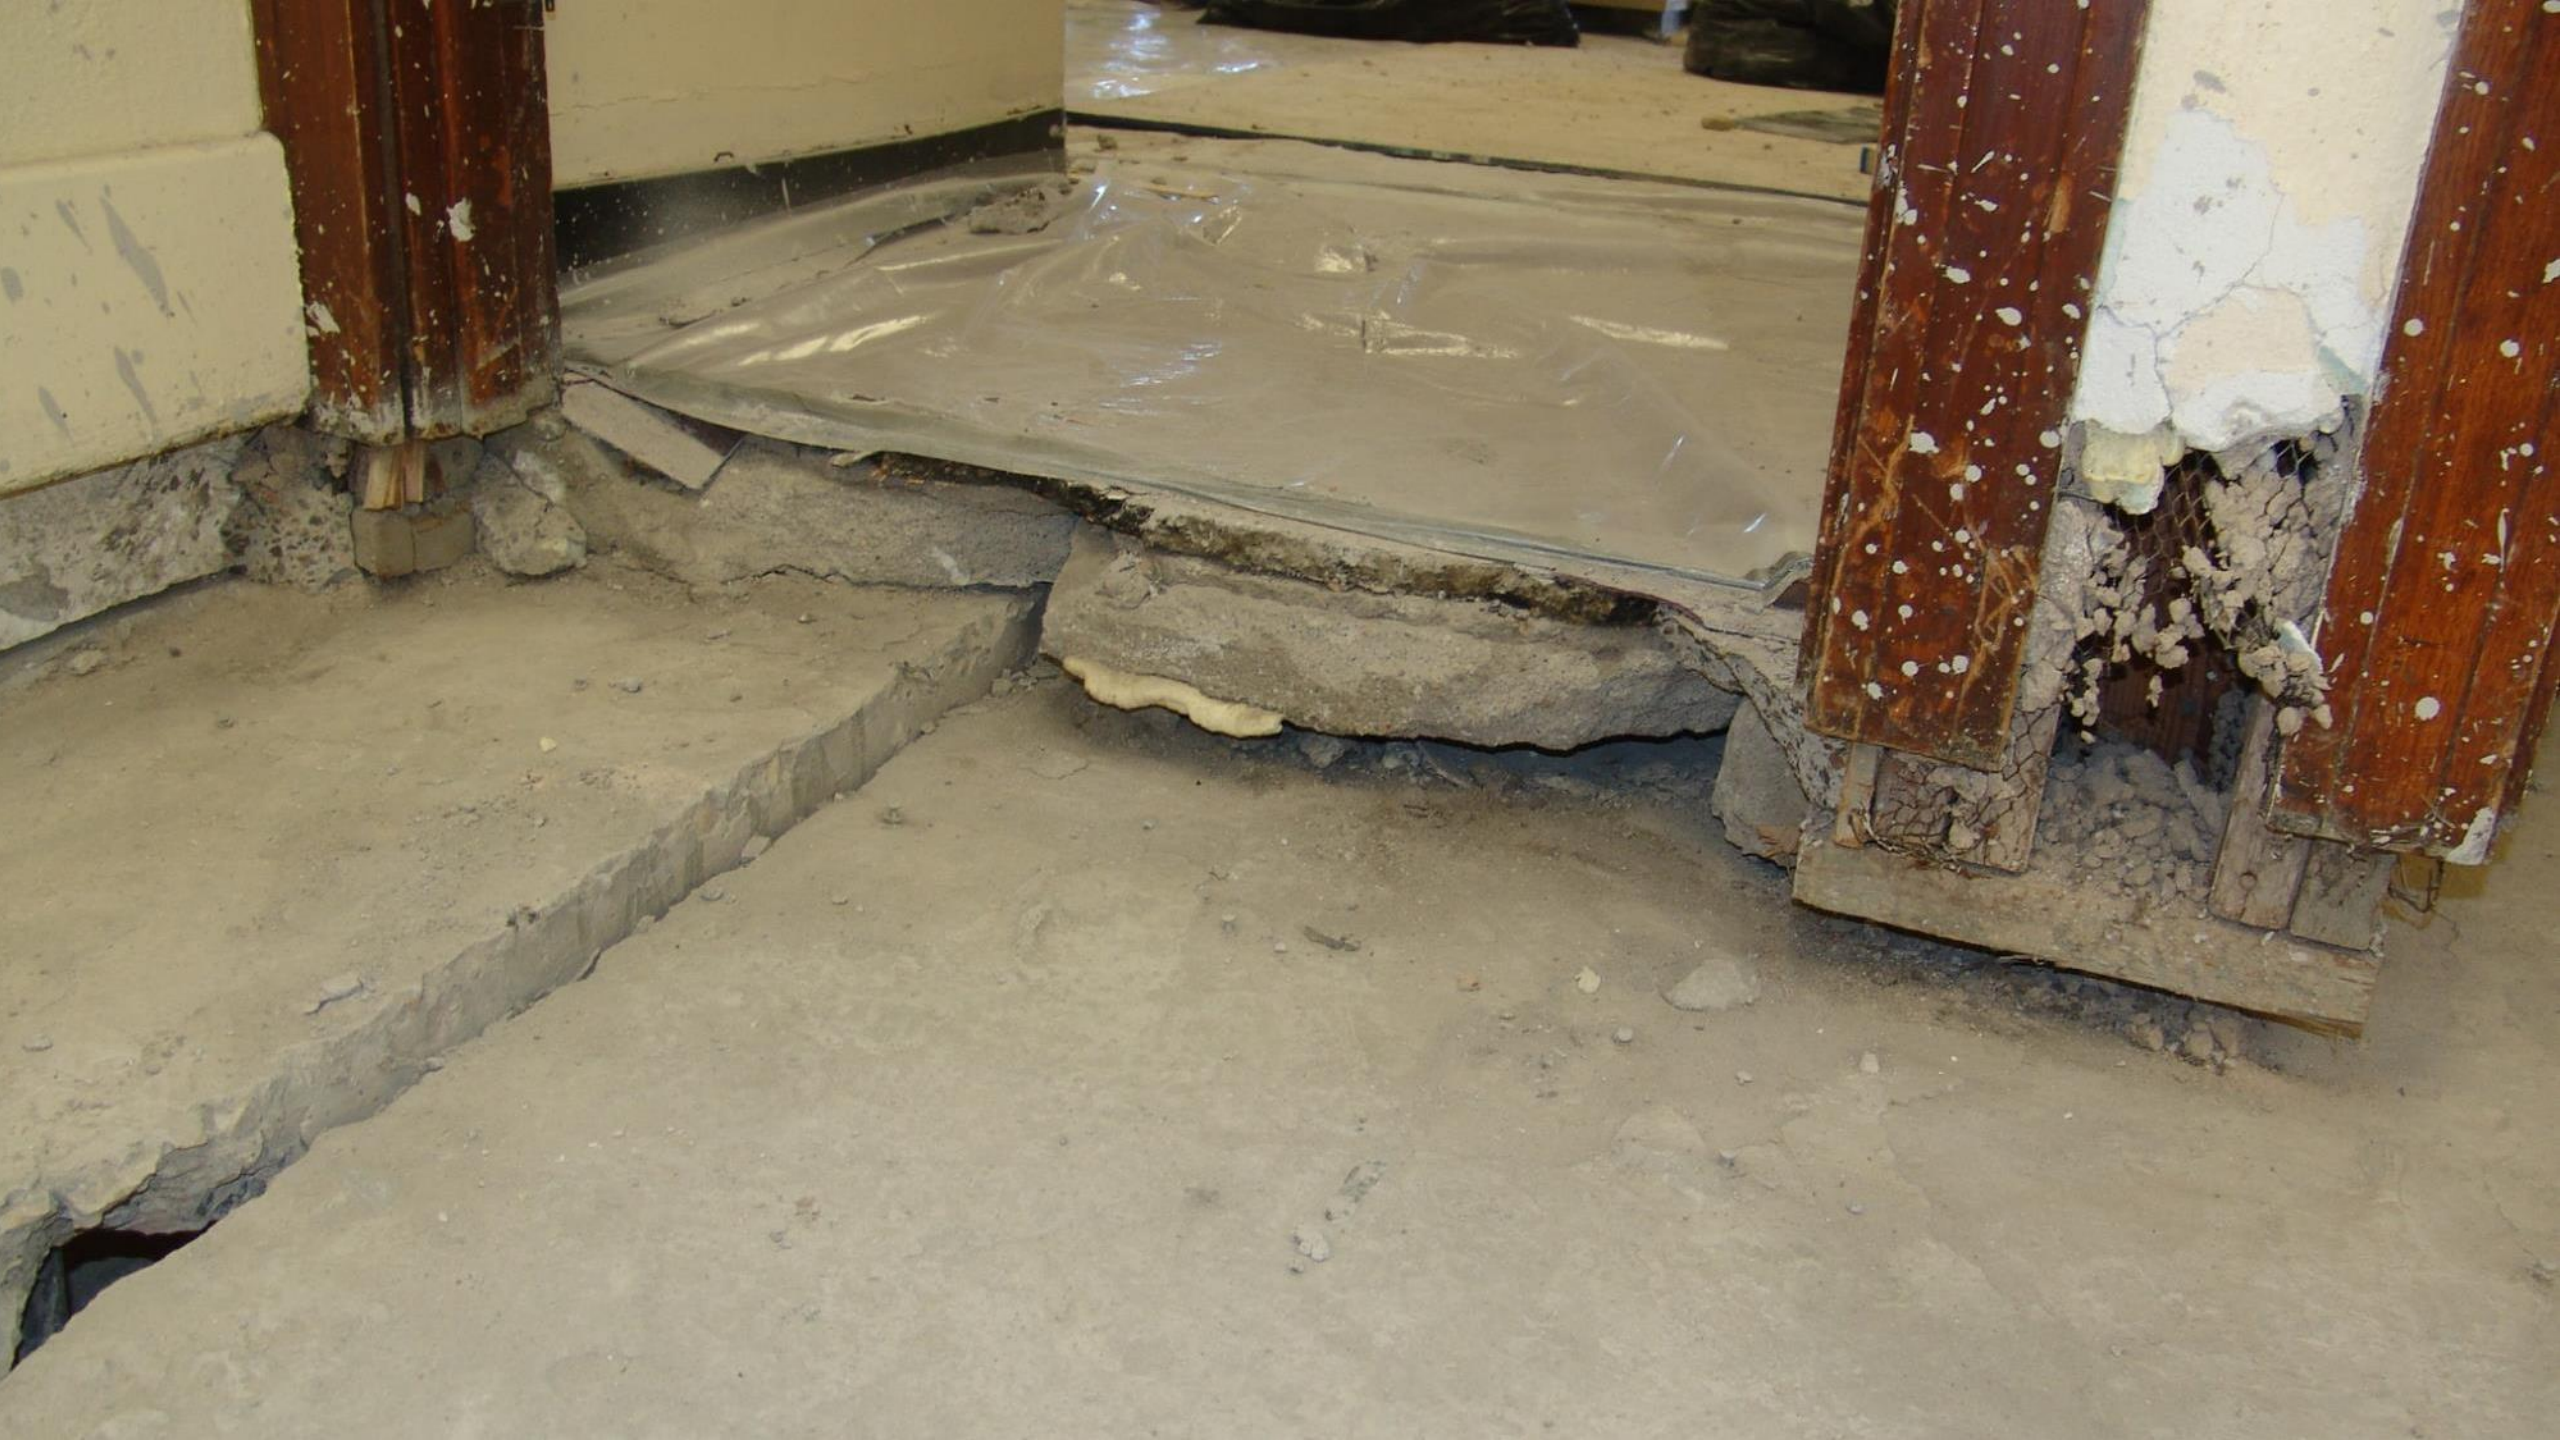
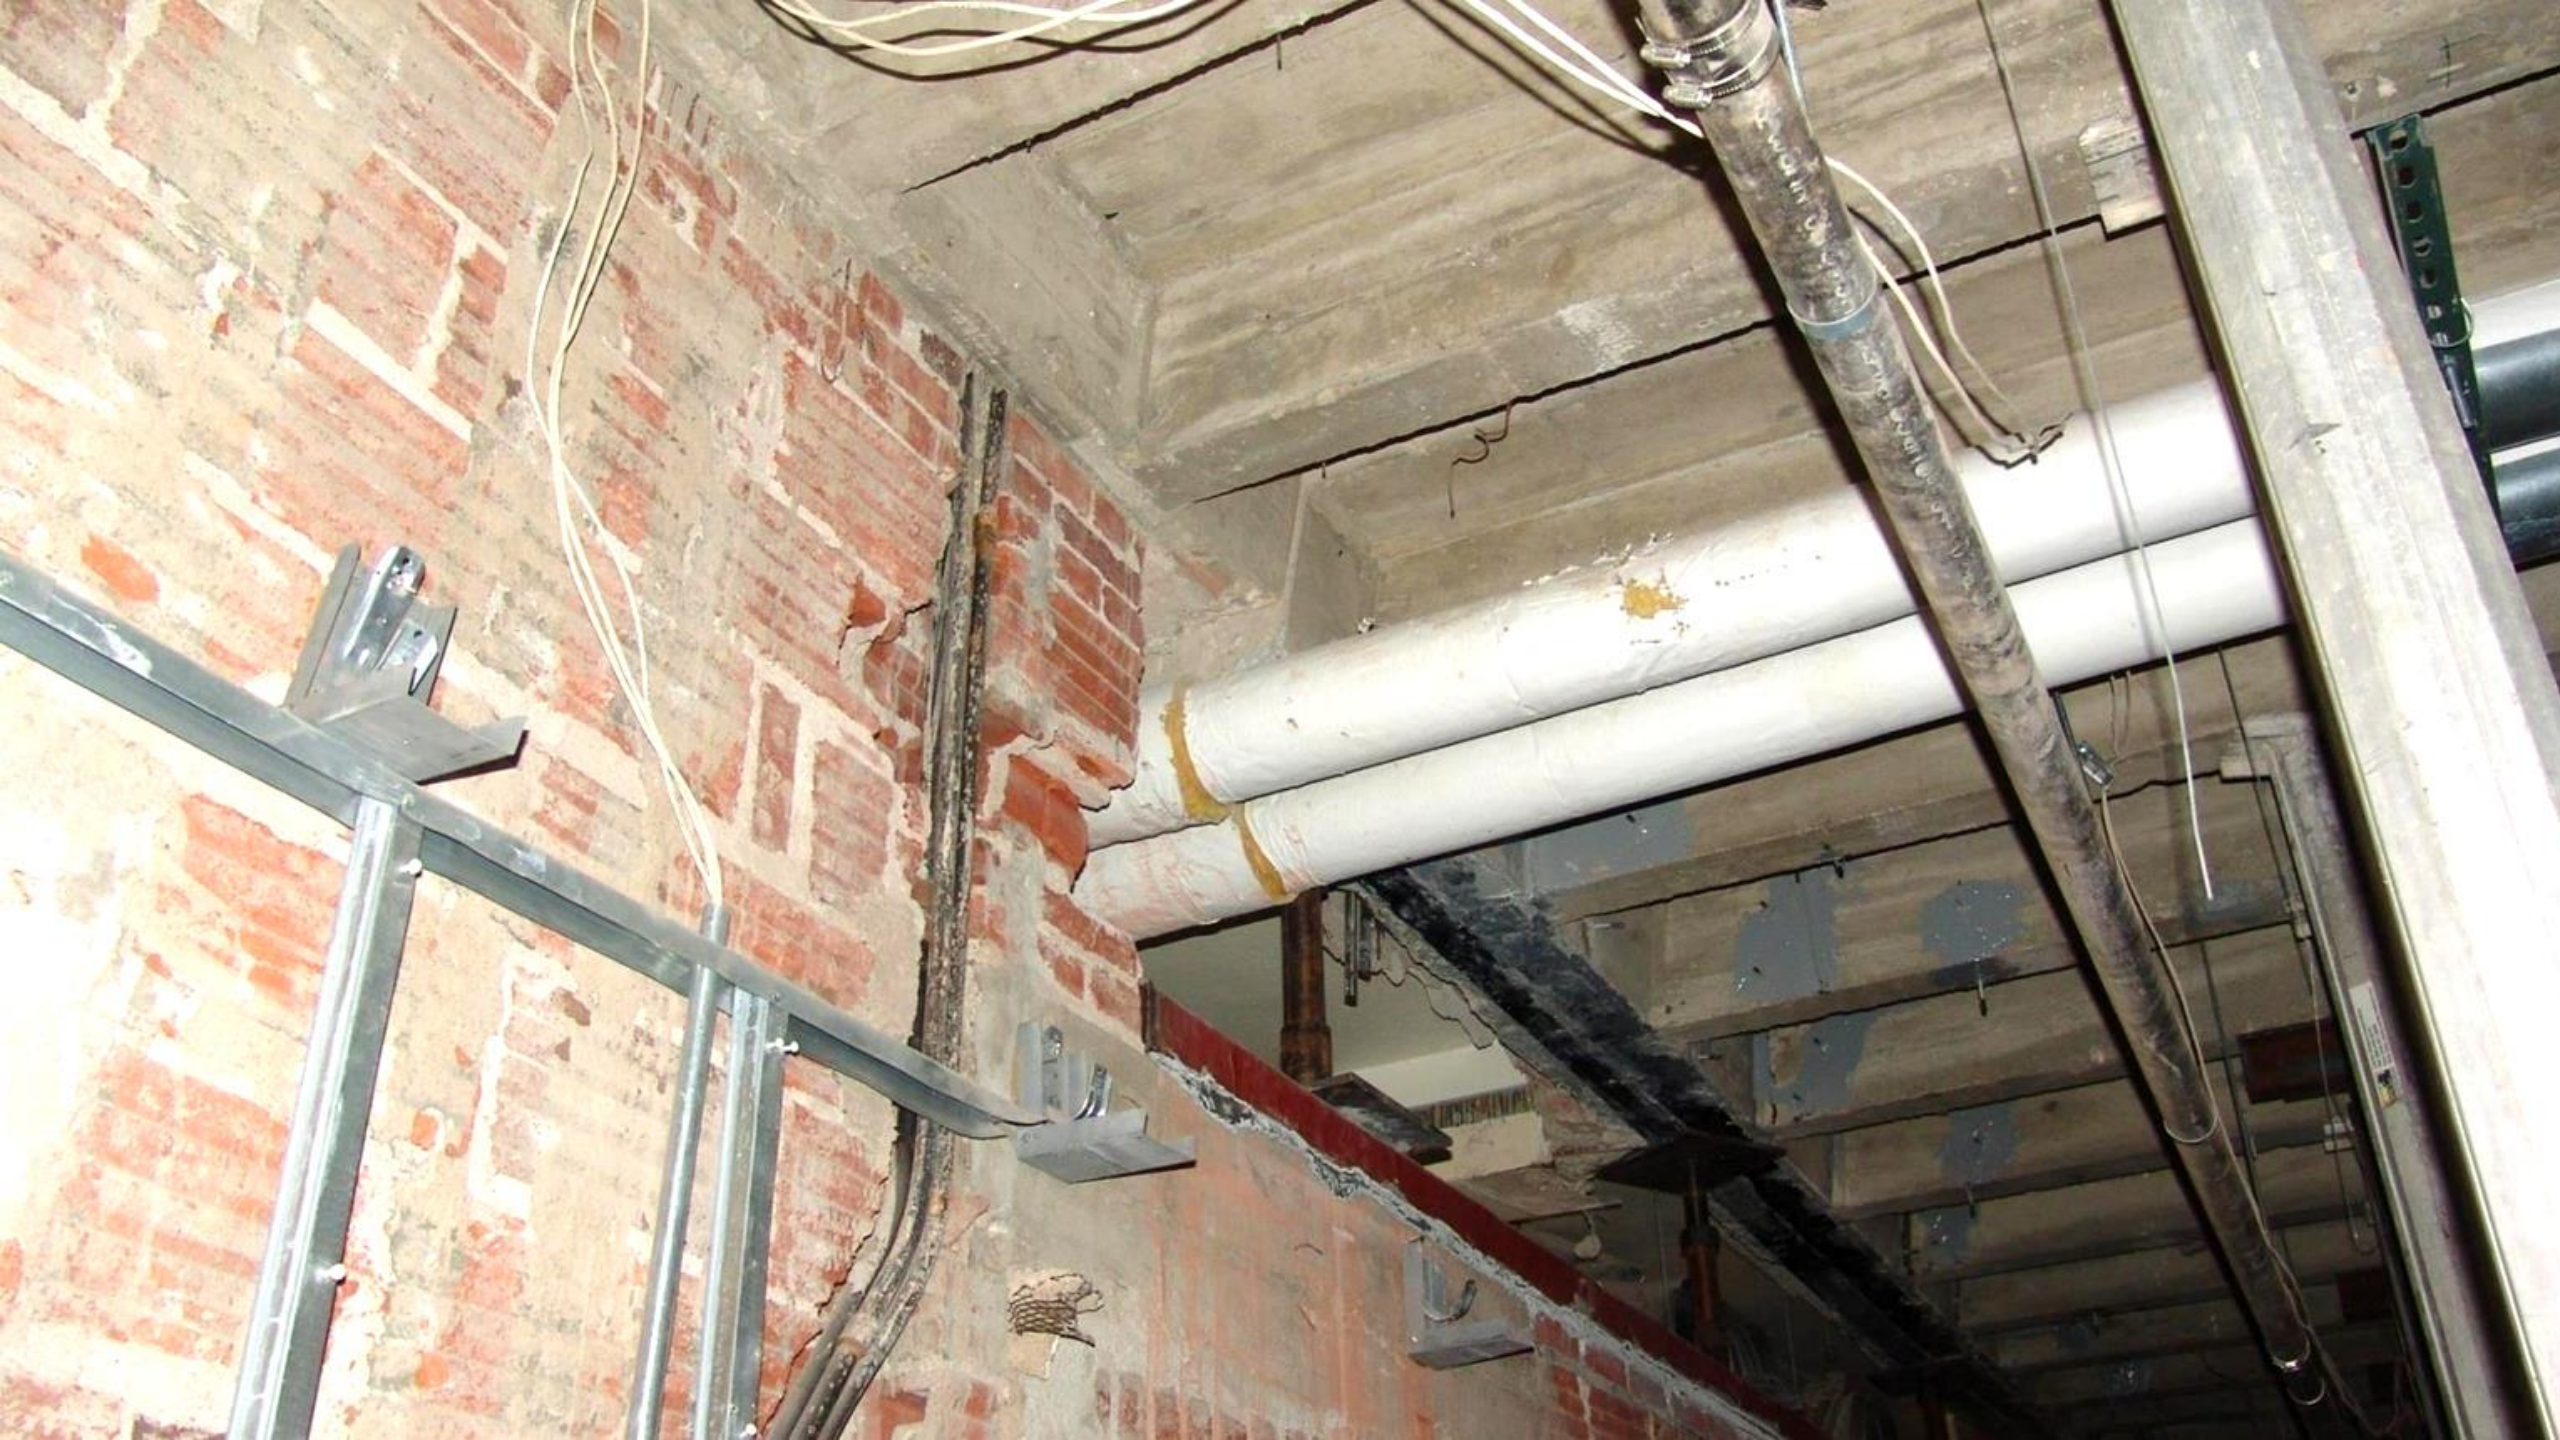
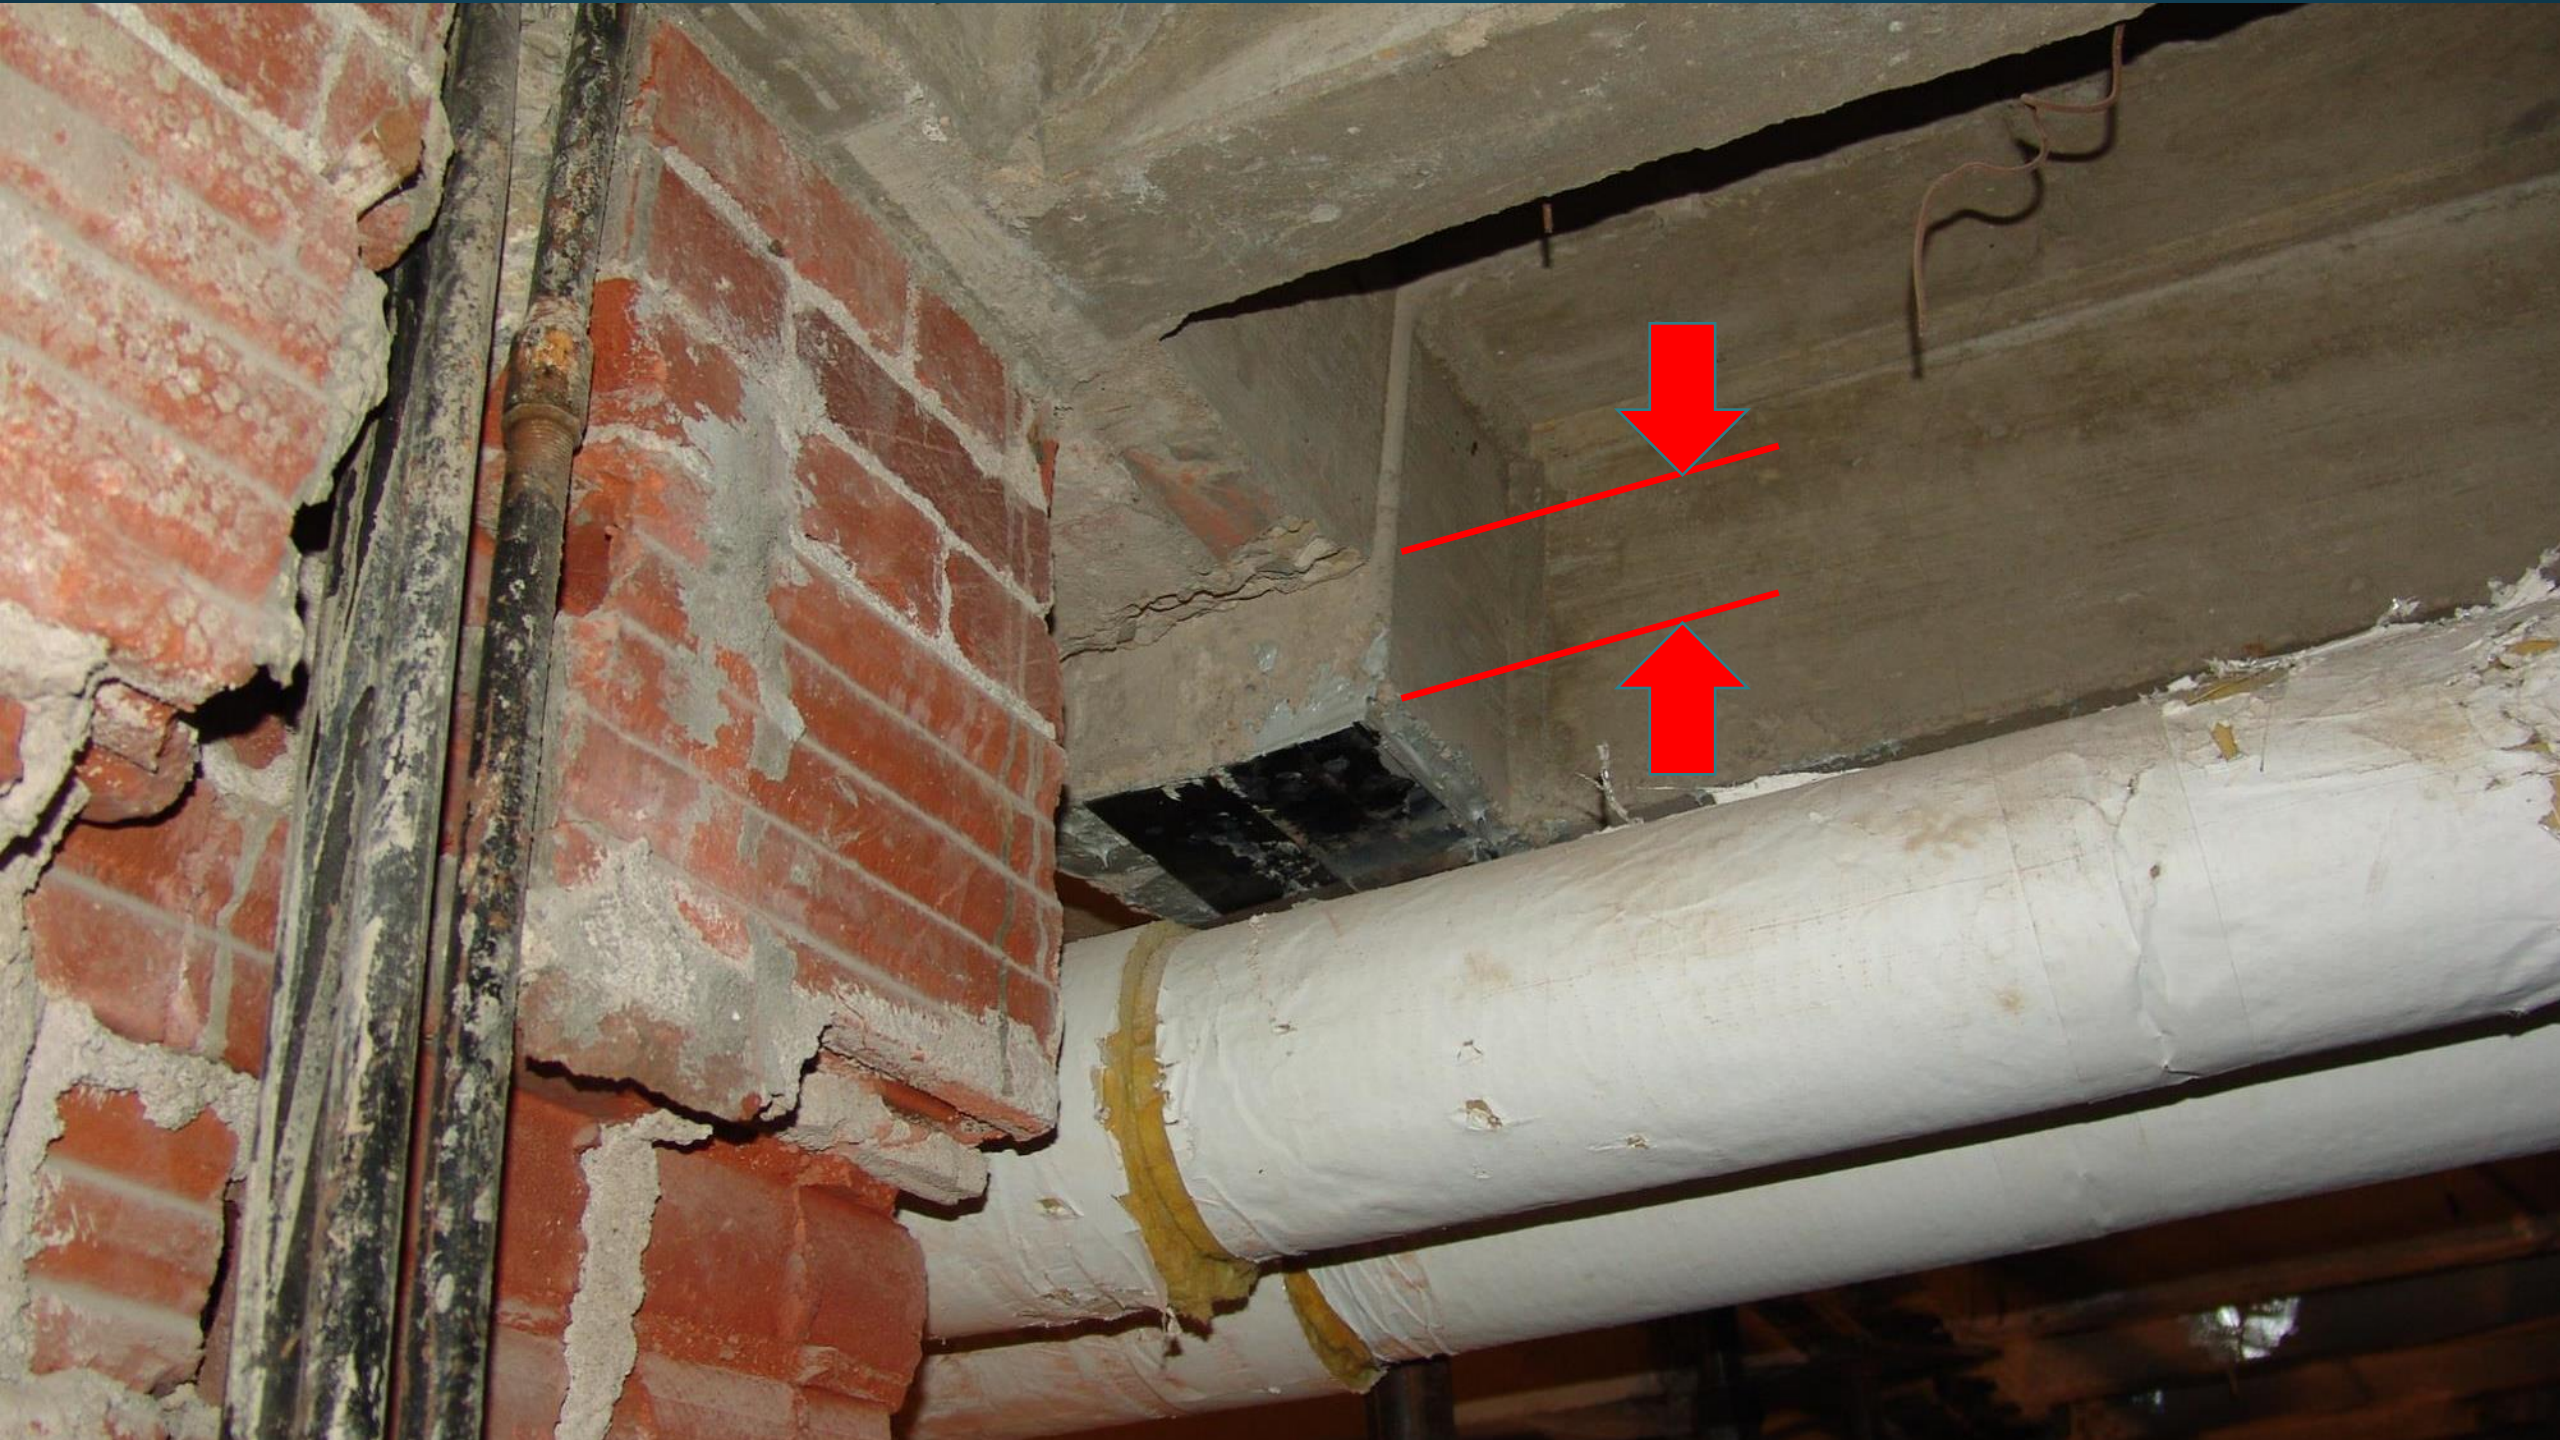
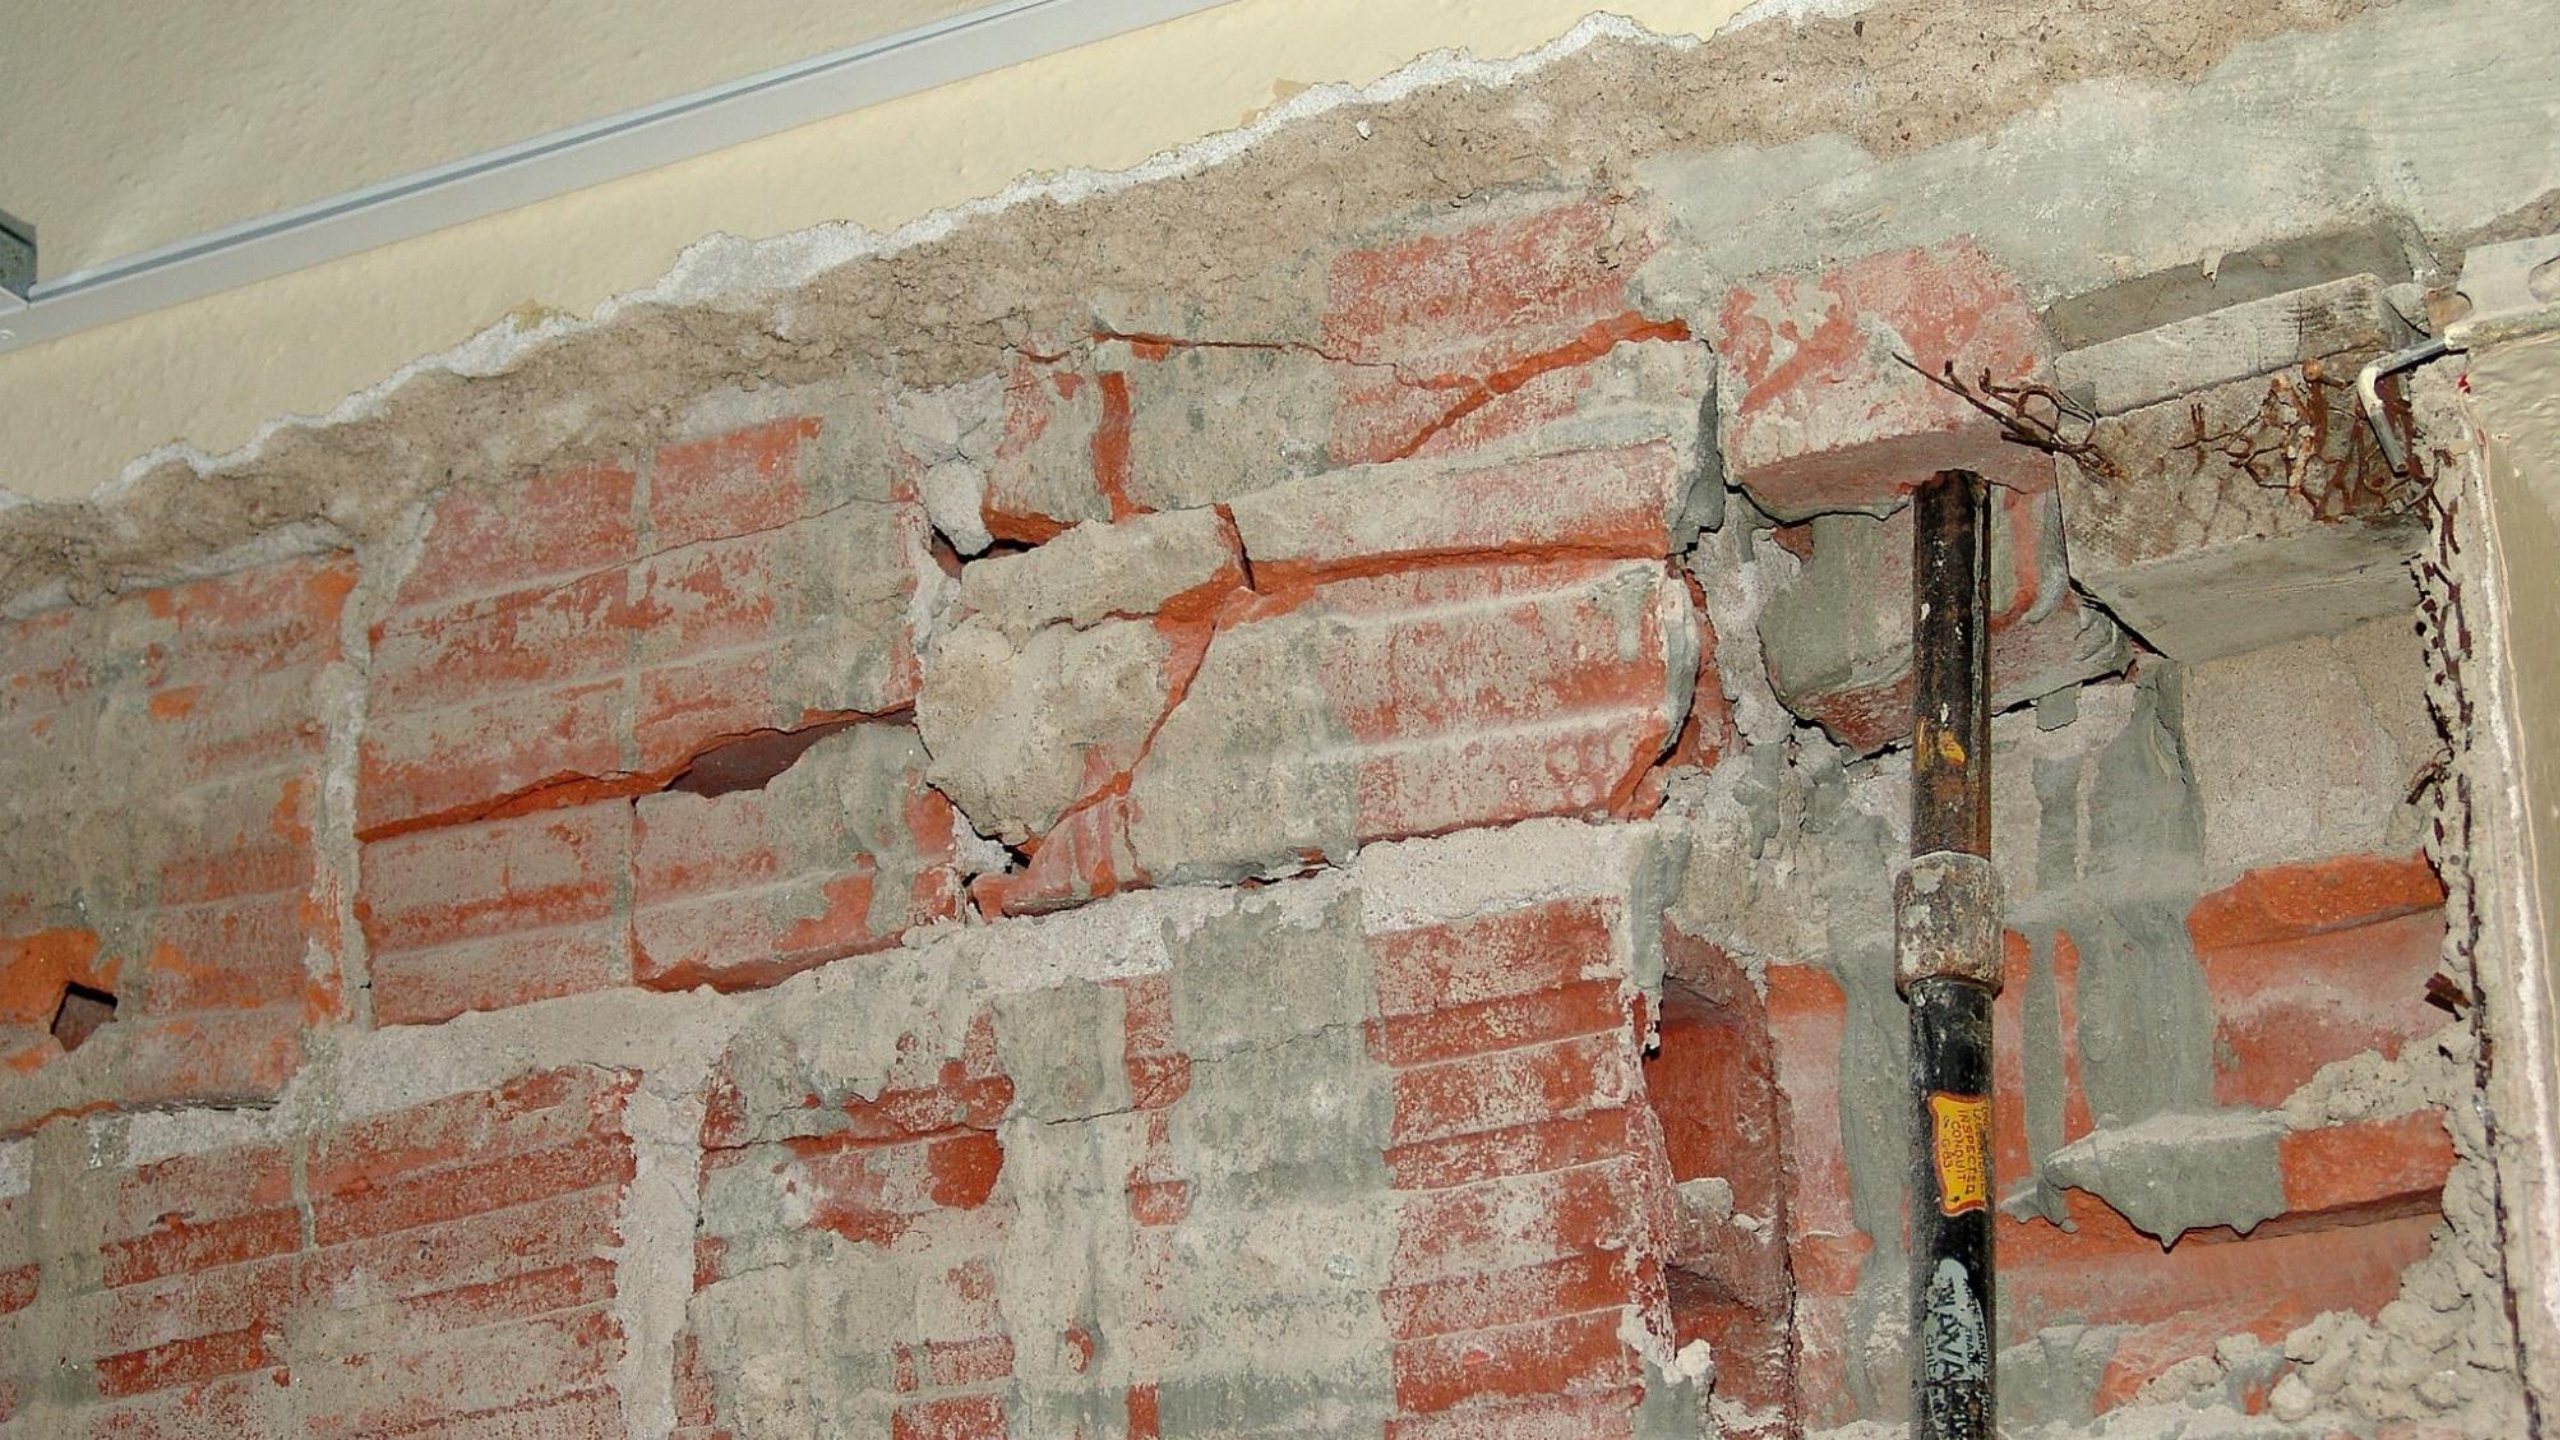
Installation of large banks of new HVAC ducts through interior load-bearing structural clay tile walls caused serious vertical displacement and near collapse of a section of the concrete floor system in one area of one of the buildings.
