Thomas L. Rewerts, SE  
THOS. REWERTS & CO., LLC  
Kansas City, MO  
[t.rewerts@rewerts.com](mailto:t.rewerts@rewerts.com)

**Complex and Innovative Structural Repair  
of Severely Damaged, 1917 era School Structures**

**Structural Repairs**  
 Phase II: Concrete Floor System Repairs  
 Allison Traditional Magnet Middle School  
 221 S. Street - White, Kansas

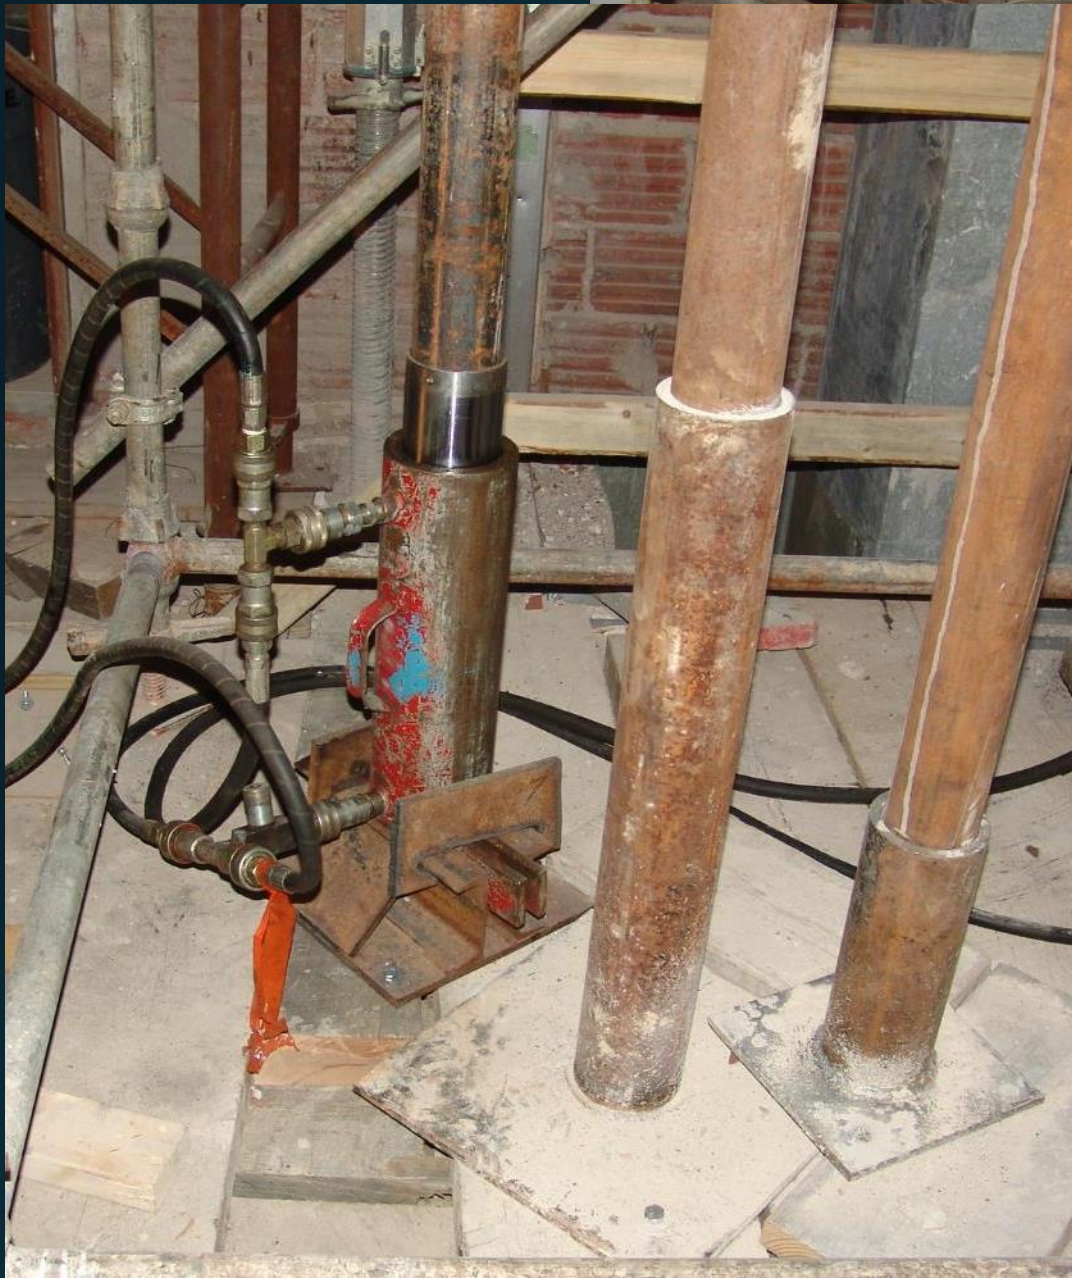
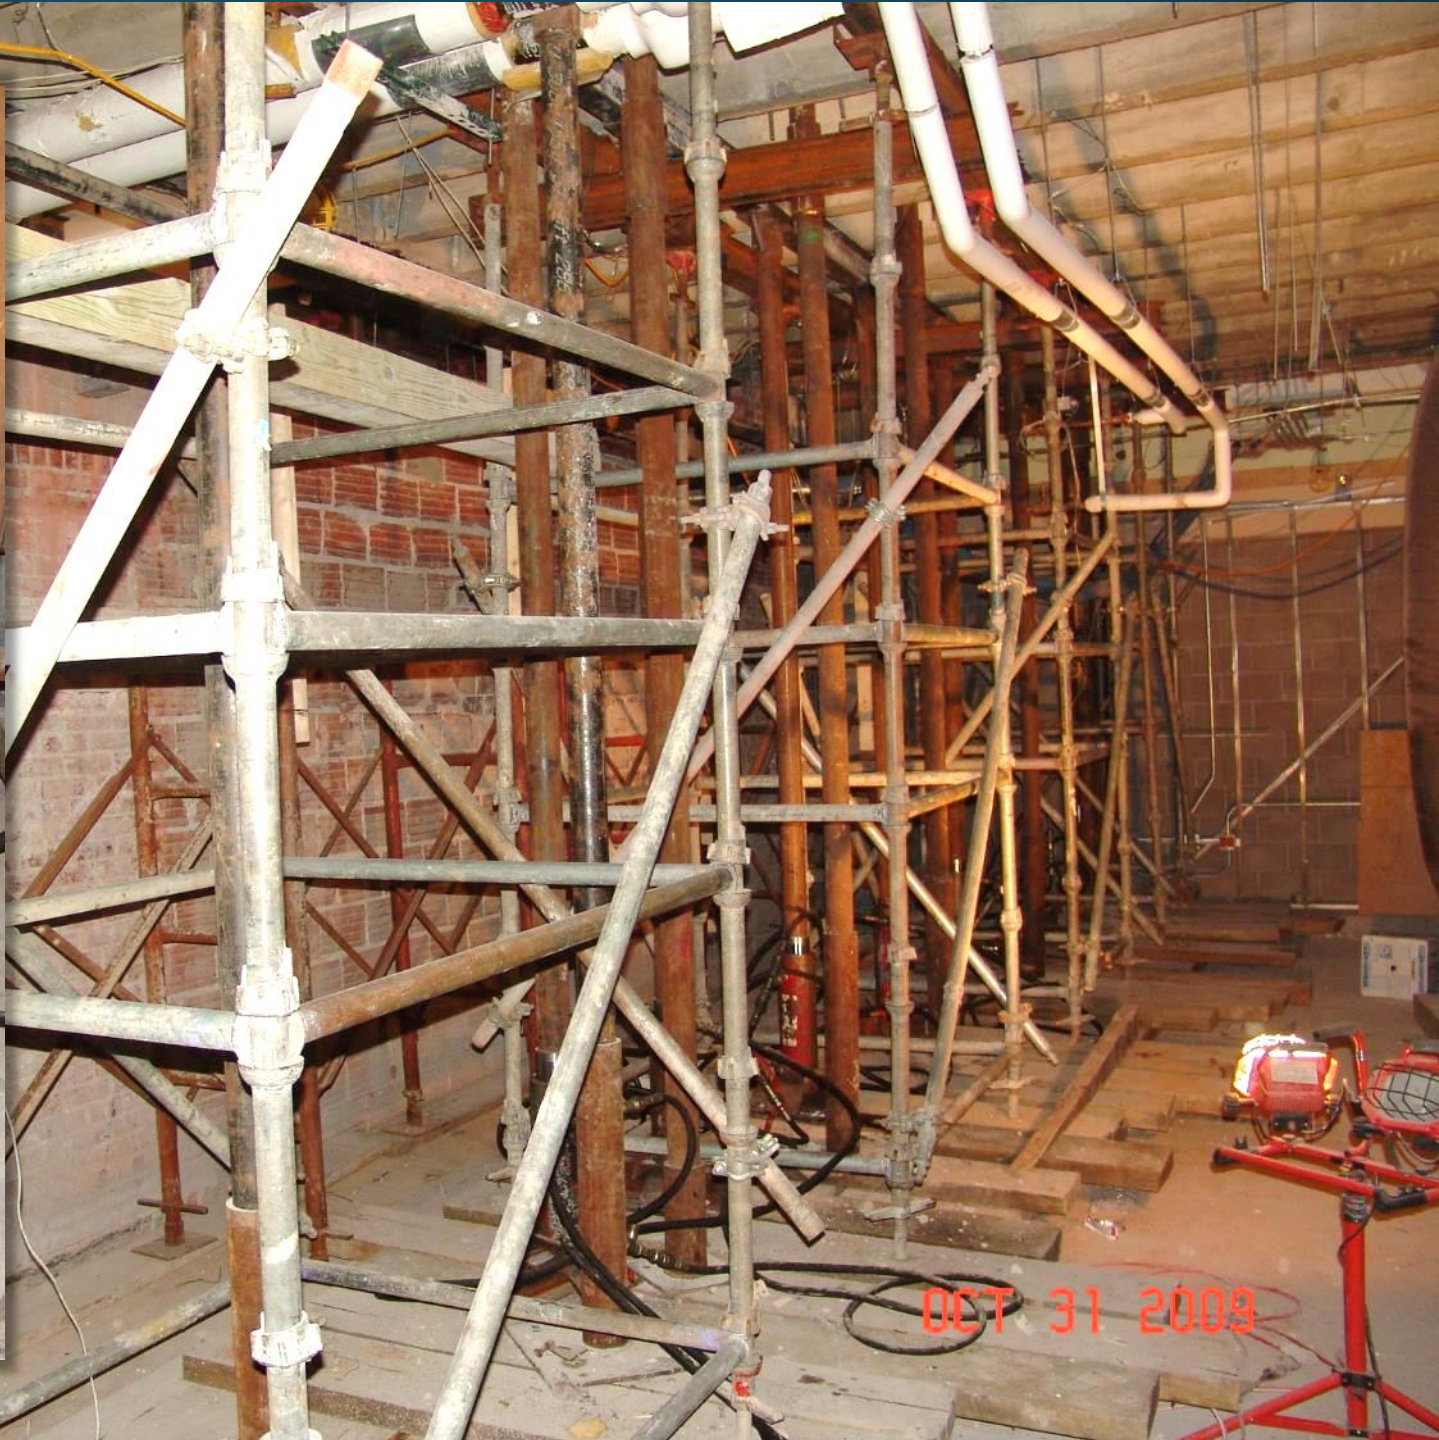
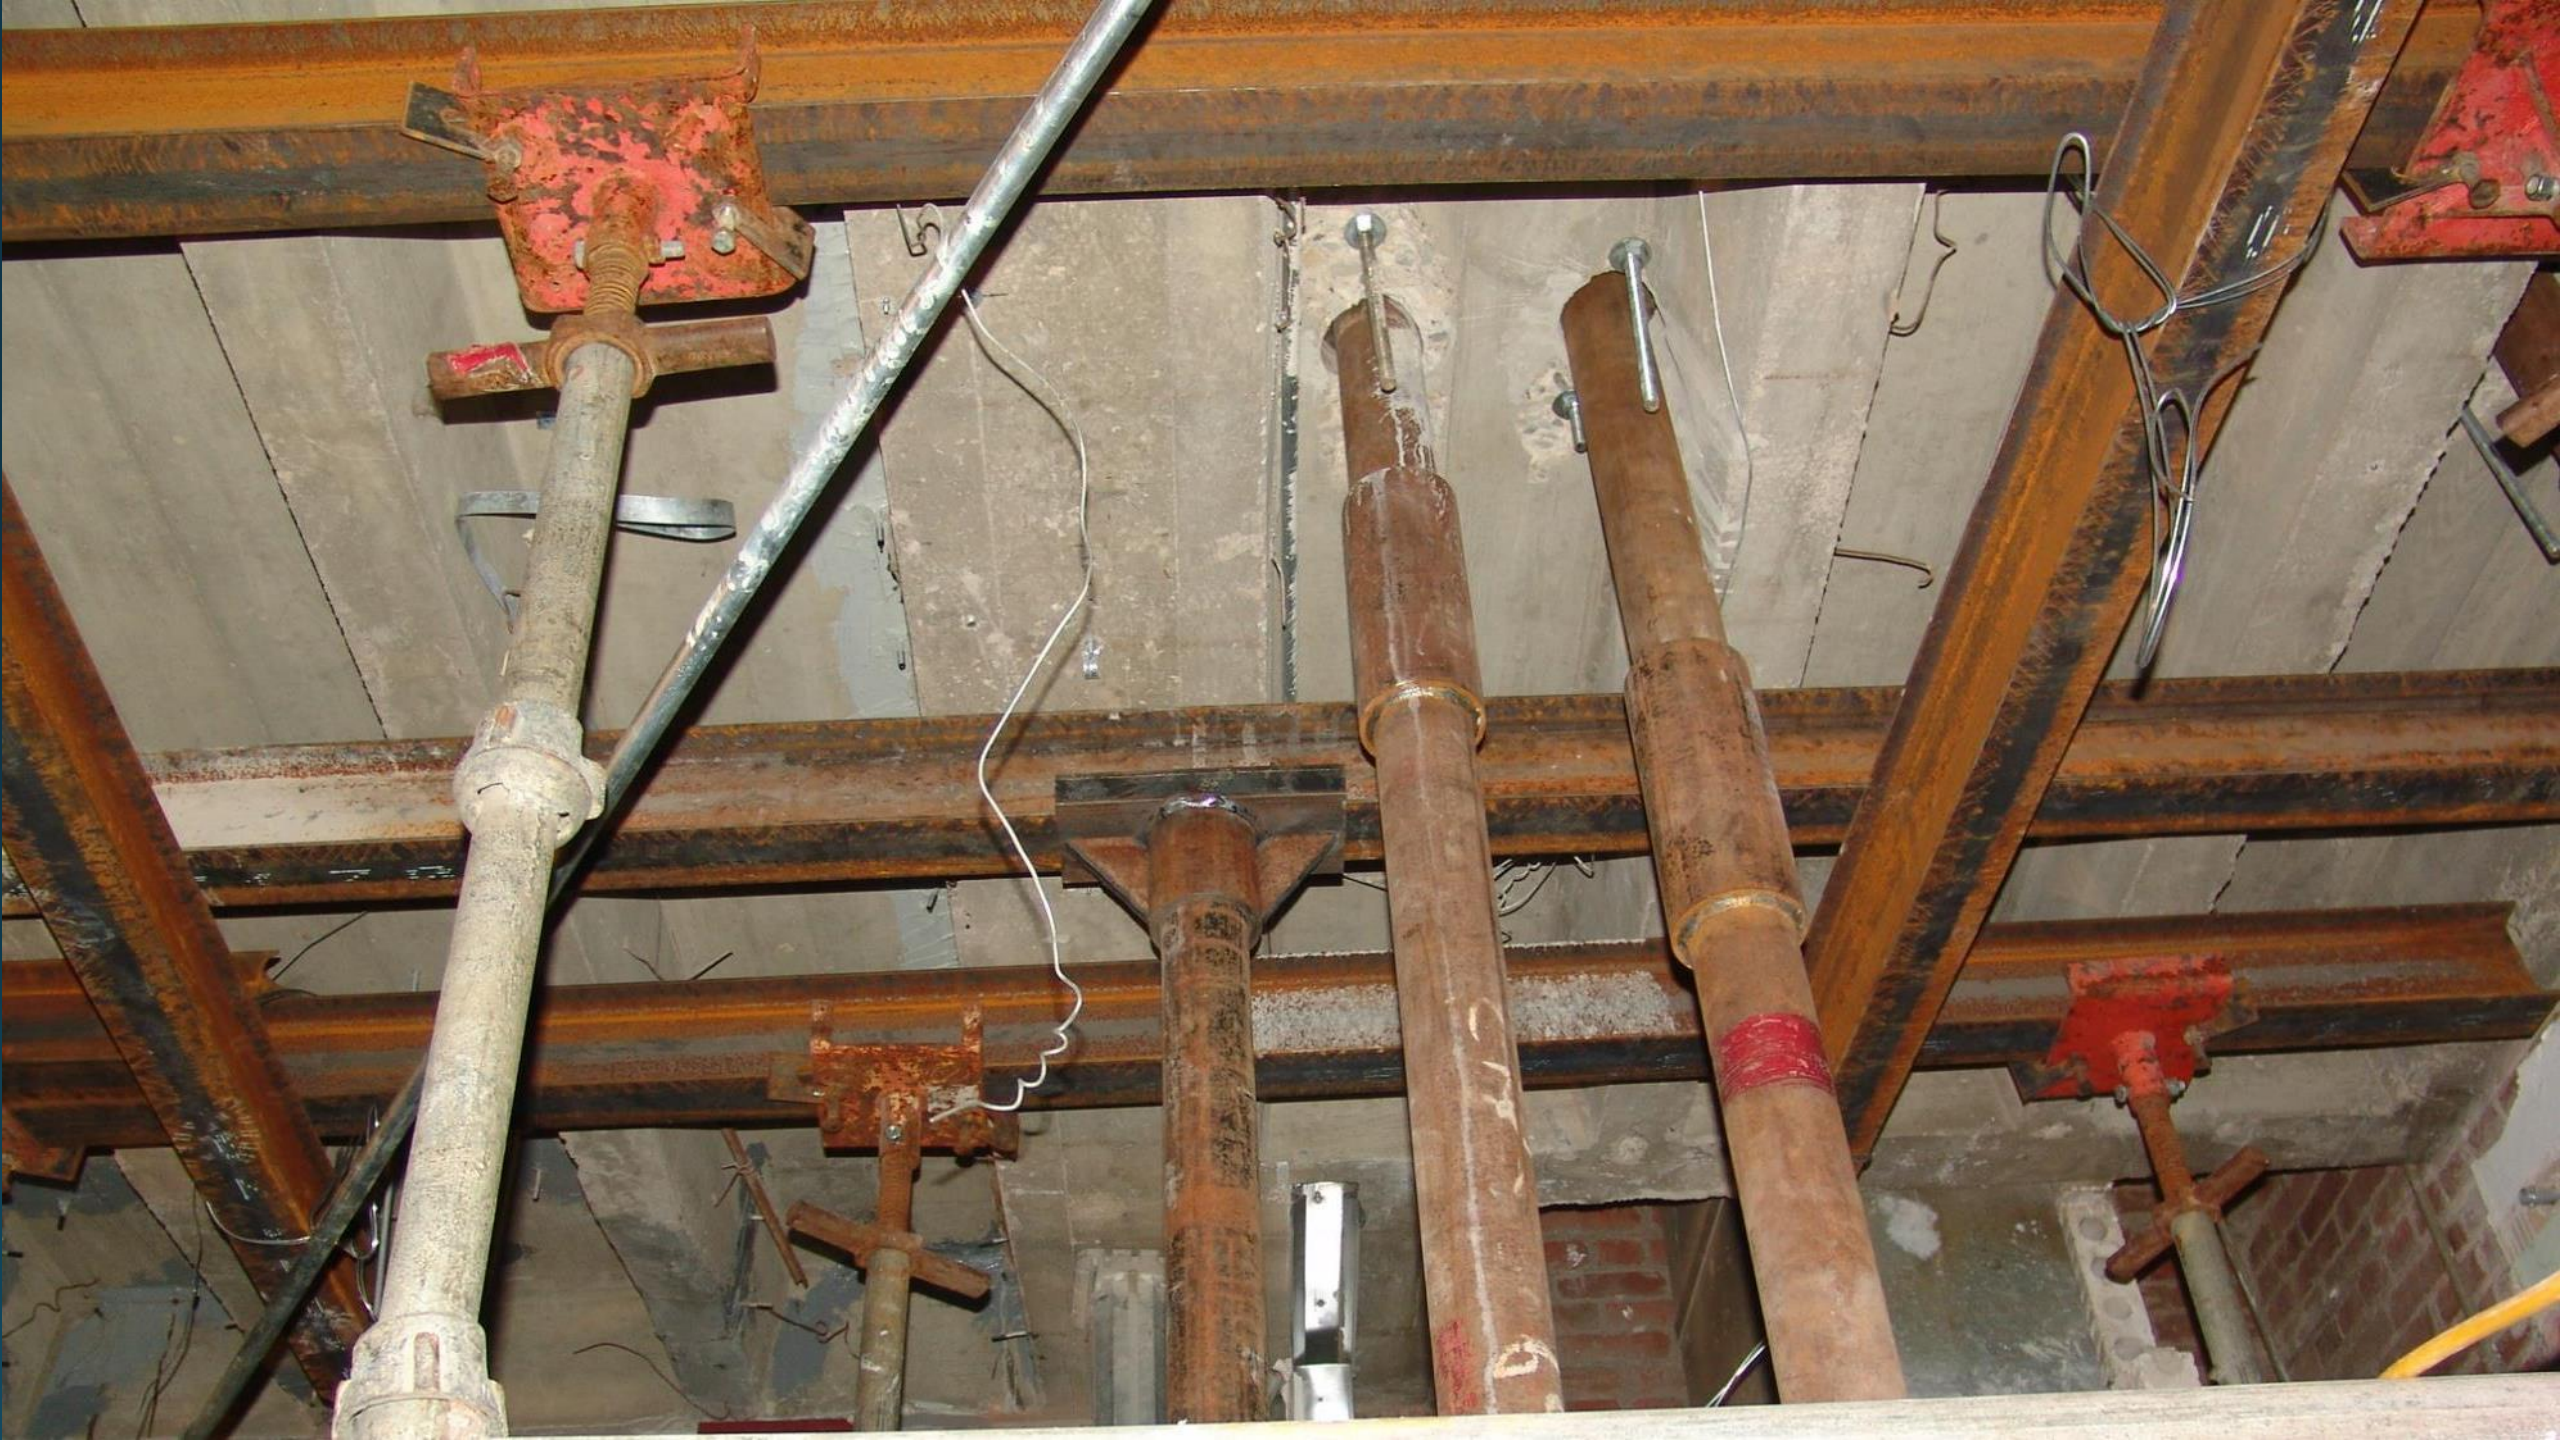
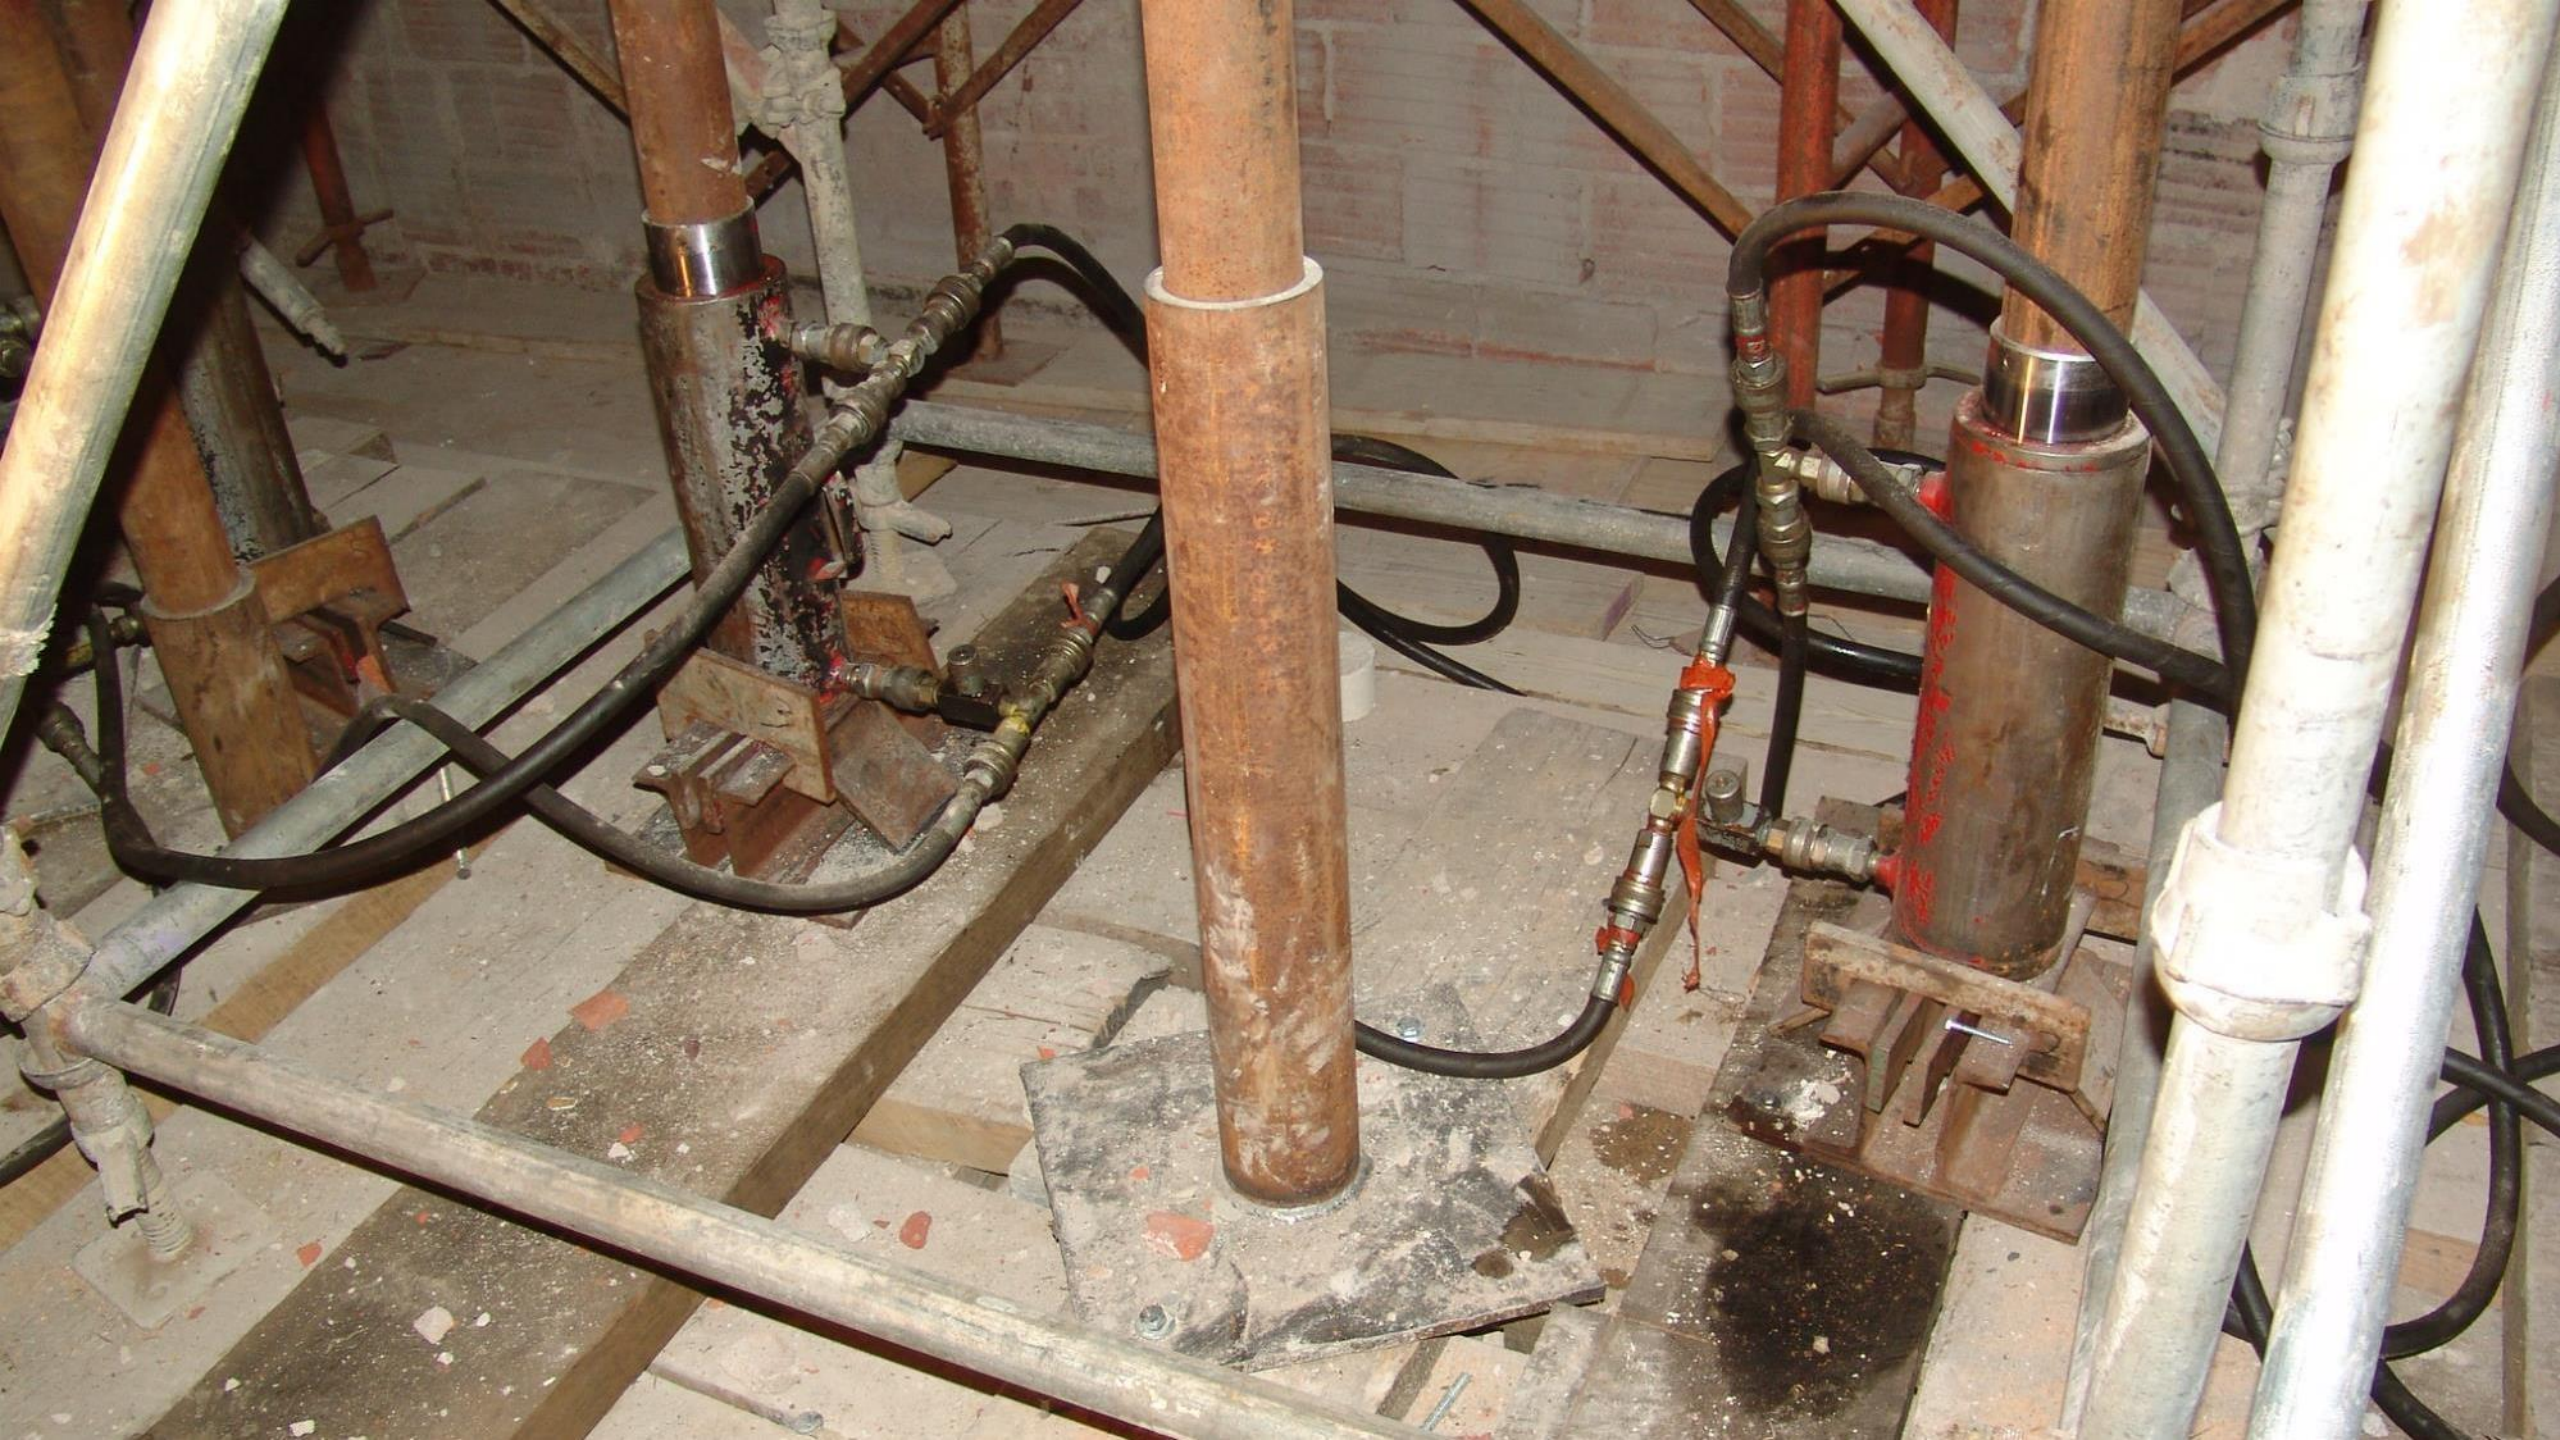
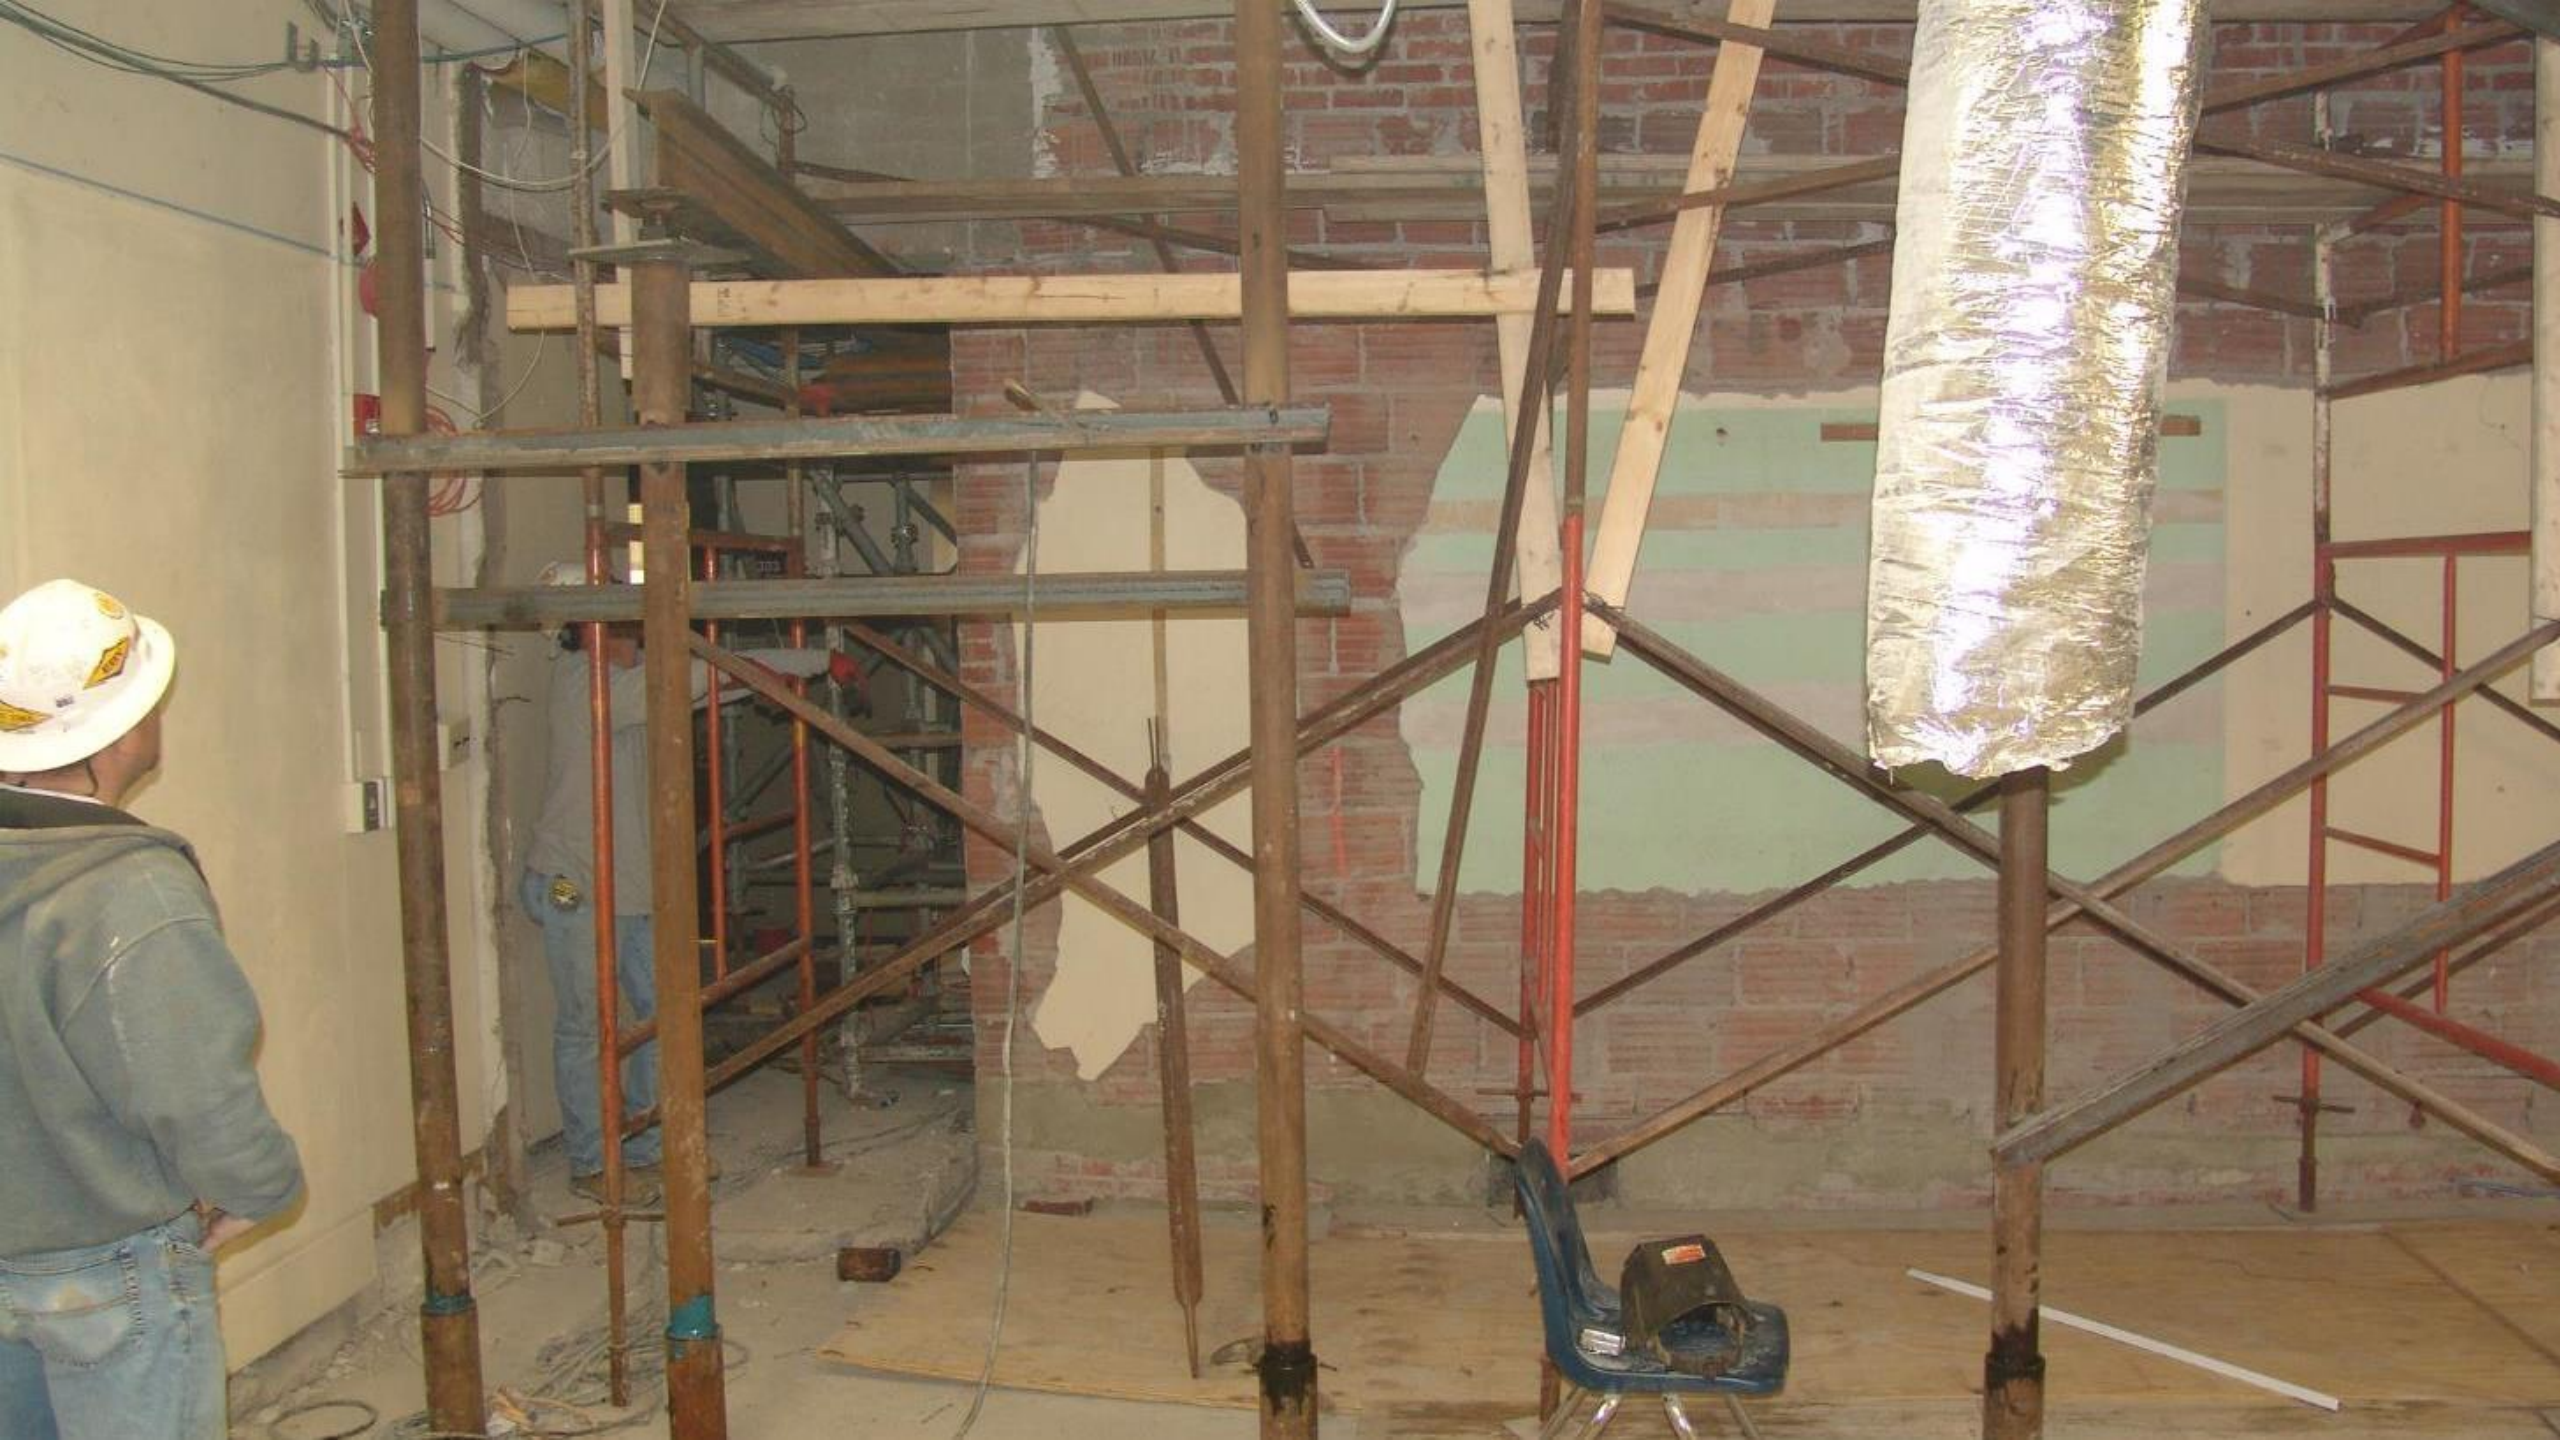
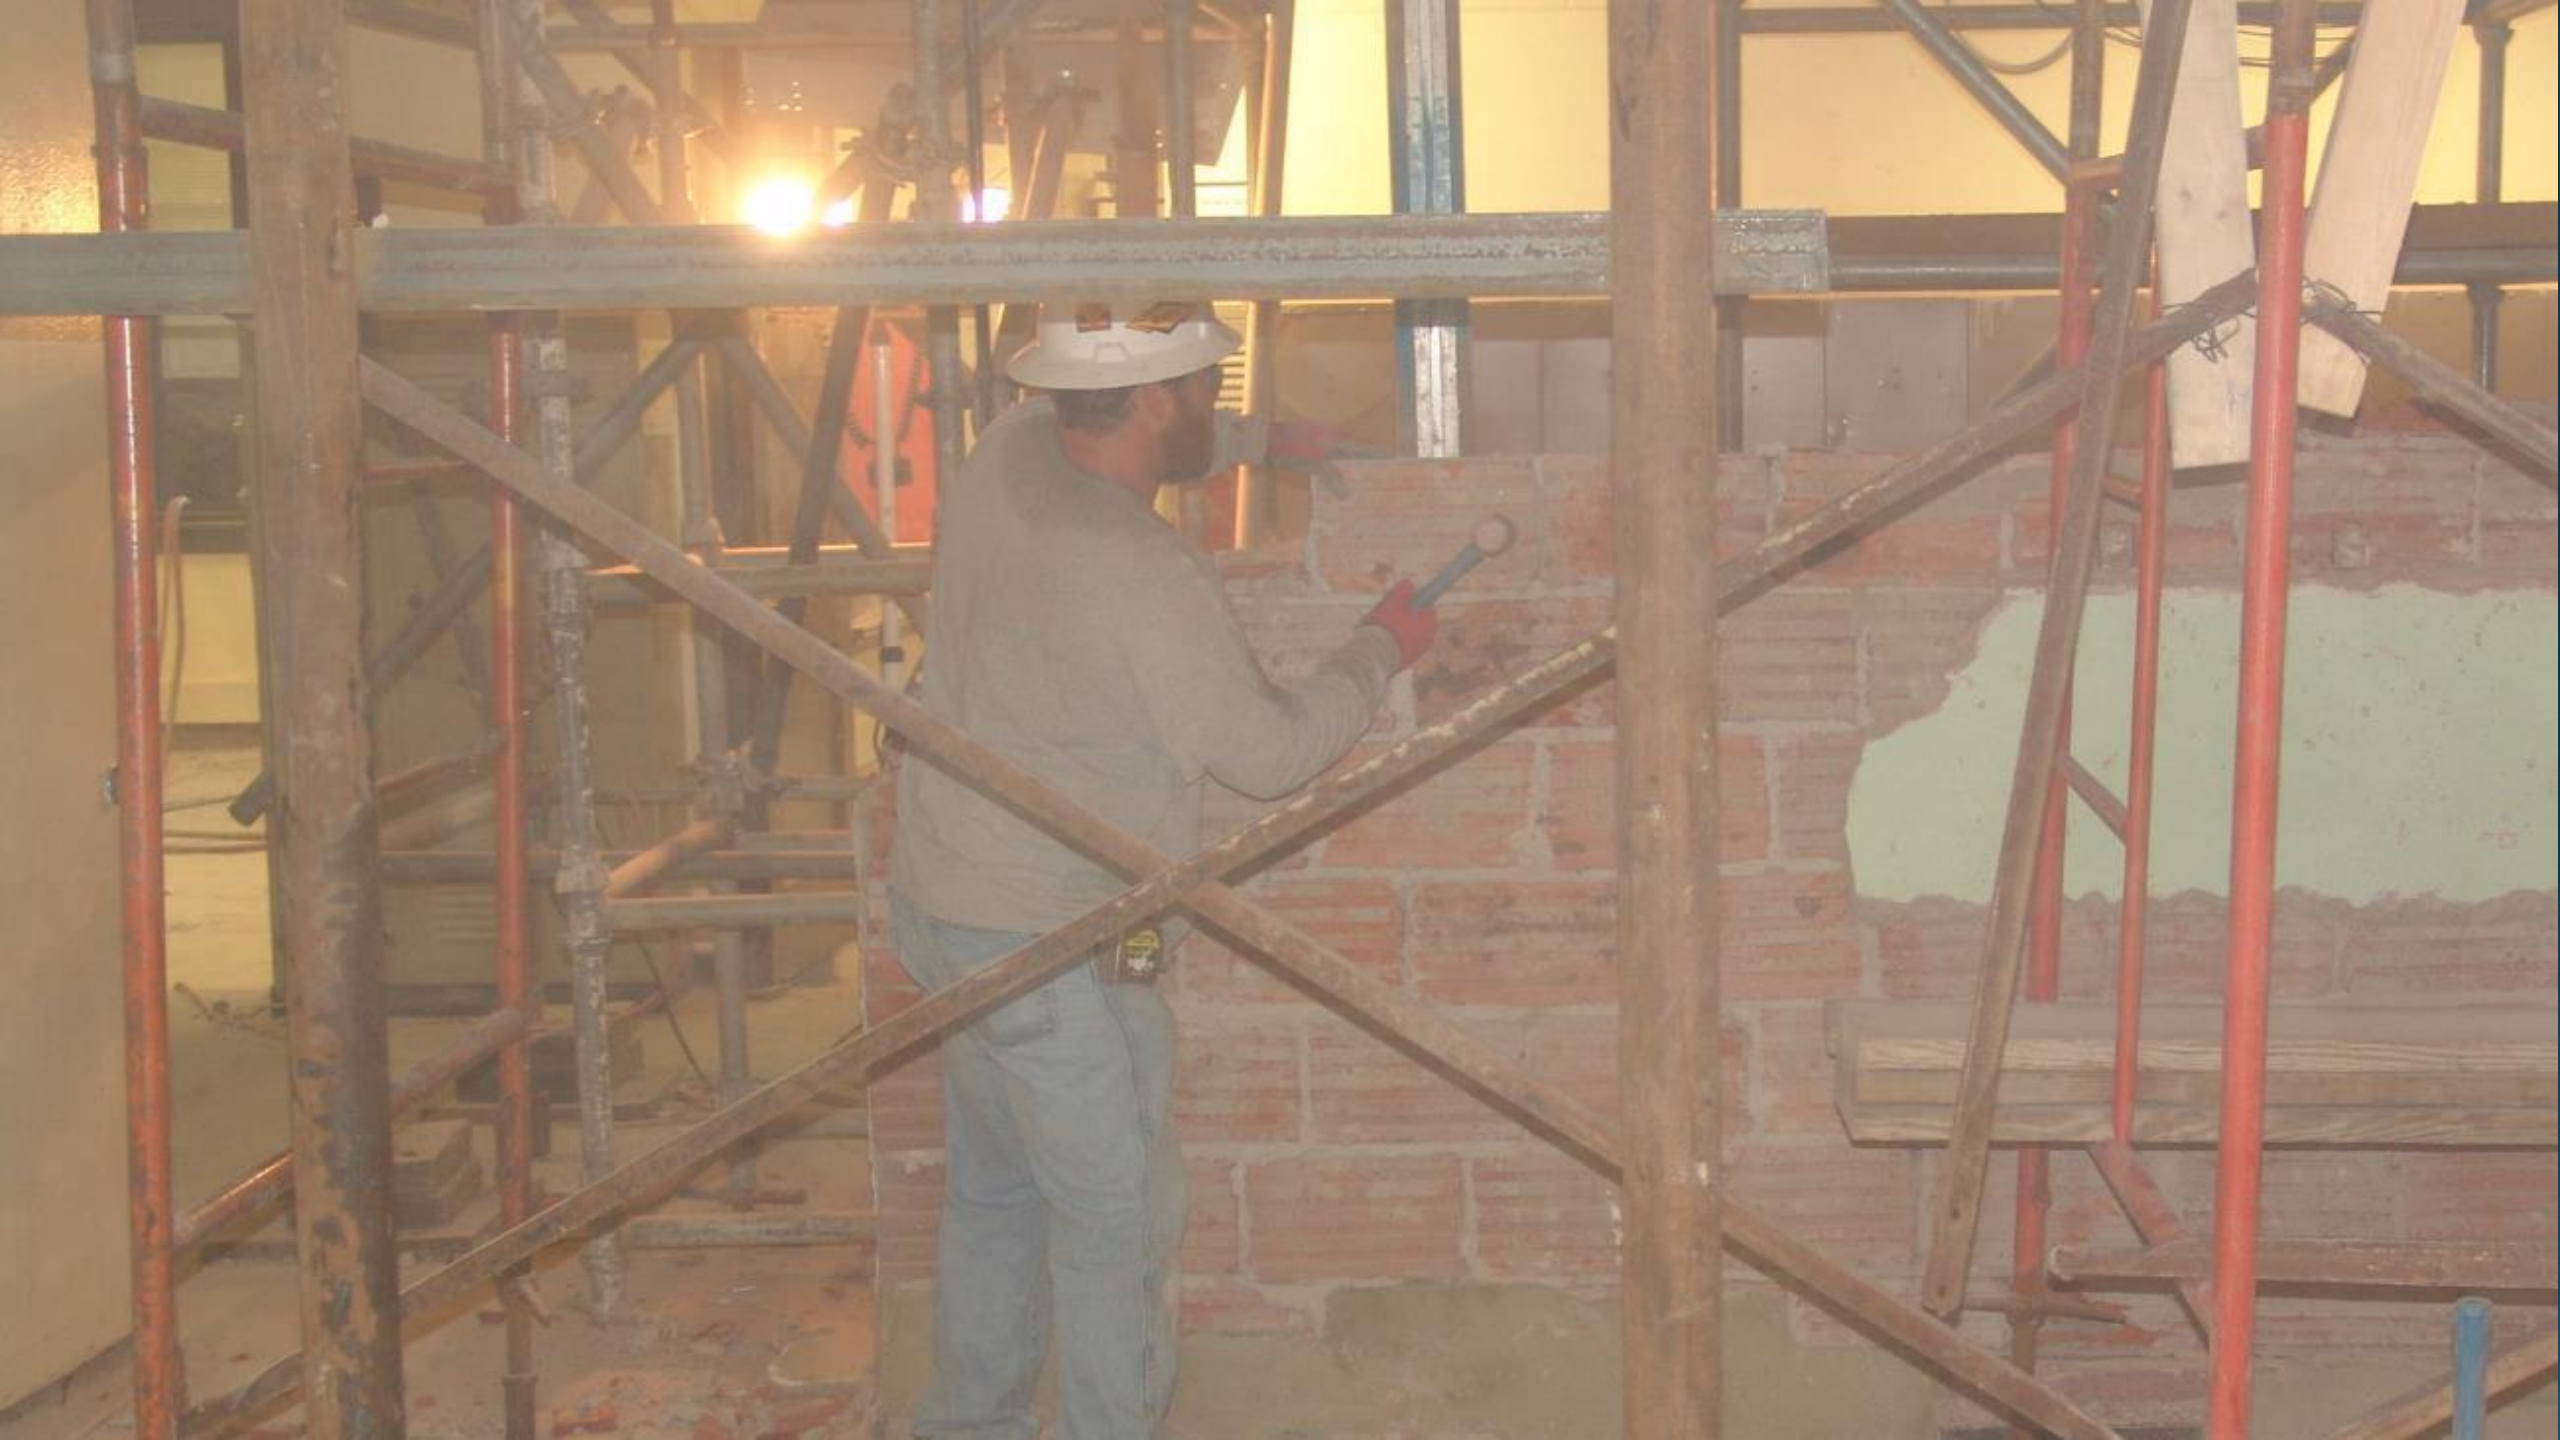
Installation of large banks of new HVAC ducts through interior load-bearing structural clay tile walls caused serious vertical displacement and near collapse of a section of the concrete floor system in one area of one of the buildings.

The partially collapsed floor system was raised back into its original orientation with a system of hydraulic jacks, and a new concrete masonry wall constructed to replace the severely damaged structural clay tile wall that originally supported the displaced floor slab section.
