October 18, 2023
ICRI 2023 Fall Convention

Lower St. Anthony Falls Dam Sill Joint Repair

Jake Fall, P.E.
Senior Materials Engineer

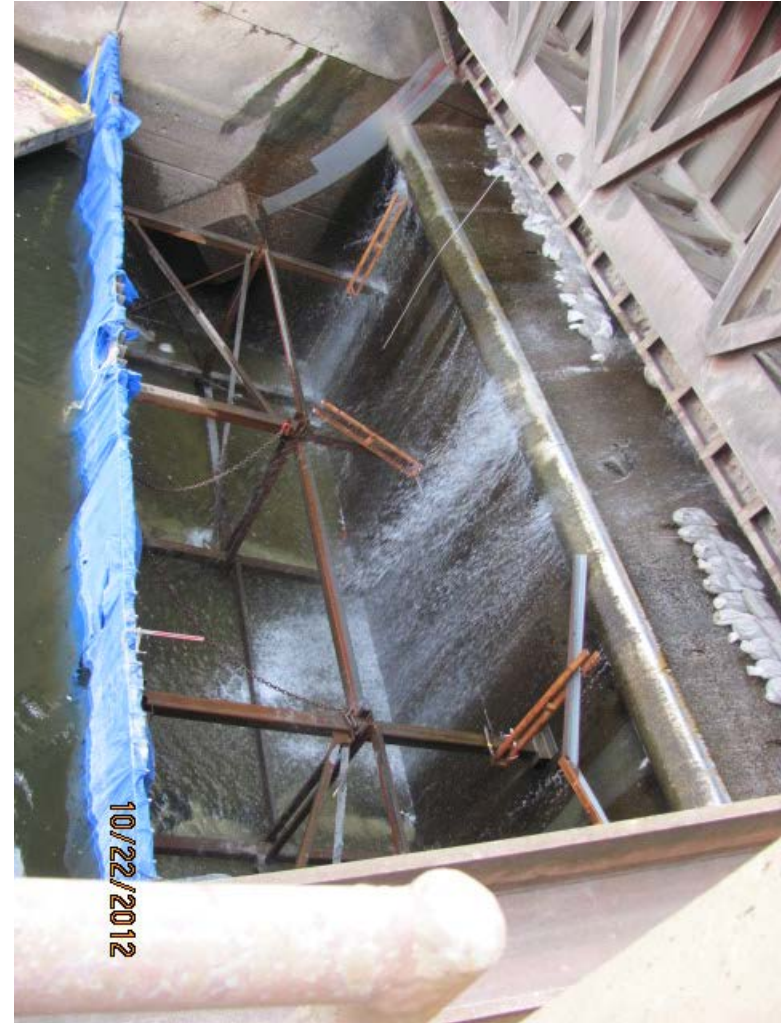
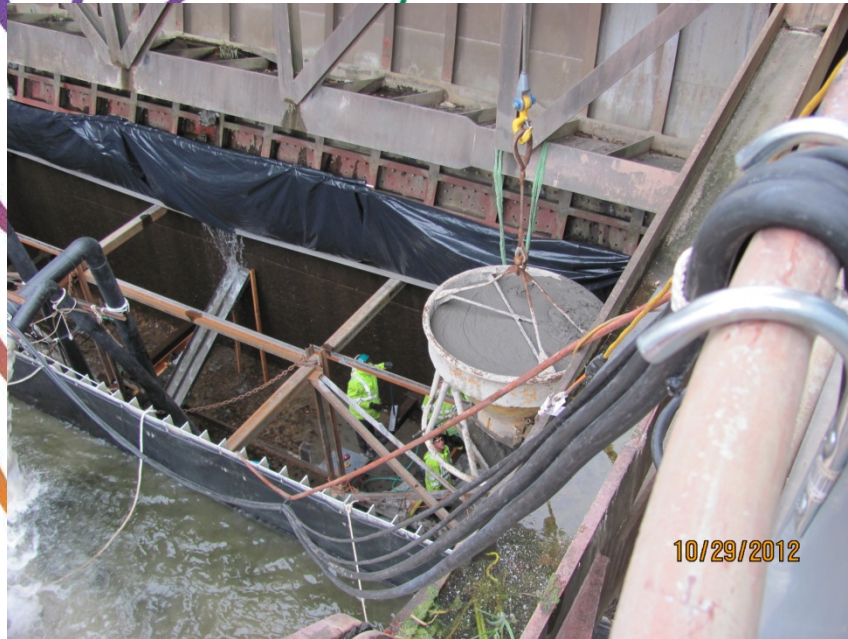
Gate Bay 3

Gate Bay 2

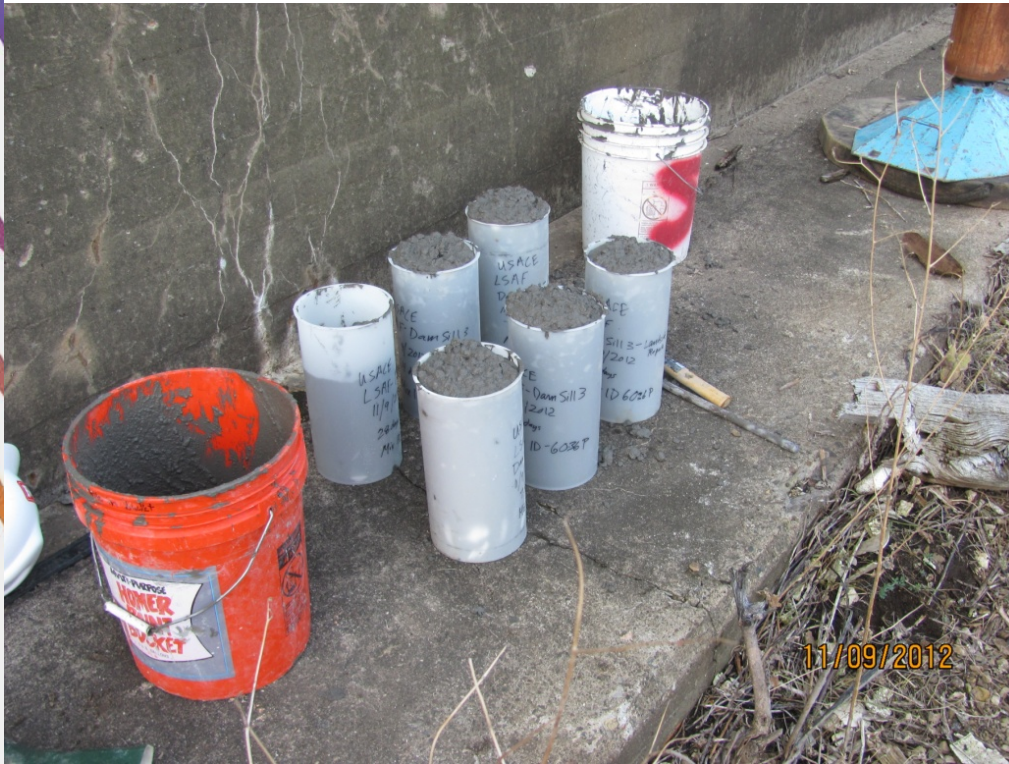
Concrete Placement – Compressive Strength

- 7 day – 5040 psi
- 14 day – 6365 psi
- 28 day – 7540 psi

Minimum Design Strength 6000 psi at 28 days
