# Unique Application of Epoxy Repair Gel to Eliminate Draft-Tube Surface Wear and Cavitation Potentially Improving Turbine Power Generation Efficiency

Norm Klapper / PEC  
Milamar Coatings, LLC  
Division of CASS POLYMERS  
Oklahoma, City, OK

ICRI - San Juan, P.R.  
March 16-21, 2016

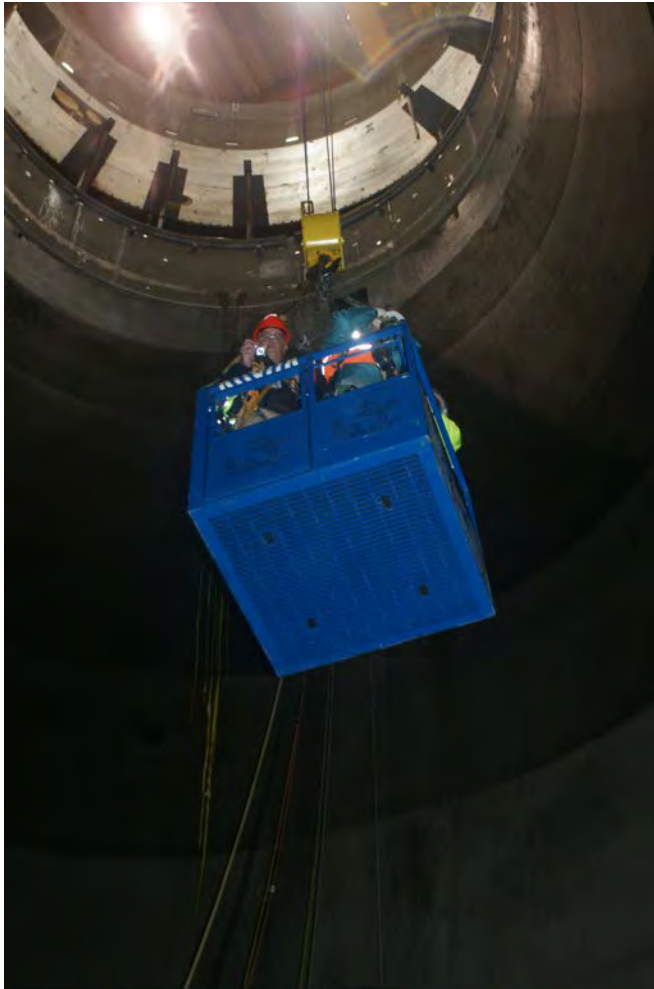
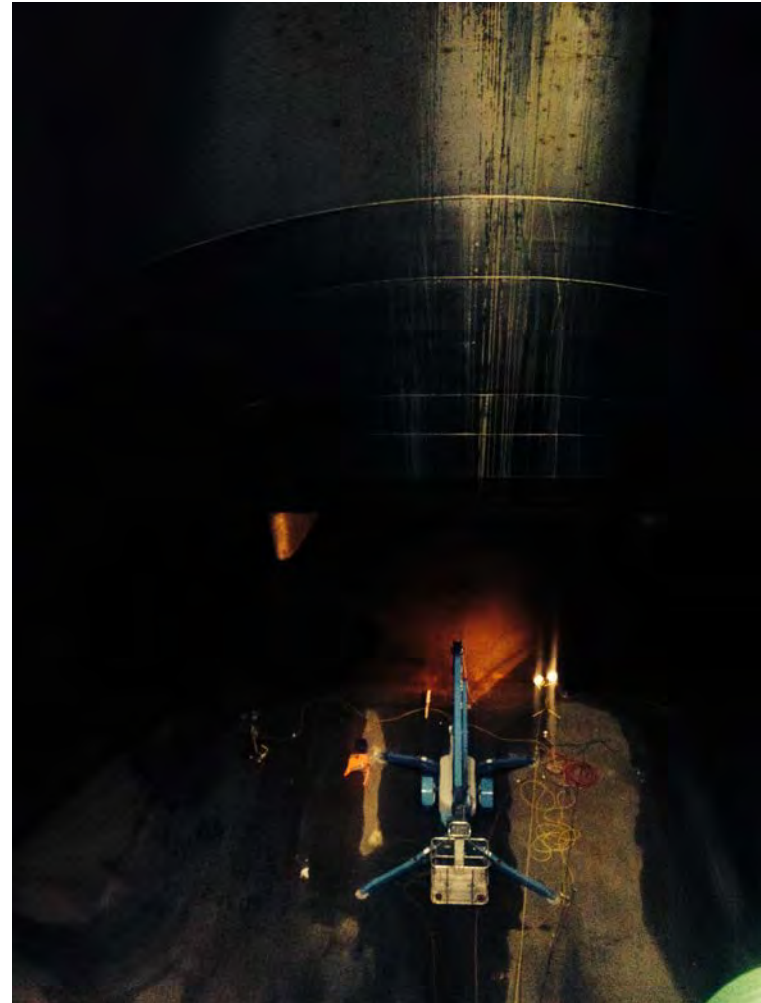
# Interesting Access Challenges

- 230 feet down for access to draft tube
- Access only by lift/basket hoist for all tools, materials, manpower
- 55 degree °F work environment
- No solvents allowed (for cleaning tools, potential automated application equipment)
- Confined space safety requirements
- Concrete walls under extreme water pressure - tried to inject water stop, hydraulic cements, other polyurethane products
- Some areas were left unrepaired / coated as a result of steady leaks

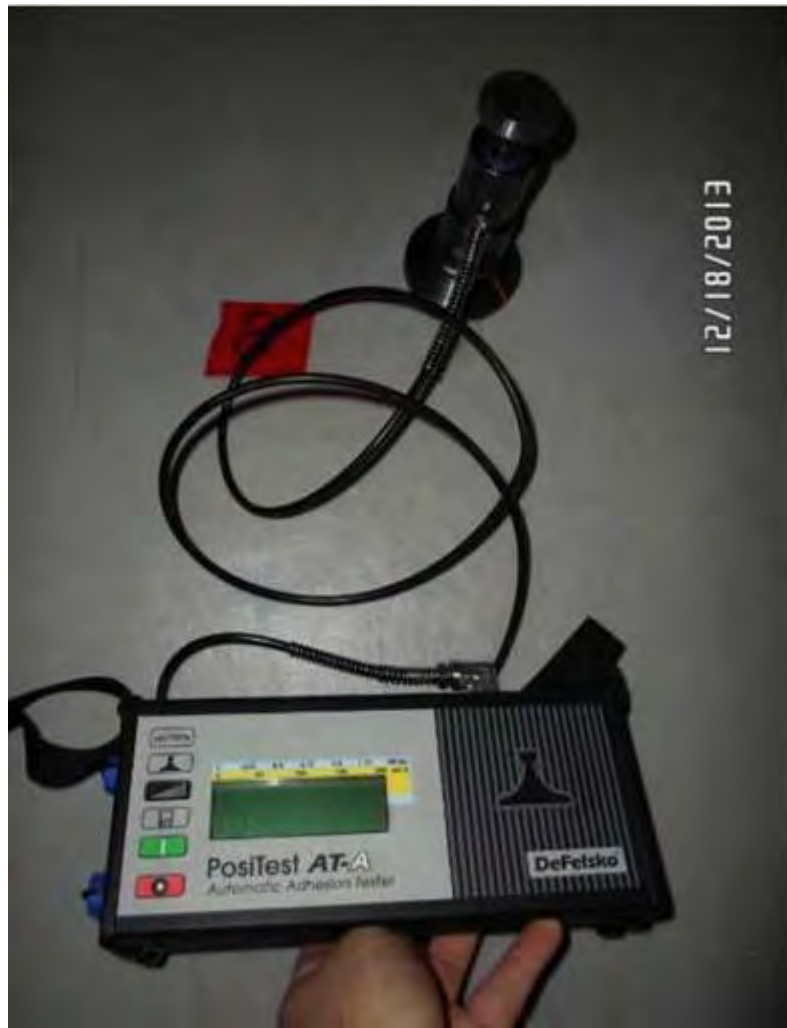
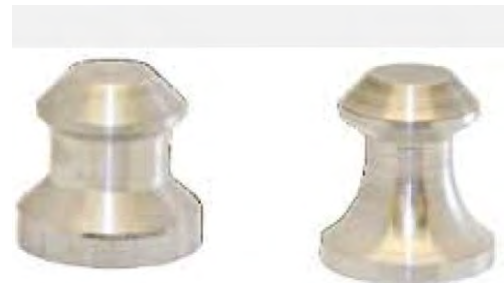
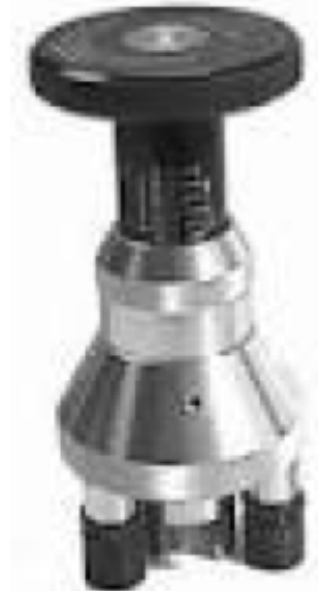
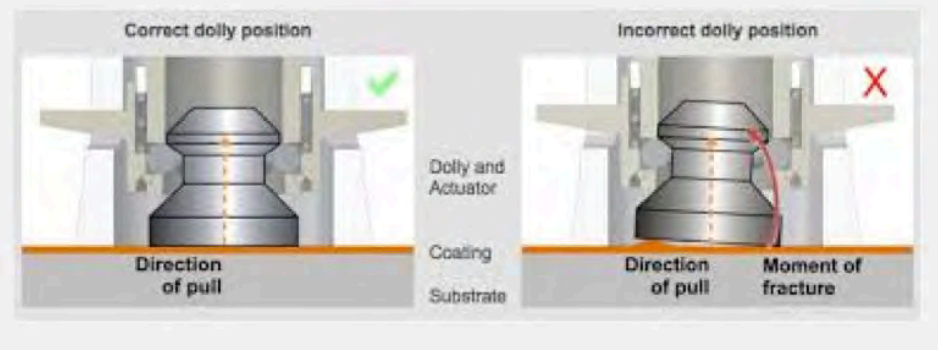
# Failure Mode Pull Testing Devices (Elcometer™)

- Medium Cure (MC) Epoxy – initial cure time 14-16 hours at 55°F / full cure after 48 hours
- Achieves maximum bond strength after 48 hours
- Bare, prepped concrete typically fails at 360-480 psi
- EPOXY GEL – failed at 460 psi, sheered at concrete NOT epoxy interface

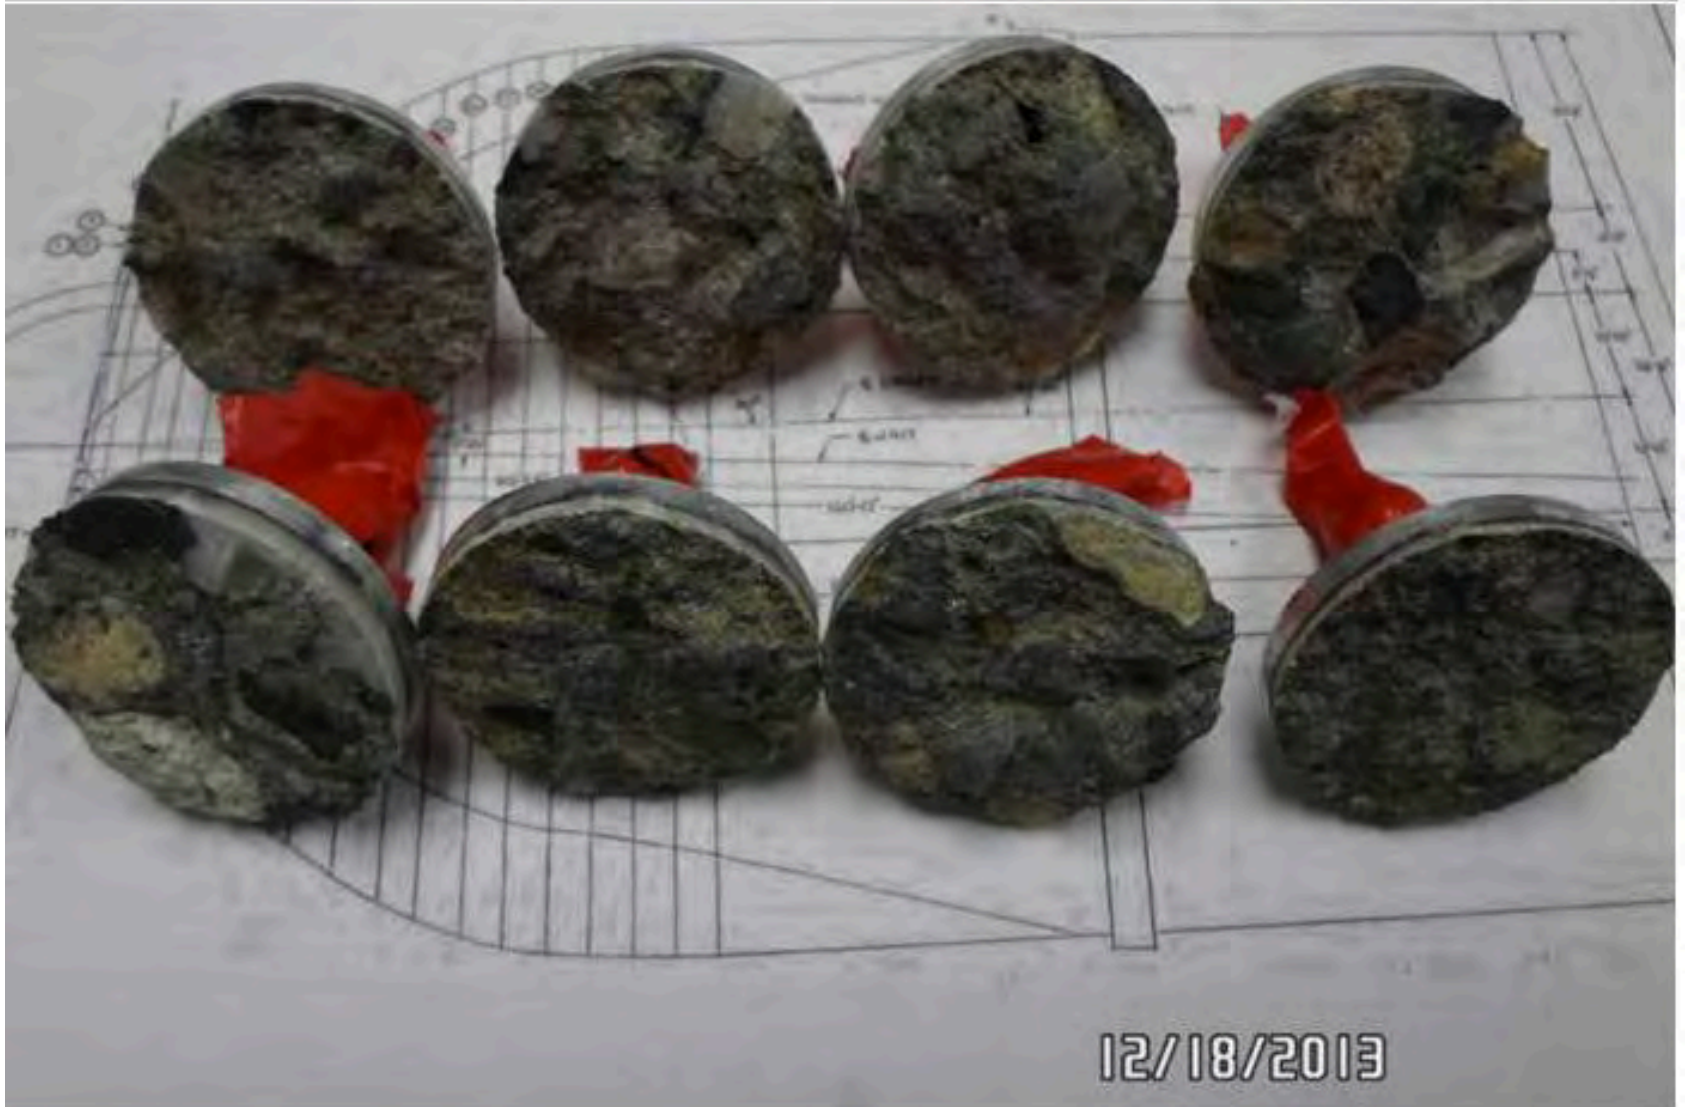
# TEST DOLLIES

**Average Bond =  
464 psi  
(concrete failed)**

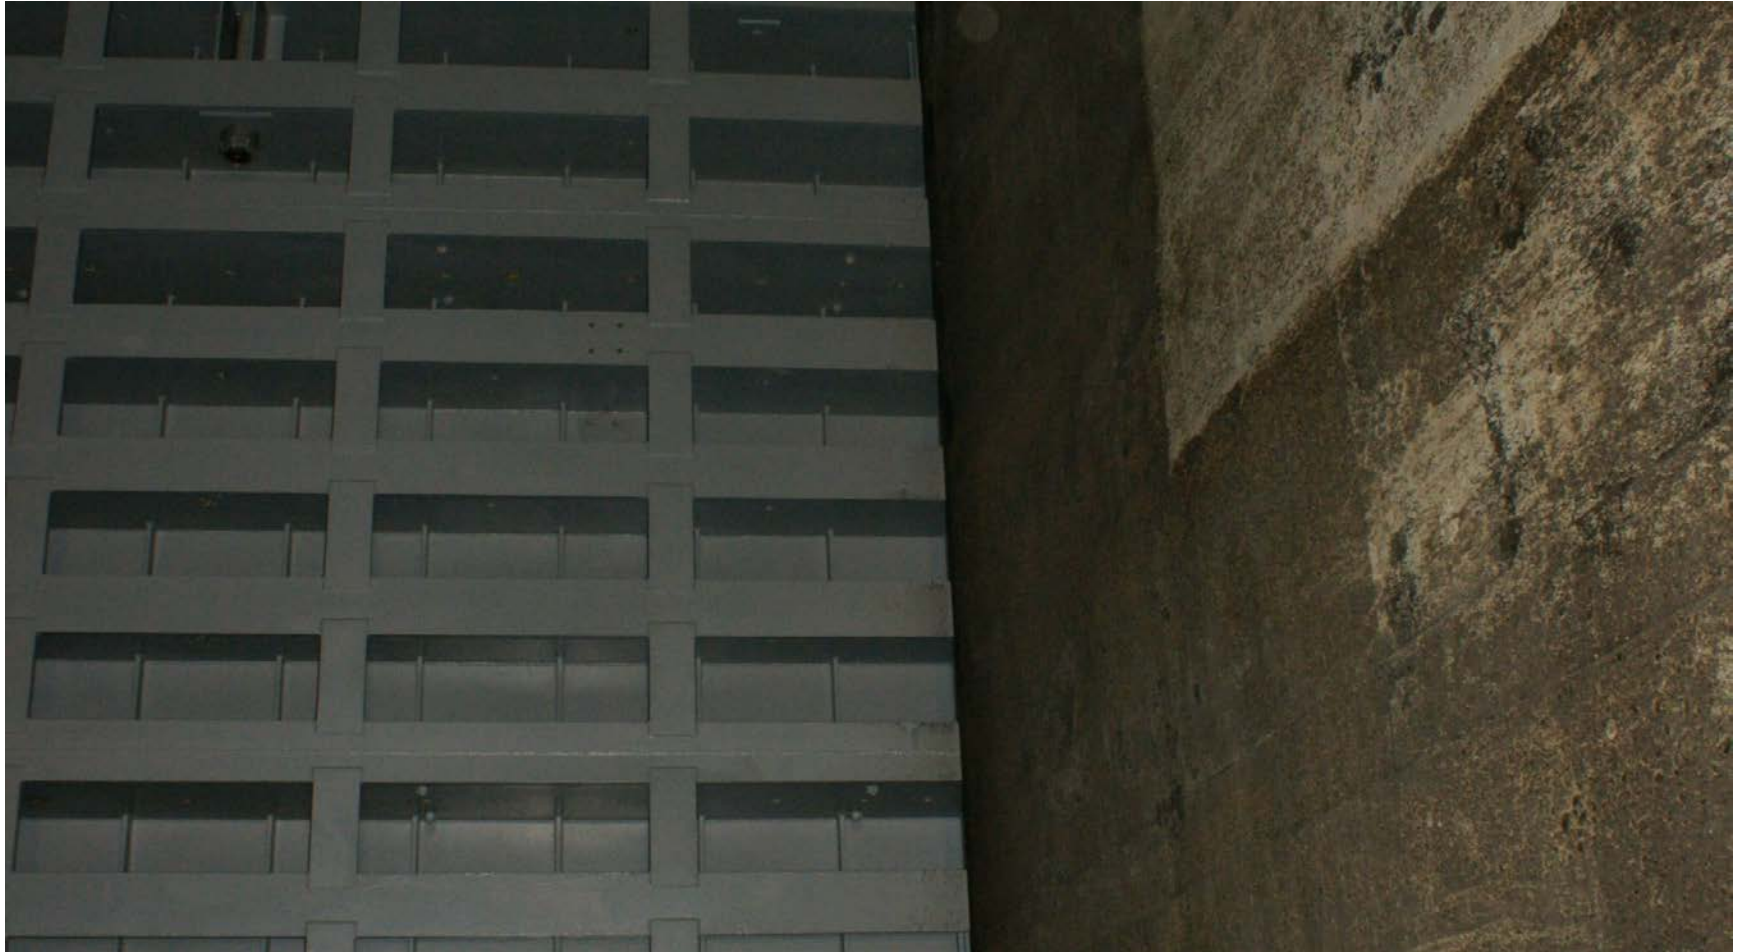
# Main Water Gate to Columbia River 40' x 40'

- Extremely deep wear/erosion from abrasion on entire concrete surface
  - $\frac{1}{2}$ " to  $\frac{3}{4}$ " deep linear wear lines, over entire 6400 SF surface, 40" x 40' x (4) surfaces
  - Holes, severe surface wear
  - Dirt and debris deeply impregnated in surface
- Potential cavitation from draft tube outflow
  - Back-pressure on water flow exiting from turbine
- Poor flow characteristics due to cavitation
  - Hazen-Williams friction factor
