# Nondestructive Evaluation (NDE) Methods for Quality Assurance of Epoxy Injection Crack Repairs

By Yajai Promboon, Ph.D., Larry D. Olson, P.E., and John Lund, P.E.

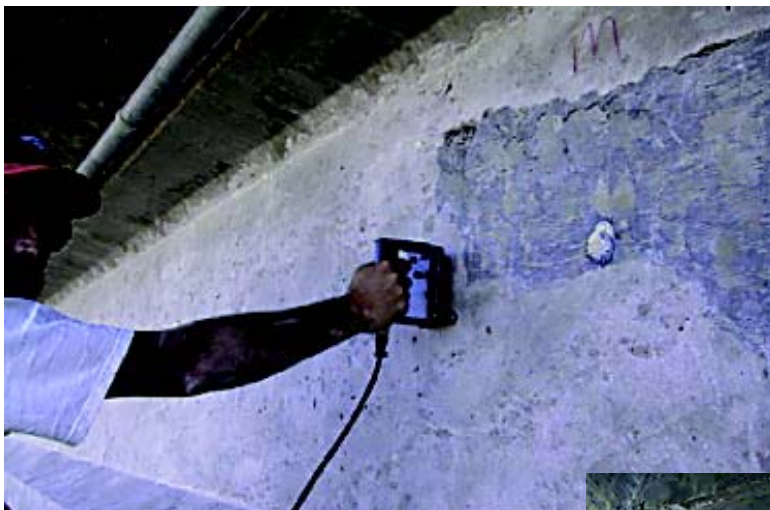
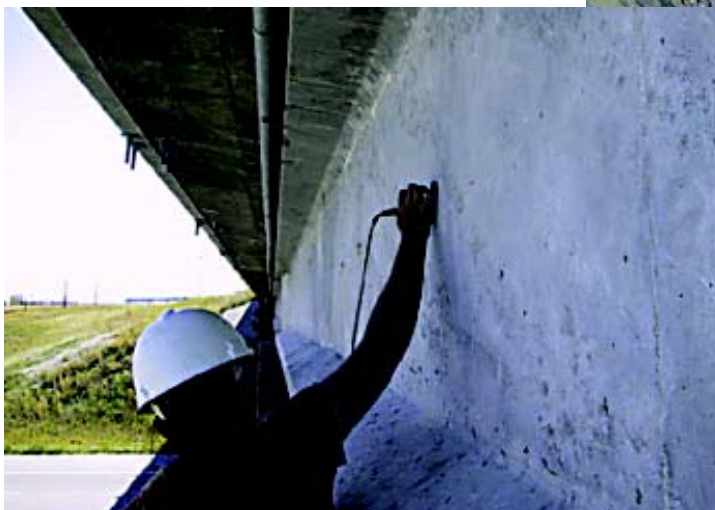
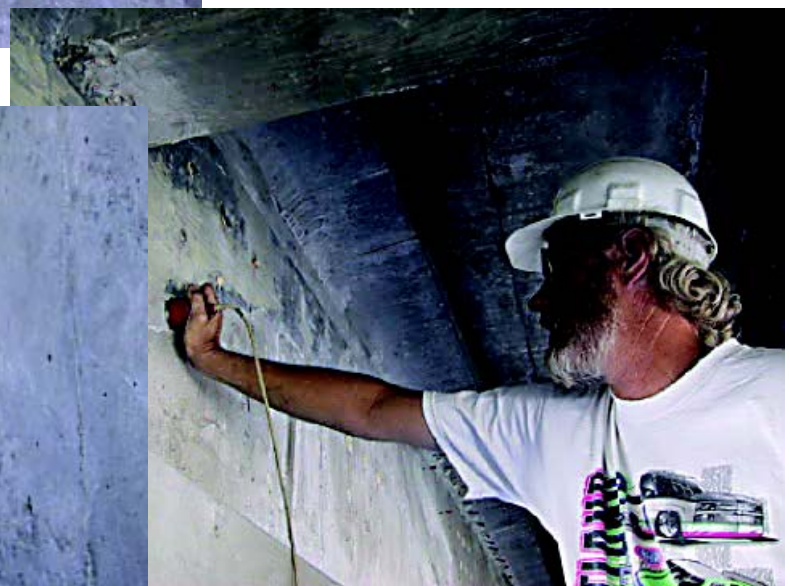
Fig. 6: Nondestructive test setups for IE and ultrasonic pulse velocity tests

IE is best at characterizing unfilled cracks or voids parallel to the structure surface. UPV is suitable for detecting unfilled cracks or voids in other directions. IE and UPV are less sensitive to cracks that are perpendicular to the test paths. However, with angular UPV test paths, the UPV method can be used to detect perpendicular cracks. A combination of the two nondestructive testing methods was found to be suitable in detecting unfilled internal cracks. The field test setup of the two tests are shown in Figures 6(a) through (c).

The damaged section on the concrete girder was approximately 70 ft long. The cracks and spalls were most severe on the web and bottom flange of the east side of the damaged concrete girder. The nondestructive tests were performed on a "spot-check" basis. A test grid consisting of a 6 x 6-inch grid over a 1 x 1-ft area was set up at each station. A total of 16 stations was randomly selected for NDE on the web of the repaired concrete I-beam girder, but all were located in areas that had filled cracks. The IE tests were performed on the west side of the girder, at every grid point, at every station. The IE test locations and test paths are shown in Figure 7(a). If the IE tests detected possible unfilled internal cracks, UPV tests were used in the area to confirm and further identify the existence and extent of the unfilled cracks. The UPV tests were performed with two grease-coupled, 54-kHz UPV transducers. The transducer that was used as a source was placed at the center of each test area on the east side of

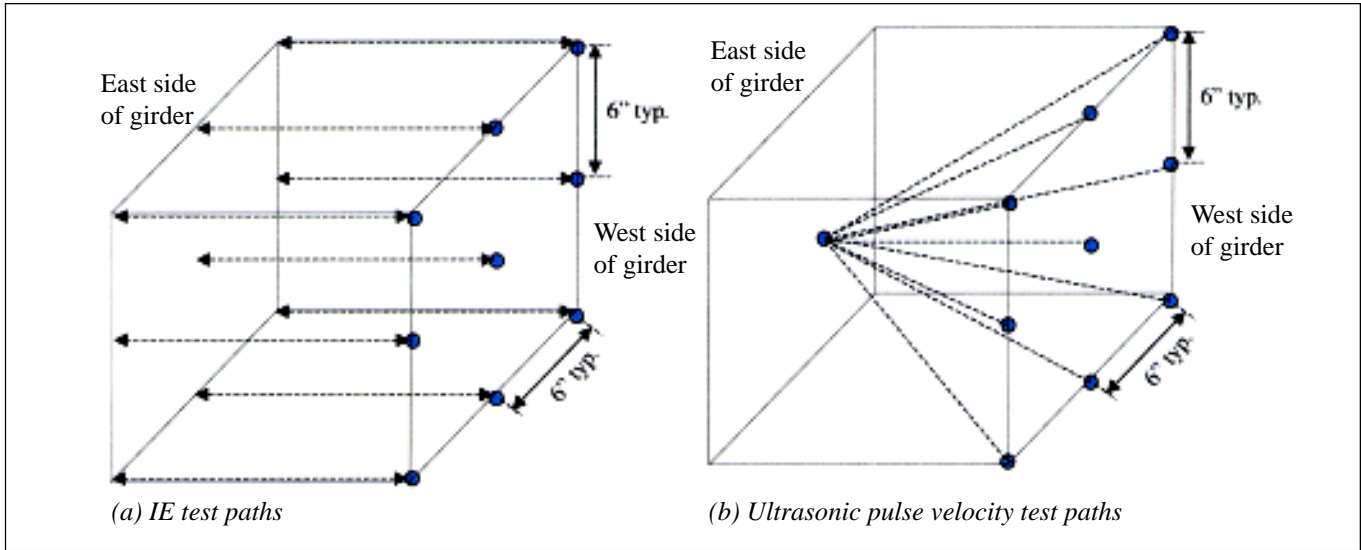
Fig. 7: Typical nondestructive test locations and paths at each station

the girder, while the receiver transducer was placed at each grid point on the west side. A total of 9 UPV test paths were performed at each station for a total of 144 test paths on the girder. The UPV test locations and paths on the web at each station are shown in Figure 7(b). Note that Figure 7 shows only the web portion of the I-beam girder.
