# Sea Colony Promenade Repairs

By Brian Daley

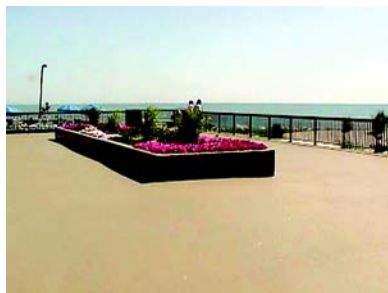
*Sea Colony Promenade*

Despite the size of the project, its complexity, and weather challenges, the restoration contractor finished within the owner's aggressive schedule. Now complete, the Sea Colony Promenade repairs were not only achieved but exceeded all the owner's goals. Nearly 400,000 ft<sup>2</sup> of top and underside concrete had been inspected, with substantial quantities of failed and deteriorated concrete replaced by new sound patching concrete. The entire complex's appearance was significantly improved. Hundreds of deteriorating and strapped-on parapet panels that blocked views of the beach and ocean and a quarter-mile of faded, dilapidated rails whose posts caused concrete cracking are all now replaced by over 6,000 linear feet of clean, new, and durable full-height aluminum rail systems, unifying the appearance of the north and south halves of the promenade and fully exposing the beautiful dunes and shoreline to all residents. Finally, over 200,000 ft<sup>2</sup> of top and bottom concrete surfaces were protected from harsh beachfront sun, sand, and salt conditions by attractive and long-lasting protective coatings. Now free of concern for the condition of their promenade, the owners and residents of Sea Colony Condominiums can fully enjoy their summer fun.
