EMERGENCY MASONRY REPAIRS TO SAM H. WHITLEY HALL

TEXAS A&M UNIVERSITY AT COMMERCE

BY MARK LEMAY

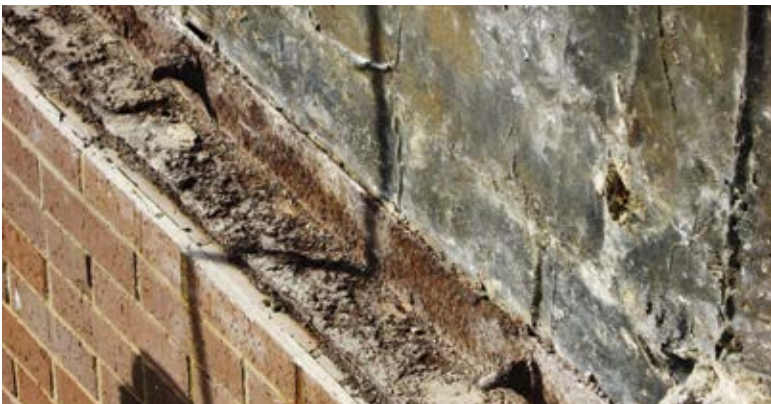
Fig. 7

Because no weep holes were observed at any of the relief angle locations, random removal of the brick veneer was performed at several floor levels. Mastic was not observed at any of the relief angles and many of the steel angles were observed to be mildly corroded on the lower levels to severely corroded on the upper levels (Fig. 7). The lack of proper flashing over the relief angles and the absence of weep holes to direct moisture to the exterior of the wall significantly compromised the life span of the brick veneer system on the east and west elevations.

Although the lack of protection for the steel relief angles had yet to result in the failure of an angle, all parties agreed that this condition needed to be rectified. Working closely with the contractor and the material supplier, the engineer devised an innovative approach to holding the upper portions of brick veneer in place while several rows of brick were removed to facilitate the removal and replacement of corroded steel relief angles. It was determined that staggered rows of stainless steel helical wall ties installed just above the removal area could hold the brick veneer in place during the short period of time it took to remove and replace the relief angles, install proper flashing, and reinstall the brick.
