Concrete Repair of Hangar Building 340

Naval Air Station, North Island, San Diego, California

By Roy Becker and Adriano "A. B." Bortolin

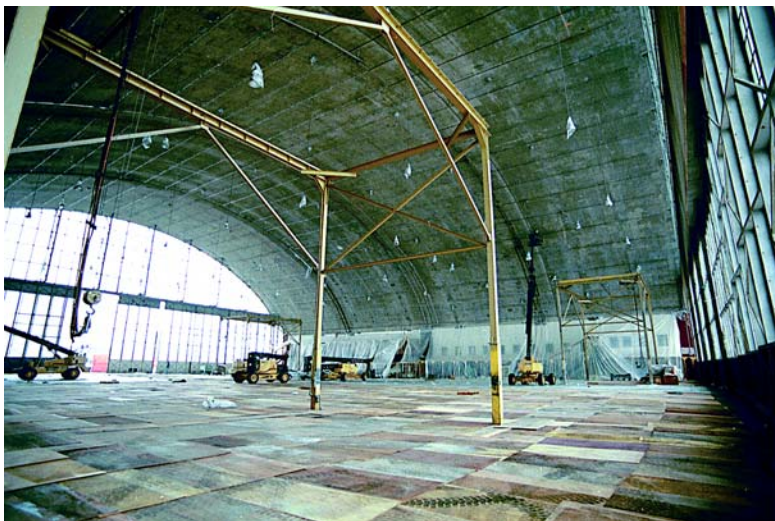
This 62-year-old reinforced concrete structure has experienced significant concrete spalling on both the underside of the thin shell concrete roof and the exterior arches. The spalling was mainly due to the corrosive marine environment that exists at this hangar, which is located about 400 ft (120 m) from San Diego Harbor.

The most significant spalling occurred in the year 2000 and greatly concerned the Navy, as some spalls fell from a height of nearly 80 ft (24 m) onto the hangar bay floor that was occupied by large numbers of Navy personnel and costly helicopters. Some of the concrete spalls were from previously repaired spalls, and they weighed as much as 5 lb (2.3 kg).

Interior of Hangar Building 340
