# Precast Concrete Façade Investigation

By Mike Hoglund

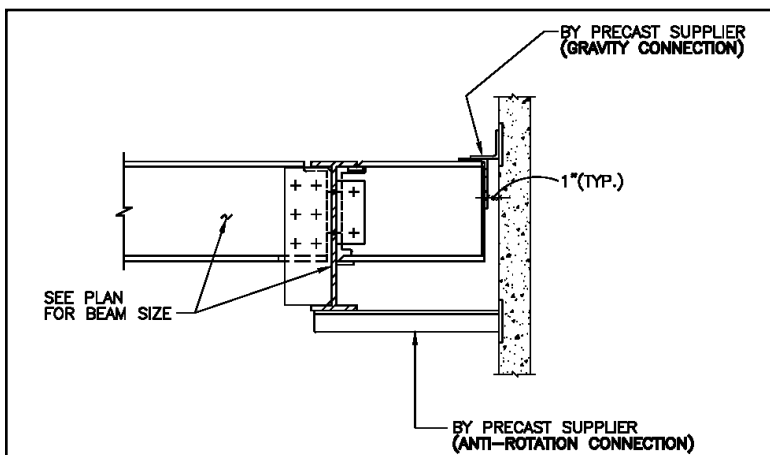
Fig. 3: Typical gravity and anti-rotation connections in a steel-framed building

Typically, precast concrete panels are connected to the building structure at two points; one to support the gravity load of the panel and the second to prevent rotation of the panel. Figure 3 shows typical precast concrete panel connection points to a building structure. This figure is of a steel-framed building where the gravity connection is on top of the slab and the anti-rotation connection is at the bottom of the spandrel beam.

Examination of the connections requires intrusive examination. Typical damage to precast concrete façade panel connections is from water intrusion resulting in rusting of the steel connections and/or delaminated concrete surrounding the connections. A temporary support of the precast panel is required while the repairs are being made, and may consist of a simple angle bolted to the slab, steel frame support, or other more elaborate temporary support.
