# MIAMI BUILDING FIRST TO BENEFIT FROM INNOVATIVE PILE JACKET

BY MO EHSANI AND ABHI TIPNIS

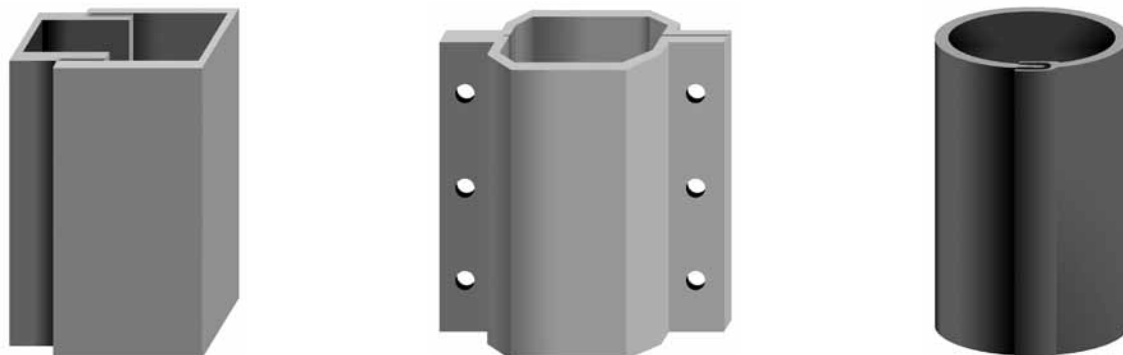
Fig. 1: Typical GFRP jackets used for repair of piles in North America

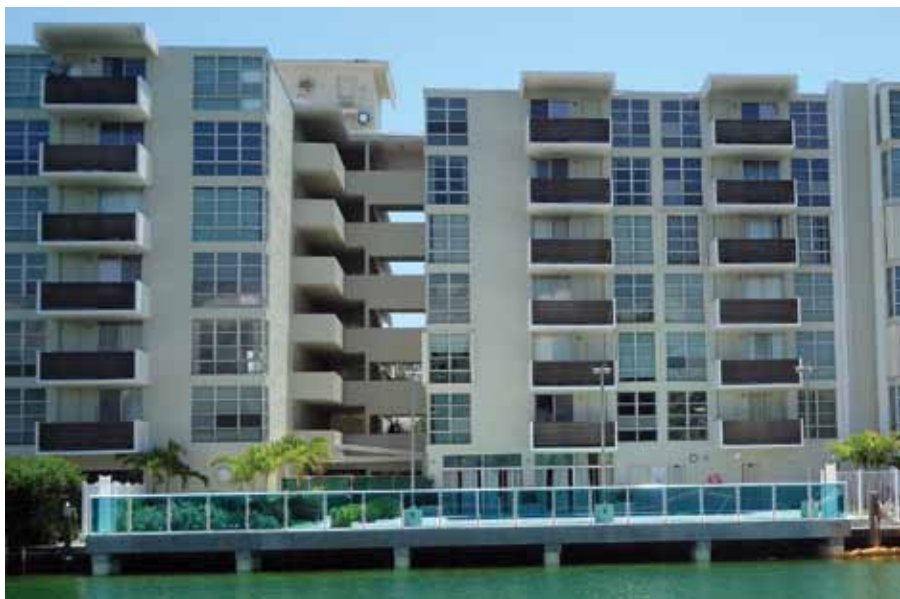
Fig. 3: Guilford House Condominiums, Bay Harbor Islands, FL

The first application of FRP laminates for the repair of underwater piles was recently completed at Guilford House Condominiums, Bay Harbor Islands, FL (refer to Fig. 3). The project is located on the environmentally sensitive South Florida intra-coastal waterway. Approval from the Florida Department of Environmental Protection (DEP) was required prior to restoration.
