Towson United Methodist Church Columbarium Restoration

Cause and Effect

CONCRETE REPAIR BULLETIN MARCH/APRIL 2001 7

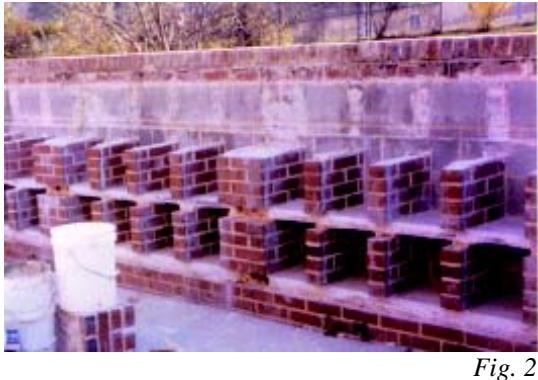
Fig. 1

Culbertson Restoration Limited of Maryland was enlisted in the spring of 1995 to perform these repairs. The specified scope of work included the removal of existing brick wall cap; removal and replacement of the masonry facade; removal of the existing concrete lintels and marble cover-stones; waterproofing of wall and niche interiors; and installation of new cover-stones, metal accent plates, and stone wall cap. Detail 6/A1 identifies, in general, the proposed scope (see Figures 1 and 2).
