Exterior Repairs to University Building

Exterior of the Robert Purcell Community Center

RPCC

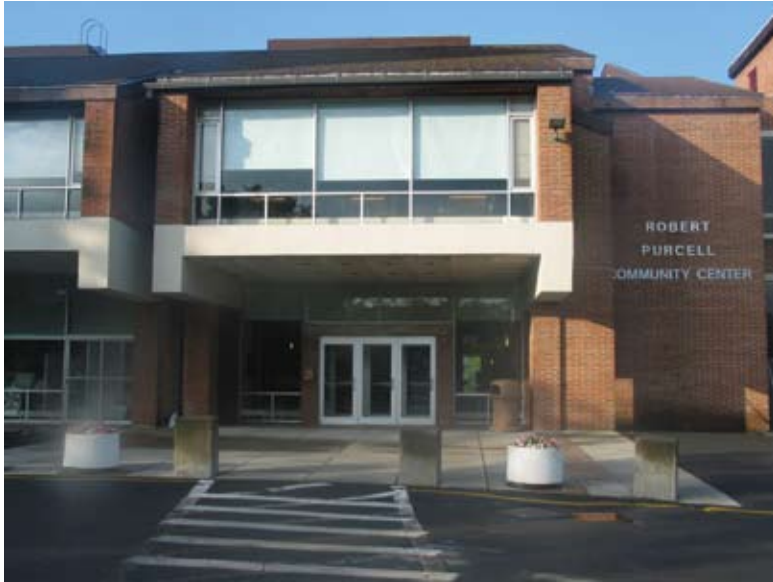
Exterior exposed concrete cantilevered beams and spandrels of third floor projecting bays on all four sides of the building have been damaged by cracking of the concrete caused by cyclic freezing-and-thawing action of moisture entering the cracks in the concrete. The damage was further exacerbated by alkali-silica reaction (ASR) between silica of certain

Concrete damage appears to be most severe in the front-end sections of the cantilevered beams. There were several primary sources of moisture in the concrete:

Moisture penetration into concrete through cracks in the top of beams was possible because of an apparent lack of through-wall flashings and weep holes at the base of masonry walls supported by cantilevered concrete beams. Delamination and spalling of the concrete posed a potential hazard to the property and public.

An alternative method proposed by the structural engineer was based on a process of vacuum injection/impregnation. This method creates a vacuum simultaneous with injection on isolated sections of beams. The vacuum process draws resins into cracks much smaller than through conventional injections. Because of the extensive cracking, much of it on a micro scale, the technology appeared to be worthy of consideration.

- removing and shoring bricks bearing on the top of the beams;
- sandblasting previously applied coatings, surface sealing cracks;
- setting a network of ports to create a vacuum, then drying the internal cracks via the vacuum;
- injection of the epoxy resin;
- test coring;
- application of the finish coating;
- adding flashing and weeps; and
- brick replacement.
