# REPAIRING LEAKING EXPANSION JOINTS AT RECLAMATION FACILITIES

BY KURT F. VON FAY AND WESTIN T. JOY

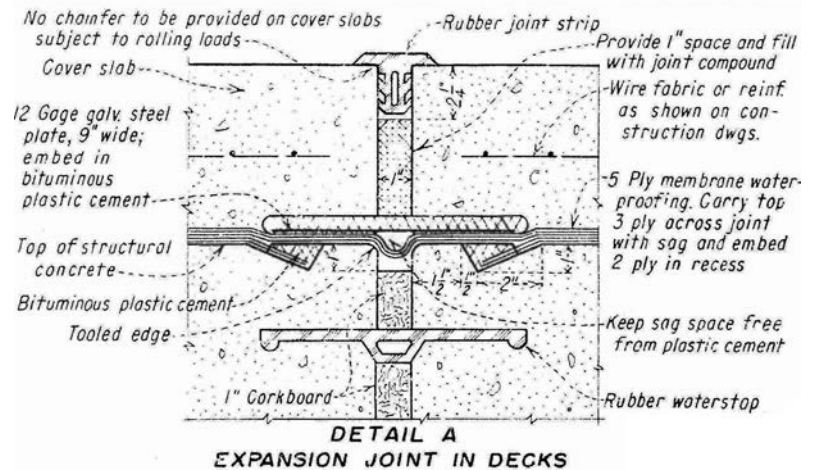
Fig. 4: Typical expansion joint detail (Note: 1 in. = 25.4 mm)

Numerous Bureau of Reclamation facilities are built with a similar expansion joint detail (refer to Fig. 4). While this detail appears sufficient and substantial, many of the facilities are experiencing leaks through these joints. MERL was first approached about trying to find a way to prevent leaks through the expansion joints at Folsom Dam Power Plant. Previously, Folsom's staff had tried unsuccessfully to repair the leaks by replacing the joint compound and rubber joint strip.

After examining the joint details, it was determined that the best approach would be to drill holes for ports that were angled to deliver the grout between the top metal plate and the lower rubber water stop (Fig. 6 and 7). The metal plate and rubber water stop would serve to help contain the grout as it expanded, resulting in a more durable repair.

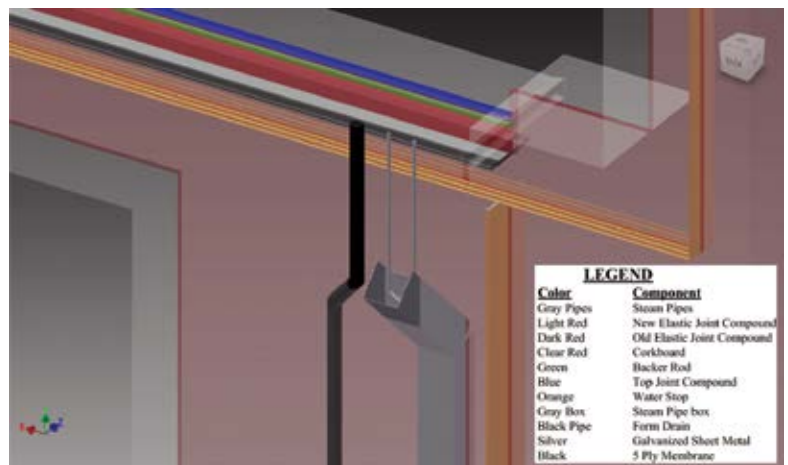
Fig. 5: 3-D drawing of expansion joint at Folsom Dam

been the result of a failing waterproofing membrane and/or water seeping through existing rock pockets that resulted from poorly consolidated concrete during construction. During injection work at Folsom, stagnant water was pushed out of the joints by the expanding grout; at other locations, grout easily flowed out the bottom of the joint, indicating there was a path around the rubber waterstop.

To determine the best way to repair the joints, a three-dimensional (3-D) cross-section drawing of a typical expansion joint at Folsom was created (Fig. 5). All of the relevant information about the
