# VENTURA PROMENADE PROJECT

BY GEORGE LEPORTE

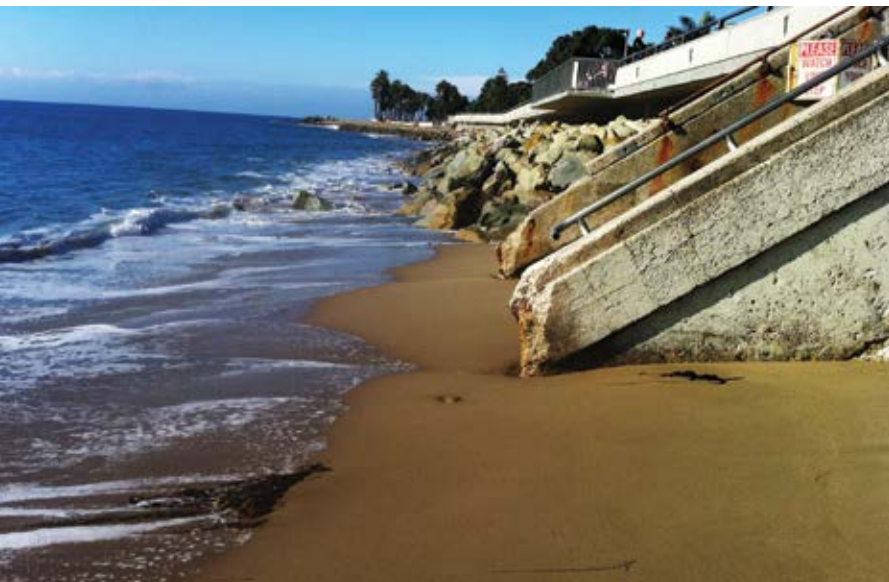
Fig. 1: Ventura seawall coastline

Built between 1967 and 1970, the Promenade stretches over 2000 ft (610 m) from the Ventura Pier northwest to the Ventura County fairgrounds. Its average height is 6 to 8 ft (1.8 to 2.4 m) above the typically sand-covered rip rap and cobblestones below, as seen in Fig. 1. This area takes a serious pounding through the winter storm months, as the waves wash away the sand and expose the rock below.

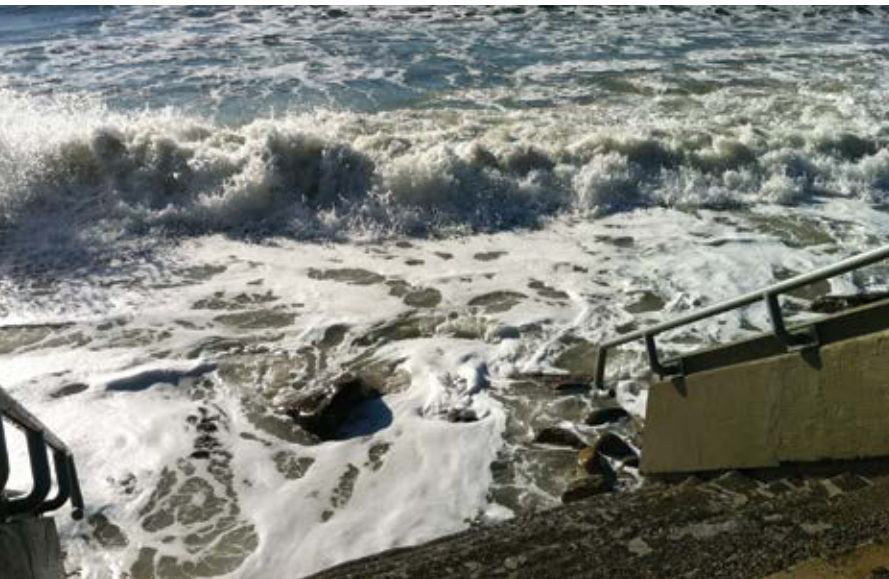
Fig. 2: King tide

An example of king tide pounding waves can be seen in Fig. 2. These relentless waves and the constant saltwater exposure create a rigorous and demanding environment for concrete structures. These harsh conditions were extremely corrosive to the reinforcement strengthening the Promenade,

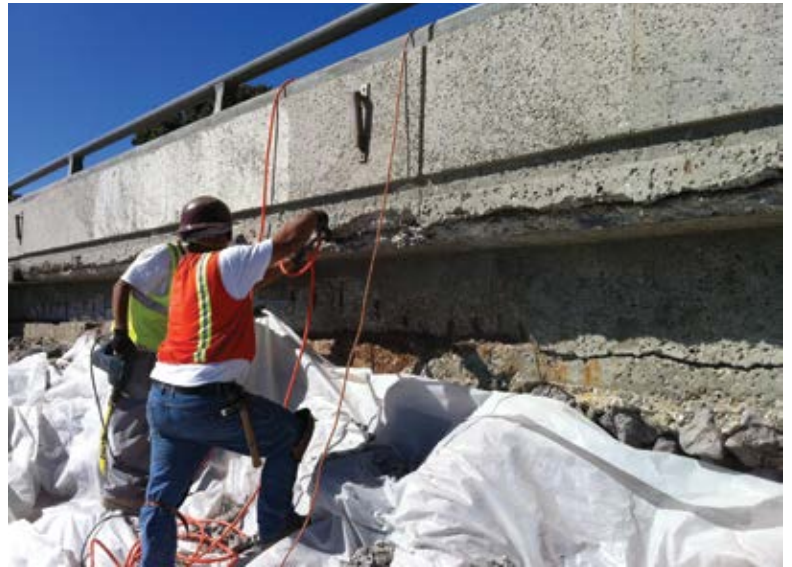
Fig. 9: Generators and equipment topside

Because of the unpredictable nature of the waves, all generators and equipment needed to stay above, and extension cords for demolition hammers and wire wheel grinders were dropped below (Fig. 9). In addition, all equipment had to be hauled topside for the 3- to 4-hour high tides every other week during the new and full moon phases. During the project, there was a storm front that moved south from the Gulf of Alaska that resulted in the evacuation of beach-front residences and closure of the Pacific Coast Highway to the south. This storm, combined with the new moon high tides, resulted in 15 ft (4.6 m) waves pounding the wall during the project repairs and gave perspective as to why the repairs were so important to the community.

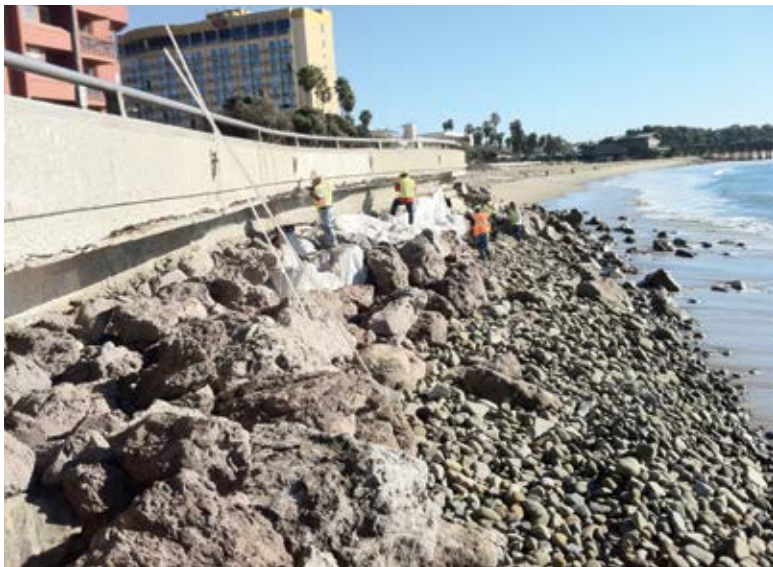
Fig. 10: Shoreline protection

In addition to the threat of waves, the other major concern during this project was maintaining a clean work area. To prevent construction debris from contaminating the area, drop cloths were placed on top of the rocks and shoreline (Fig. 10). Because of the potential inundation, all debris was constantly removed from the work area.
