# Maynard Street Parking Structure Renovation and Restoration

Award of Excellence Winner,  
Municipal Category

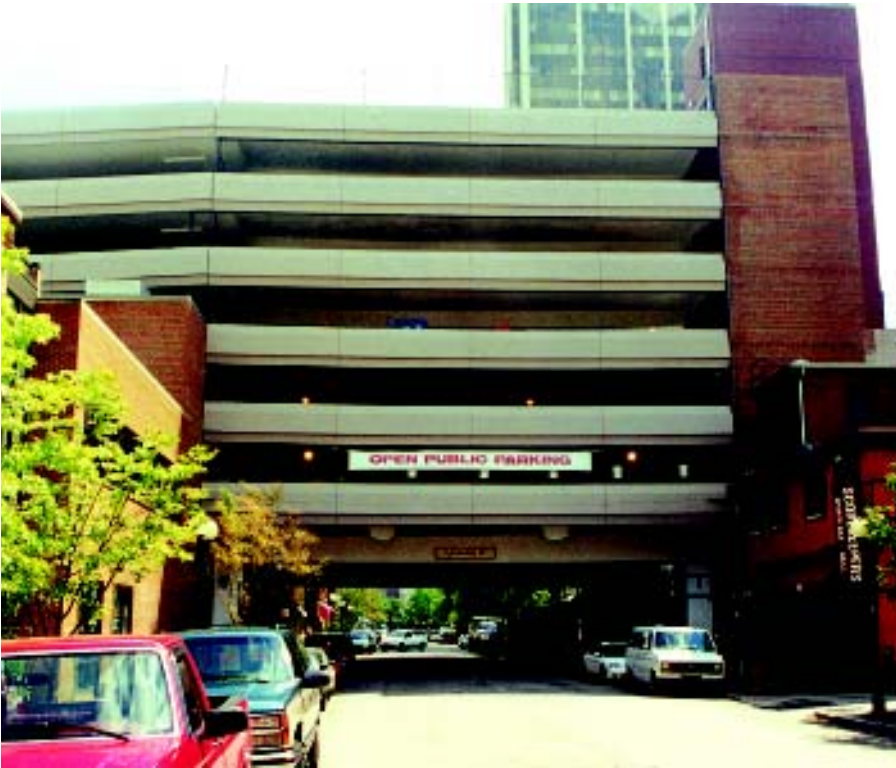
Renovated structure—Maynard Street view

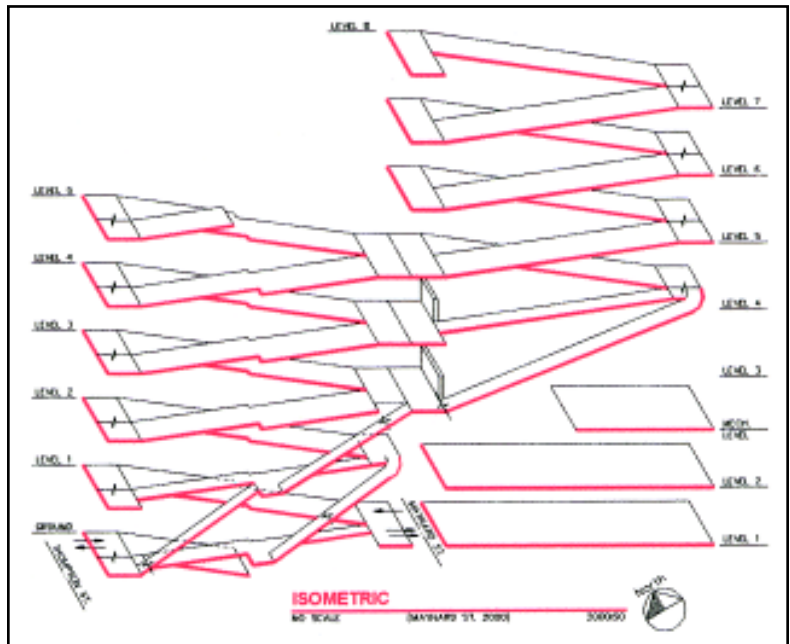
Figure 1: Isometric view of complex Maynard Street Parking Garage

The two-bay structure consists of eight parking levels providing approximately 285,000 square feet of parking for 811 vehicles. The parking structure footprint is approximately 140 feet in the north/south direction by 465 feet in the east/west direction. Vehicular access to the structure is provided by two entry/exits on opposite ends of the parking structure (Figure 1).

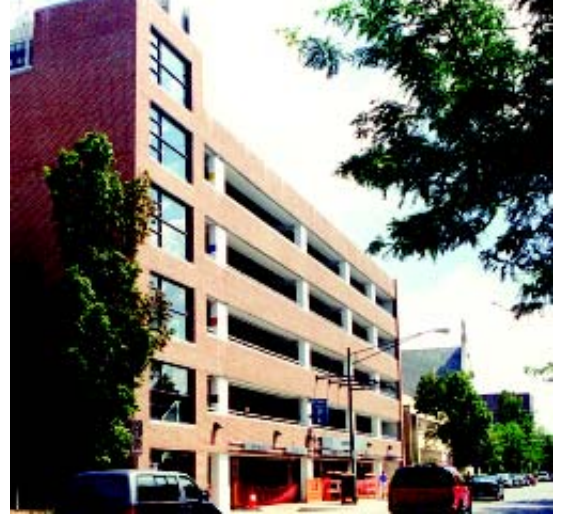
*Renovation complete—Thompson Street view*

Because the structure needed extensive masonry repairs, the entire brick masonry veneer was removed and replaced with new masonry brick, capstones, and hot-dipped galvanized pedestrian railings. To improve the natural light and ventilation into the ends of the structure, the existing wall heights were lowered and pedestrian railings were installed to provide the code-required pedestrian railing heights.

The lighting was also improved in all full slab replacement areas, which received new metal halide

lights. Lighting in the remaining areas of the structure remained the previous high-pressure sodium type, but was supplemented with salvaged fixtures from the full slab replacement areas.
