Fairview Hospital Parking Garage

The Fairview Hospital Parking Garage is a six-level, precast concrete parking garage (approximately 735 cars), built in 1975. The hospital is located in a residential area, so a very limited area is available for employee, patient, and visitor parking. The original parking garage construction consisted of precast concrete double-tees placed on precast columns and beams. A concrete topping was then installed over the precast tee units. Heavy use of deicing salts over the years,

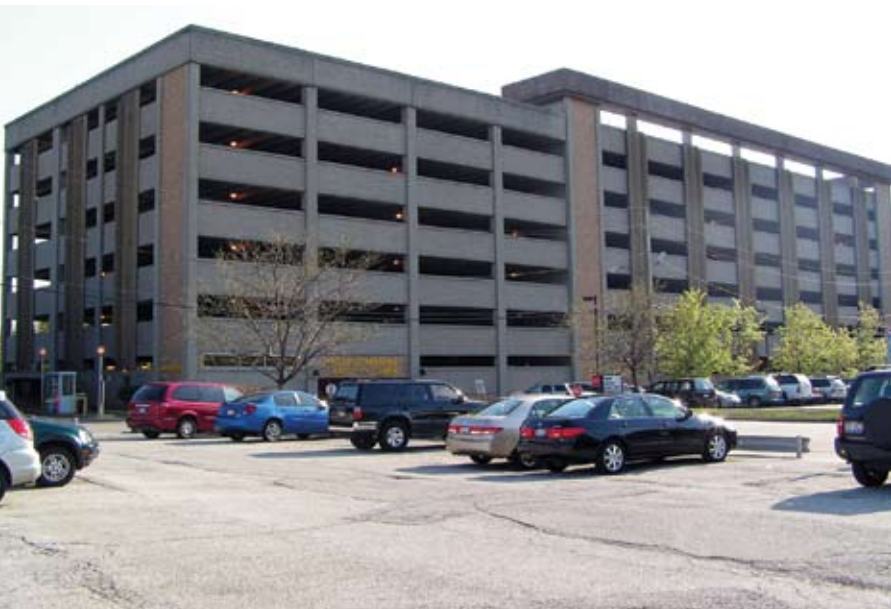
Fairview Hospital Parking Garage

adequate cure time. Forms were then removed and the area was reopened for parking.

Finally, an anti-corrosion coating was applied to any exposed steel in the partial- and full-depth repairs.
