# Hyperbolic Cooling Tower Column and Lintel Beam Cathodic Protection

Jacksonville, Florida

Submitted by Existing Structures Engineering

2006 Award of Excellence

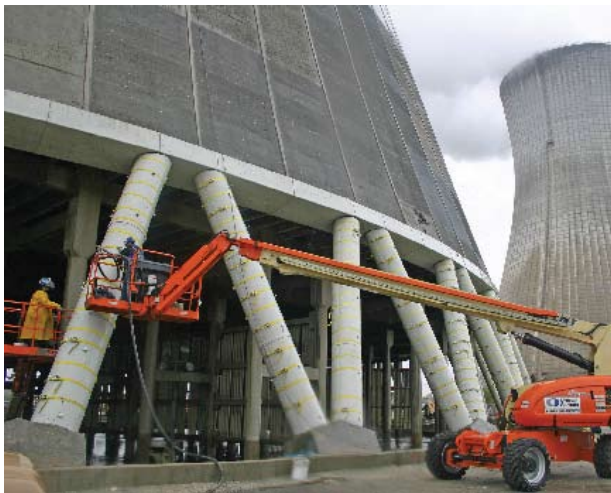
Fig. 1: St. Johns River Power Park Unit No. 2 Hyperbolic Cooling Tower

Located at St. John's River Power Plant in Jacksonville, FL, this project featured work on the Unit No. 2 hyperbolic cooling tower (Fig. 1). Hyperbolic natural draft cooling towers are eye-catching in form, but this shape serves a functional purpose in that it cools the water received from the steam condensers at a much lower operating cost than mechanical draft cooling towers.
