# Missouri State University's Historic Quad Restoration

Springfield, Missouri

Submitted by Structural Engineering Associates, Inc.

2008 Award of Excellence

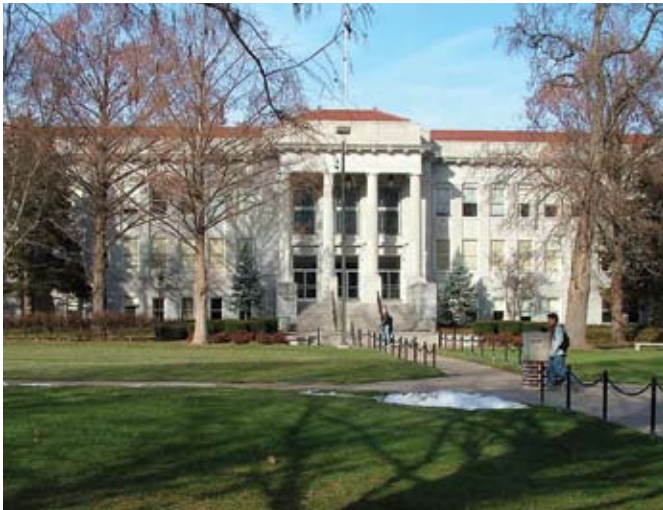
*Siceluff Hall*

Years of exposure to the elements had led to deterioration of some of the mortar joints. During

the investigative stage, the amount of required tuckpointing was quantified. Areas where stone had been damaged either from impact or weathering were also identified and quantified. Exposure to the elements had also resulted in a dirty or stained appearance. Some of the stone was experiencing a general weathering effect pointing to the need for the application of penetrating water repellents to extend the life of the stone.

Water infiltration was attacking both the top and bottom of the building, seeping in through the foundation and leaking through the original concealed copper gutters. Piezometers were installed at select locations around the building foundation to rule out the possibility of significant ground water sources. The absence of a significant ground water source allowed the design of a below-grade waterproofing system without the need for ground water collection systems. The foundation walls were waterproofed below grade with a self-adhering sheet waterproofing system and a drainage mat that serves to transport surface and below-grade moisture to foundation drains. The foundation drains collect this water and are connected to the storm sewer system.

Leaks through the joints of the original copper gutters had led to rotting of the bottom chord of the main timber roof trusses at support locations. This created great concern for the structural stability of the roof, and it was strengthened by adding structural steel members to each side of the bottom chord and the first panel of the truss members. New steel was then welded to the steel plates embedded in the masonry pilasters. Great care had to be taken during the welding of these structural steel members, which were adjacent to the wood truss members and needed protection against fire.

Sicheluff's front steps were constructed of concrete with limestone treads with walls constructed of brick and stone veneer. Corrosion was so significant that full removal and replacement of the concrete stairs was required. After the new concrete stairs were constructed, a new sheet-applied waterproofing membrane was installed to prevent water and chloride

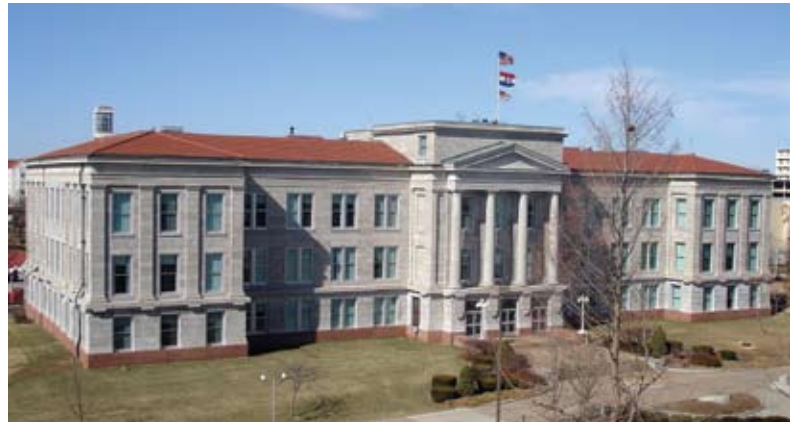
*Carrington Hall*

Carrington Hall, the second phase of this project, showed signs of deterioration from the elements. Mortar joints were deteriorated, cracked, or missing and some of the stone showed signs of general deterioration. At one time, space was added to the building by enclosing open-air entry ways. Stone and cast stone were removed from their original locations and reused to clad the addition. This process was not kind to the stone, damaging it and leaving a multitude of small chips in the face of the stone. In addition, one of the cast stone parapet caps had once been replaced with a very poor match.

The gutters were in relatively good condition with the exception of the joints, which were soldered and sealed. The downspouts had been damaged from impact and freezing water. Copper gutters matching the originals were used. The copper was patined to match the original.

To repair the mortar deterioration, the building was tuckpointed and sealant joints were replaced. Damaged stone was patched using a stone patch material that was specially formulated to match the existing stone. The end result was stone and cast stone patching that was virtually undetectable from the ground surface.

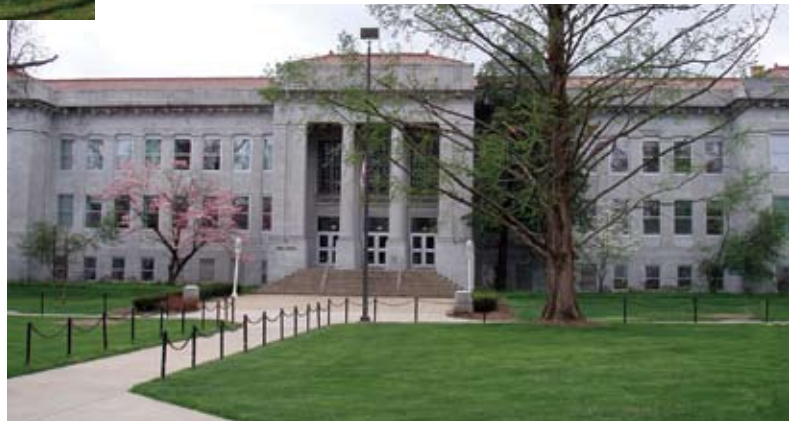
*Hill Hall*

Hill Hall was the final phase of the Quad Restoration project. After the initial building investigation, it was clear that the major concern was deterioration of some of the building stone. Signs of moderate deterioration indicated that if steps were not taken, the deterioration, fractures, and spalling could advance to the point where the original beauty of the building could be scarred forever. A stone consolidator was applied to certain portions of the stone that showed deterioration.

Mortar joints were also deteriorated and the building was dirty and stained. Several penetrations had been made in the original veneer for drains and

During the initial investigation, settlement problems were also uncovered at the building's ADA access ramp, which had been added approximately 75 years after the original construction. It had undergone considerable settlement, which was observed by offsets in mortar joint planes and gaps between the original building and the addition. Extensive excavation and underpinning were performed to stabilize and lift the ADA ramp back to its original location.

plumbing. These were repaired by the restoration contractor using a specially formulated stone patch material that resulted in an excellent match.
