SUNY Health Science Center Brooklyn Parking Structure Strengthening

Brooklyn, NY

Submitted by Carl Walker, Inc.

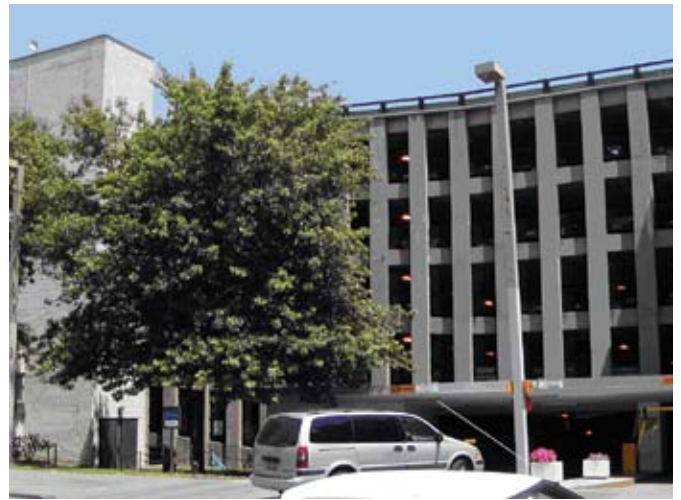
FRP strengthening

The surface was primed and then two layers of carbon FRP were installed. A saturator was used to saturate the fabric prior to being applied. To provide a durable wear-resistant protection for the structural FRP, an extra layer of epoxy resin was installed on top of the second layer of FRP. A urethane traffic bearing membrane was then installed over the entire area and adjacent unstrengthened concrete areas to provide a uniform and waterproof coating.
