# Terminal Tower Façade Repairs

Cleveland, Ohio

Submitted by Sika Corporation

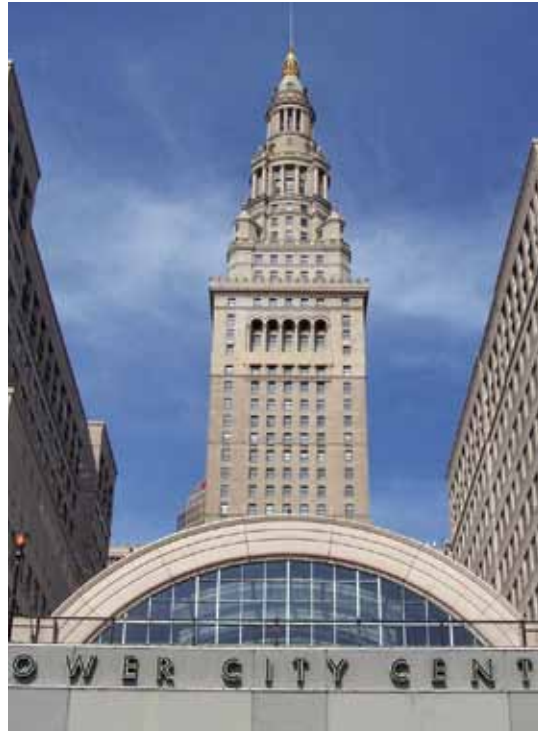
Continued water infiltration as a result of decades of exposure to the harsh Midwest coastal environment caused interior water damage and accelerated deterioration. Active paths for water infiltration included failed mortar joints, flashing, and terra cotta units. There were cases where sealant had pulled away and exacerbated the problem

*Terminal Tower Façade Repair Project, Cleveland, OH*

by slowing the evaporation of water. Steel flanges rusted and expanded, causing pieces of terra cotta to loosen and fall and resulting in cornices that needed to be strapped into place.
