# Upper Perry Arch Bridge Repairs

La Grande, Oregon

Submitted by The Euclid Chemical Company

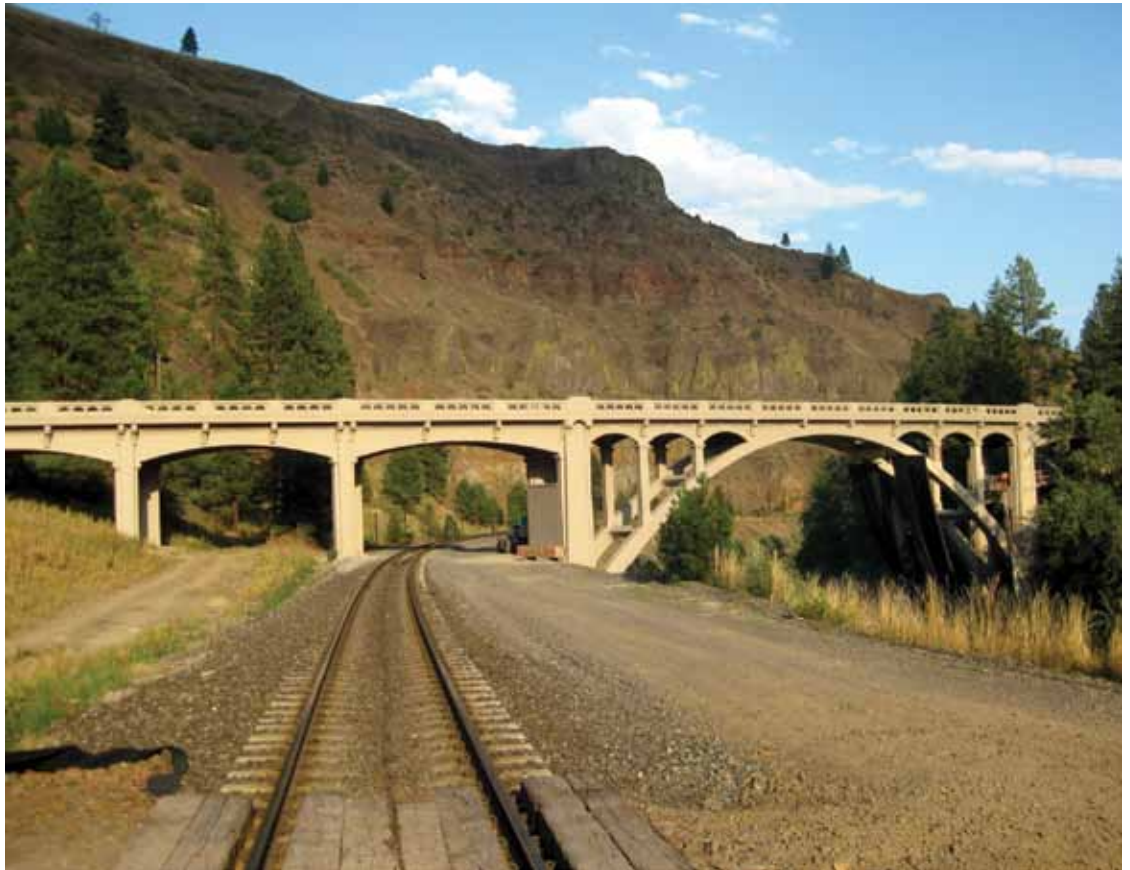
*Upper Perry Arch Bridge after restoration*

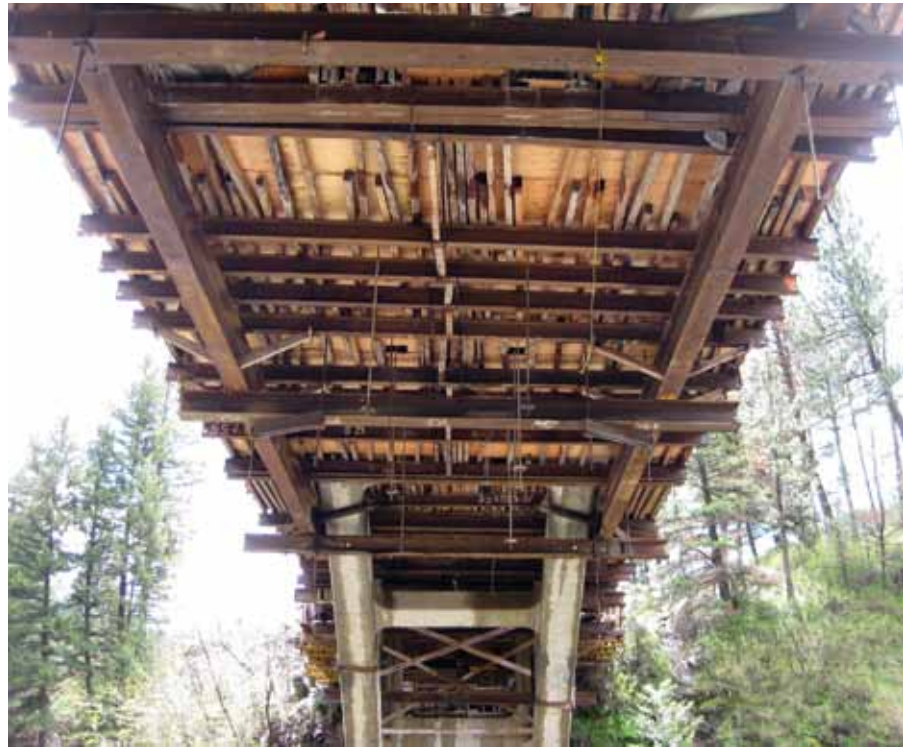
*Deck shoring from below*

The owner, design team, and contractor worked together to address the special considerations regarding sequencing, which were necessary so that the arch was loaded equally during demolition, repair, and construction.

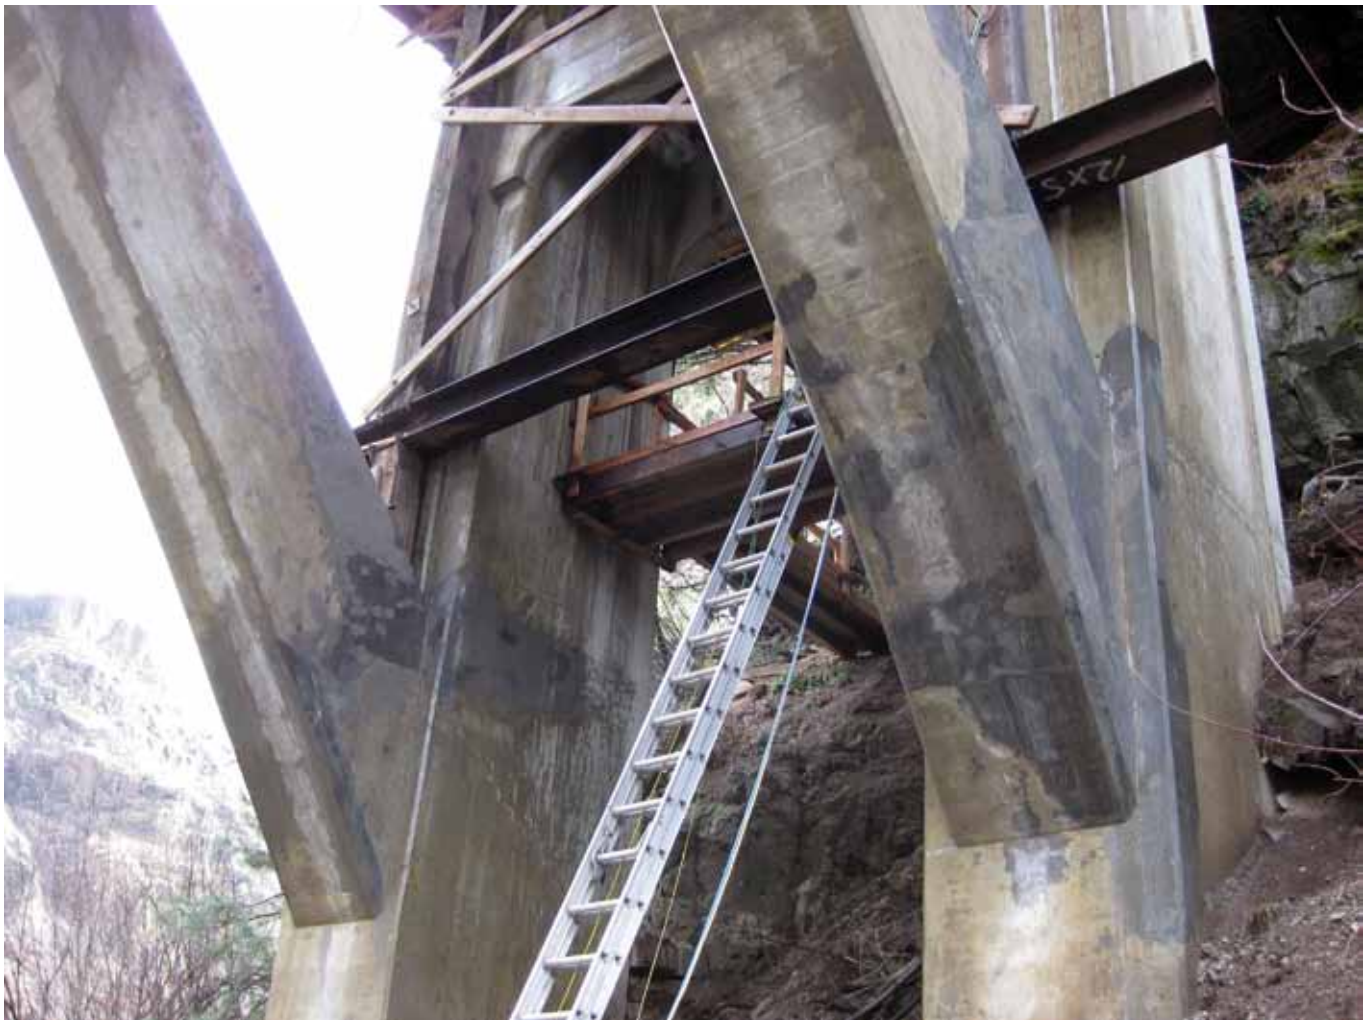
*Repaired arch*

Repair work to the bridge included a total of 1130 linear feet (344.4 m) of epoxy crack injection, over 2000 ft<sup>2</sup> (185.8 m<sup>2</sup>) of regular cast-in-place concrete repair (up to 2 in. [50.8 mm] in depth), and 810 ft<sup>2</sup> (75.3 m<sup>2</sup>) of deep concrete repair (up to 16 in. [406.4 mm] in depth), which was also cast in place. Over 2800 ft<sup>2</sup> (260 m<sup>2</sup>) of damaged concrete was removed and replaced with 550 ft<sup>3</sup> (15.6 m<sup>3</sup>) of the prepackaged repair mortar, which is 65% more damaged concrete than originally anticipated.

blankets. Due to the poor condition of the concrete, only 10 ft (3.05 m) sections of each arch could be repaired at a time.

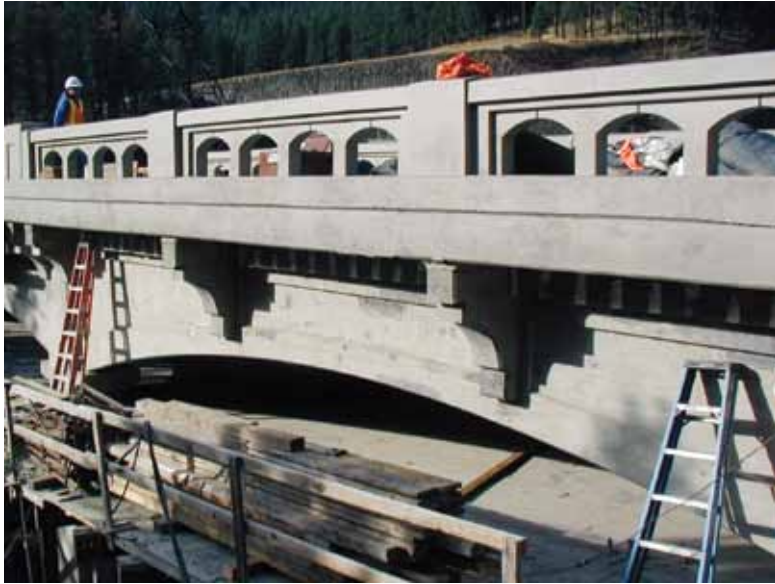
*Repaired corbels and concrete railings*

This work included rehabilitating four approach spans and complete replacement of the span supported by the main arches. All bridge rails, cross-beams, decks, spandrel posts, sidewalk brackets, and corbels were demolished and replaced. The arches and bents were salvaged; the cracks were injected with epoxy; and the unsound, deteriorated concrete was removed and repoured in place.

A total of 306 dentils and 68 sidewalk brackets (corbels) were demolished, meticulously formed, and cast in place.

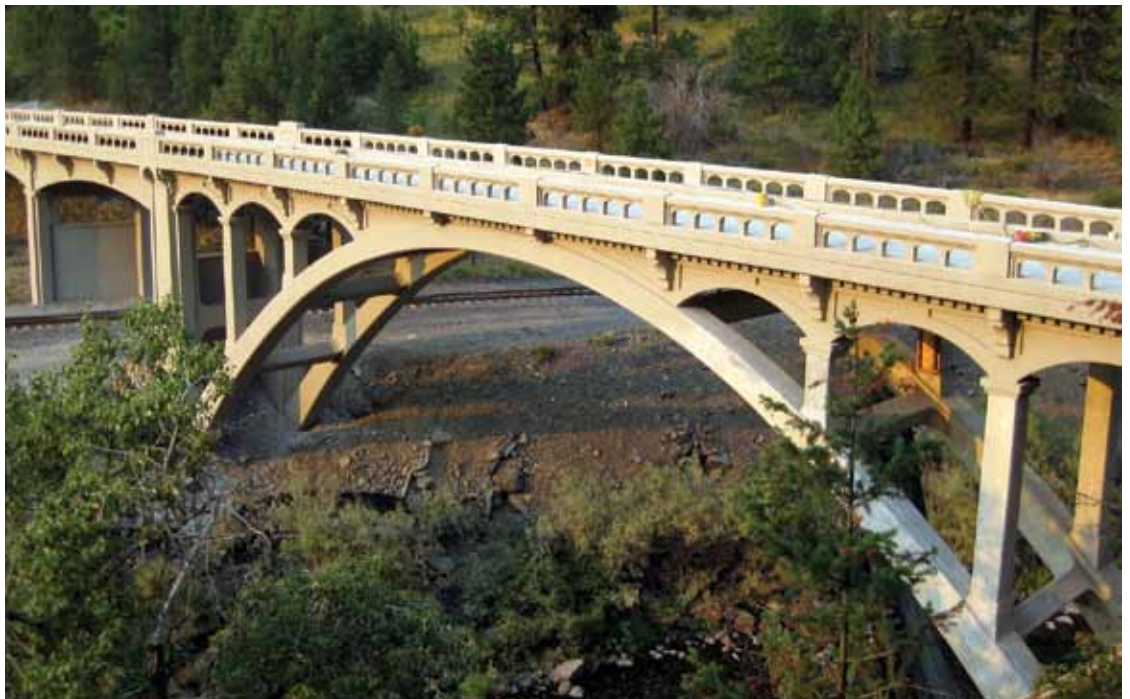
*Upper Perry Arch Bridge after restoration*
